# **The Use of Infrared and Solar-blind UV Cameras and UAS / Drones to Inspect Utility Transmission Lines**

James Brady, Level III Certified Infrared Thermographer

Brady Infrared Inspections, Inc.  
935 Pine Castle Court  
Stuart, FL 34996

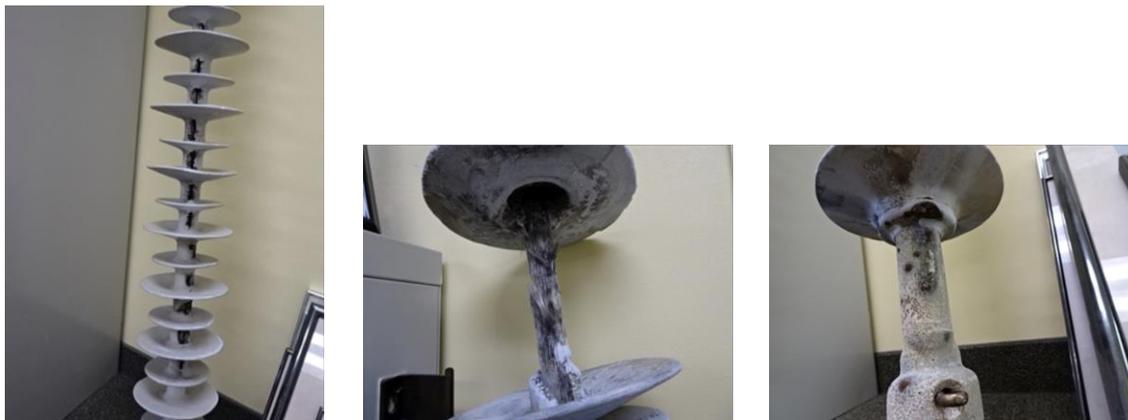
What brought our company into the world of solar blind UV camera inspections was one of our utility clients had experienced sudden and catastrophic failures on 138kV polymer insulators (Figure 1). This was a line that we were inspecting annually with infrared so it was no surprise that questions arose to the effectiveness of this survey. Looking at the failure pattern on the insulator(s) it was suspected that corona was to blame for the failures and performing an inspection specific to detect it would be beneficial.

**Figure 1: Showing rupture pattern on polymer insulator; dark areas between sheds in the failure pathway the fault followed to ground. Middle photo shows sheds closer to live end and photo on left is the ground side; show existing path of electrical fault.**

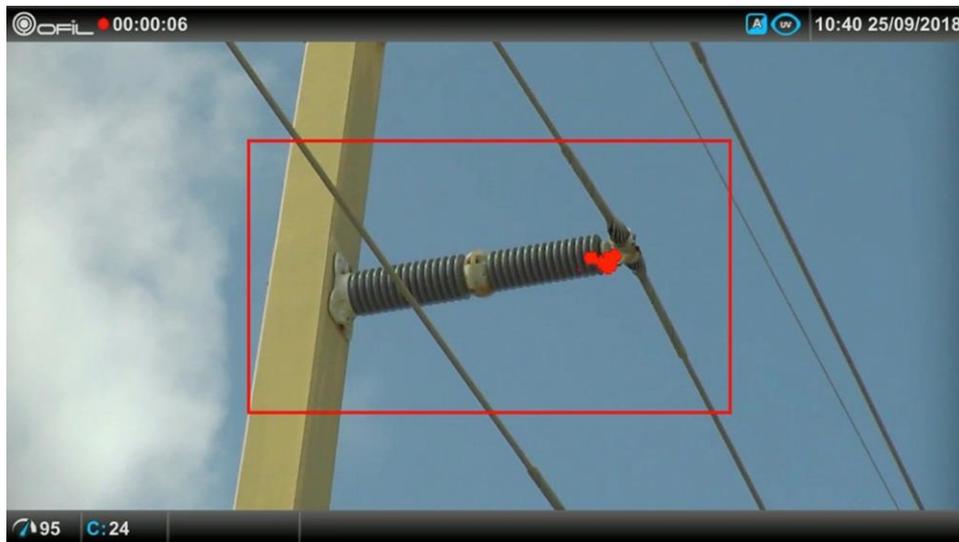
**Figure 3: showing a 69kV ceramic insulator with corona activity on the live end conductor shoe.**

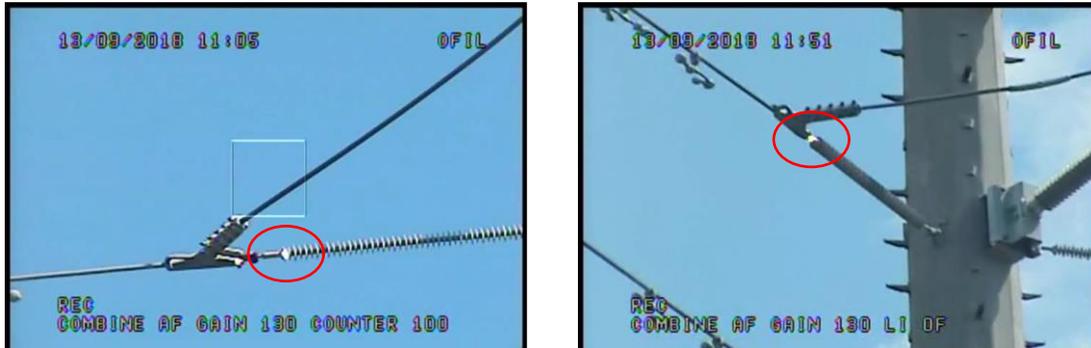
The corona pattern shown in Figure 5 is typical for what was found on dead-end structures; activity on the live-end mold seam line where the polymer sheath meets the end housing. There were 15 to 20 similar-type problems found during the survey.

**Figure 5:** shows examples of corona detected on the live end of dead-end insulators (red circle).

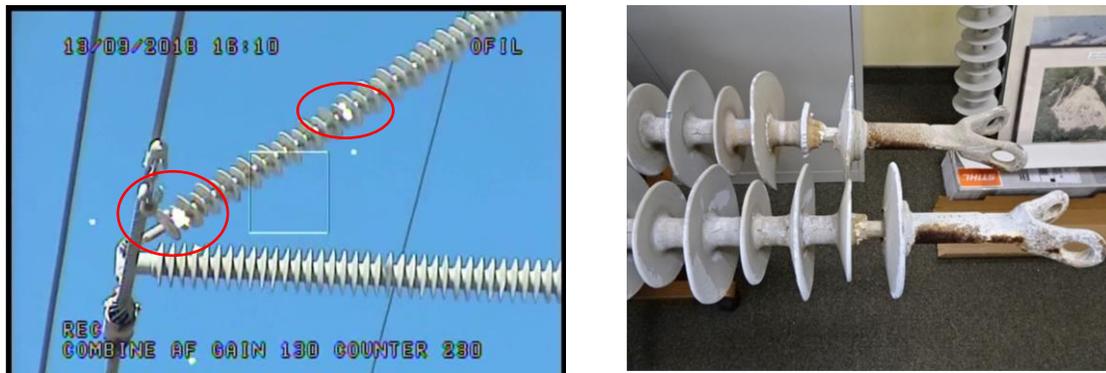
The corona pattern shown in Figure 6 was one a several findings of serious corona damage found on 45-degree bracing insulators. During the survey, three of these types of findings were immediately replaced and another 5 to 6 were scheduled for replacement over the next month. It is suspected that the smaller diameter insulator is causing the equipotential field to tighten significantly and generate a strong E-field; a favorable environment for corona to develop. The failure mode in this case is similar to that explained earlier, when water enters the interior of the insulator. The left image shows the migration pattern of corona activity and the shortening of the arc distance from the live end to ground.

**Figure 6:** shows examples of corona detected on 45-degree bracing insulator (red circle). The photo on the right is a close up of two insulators that were found and immediately taken out of service during the survey. Note the exposed fiberglass rod at the site of corona activity.

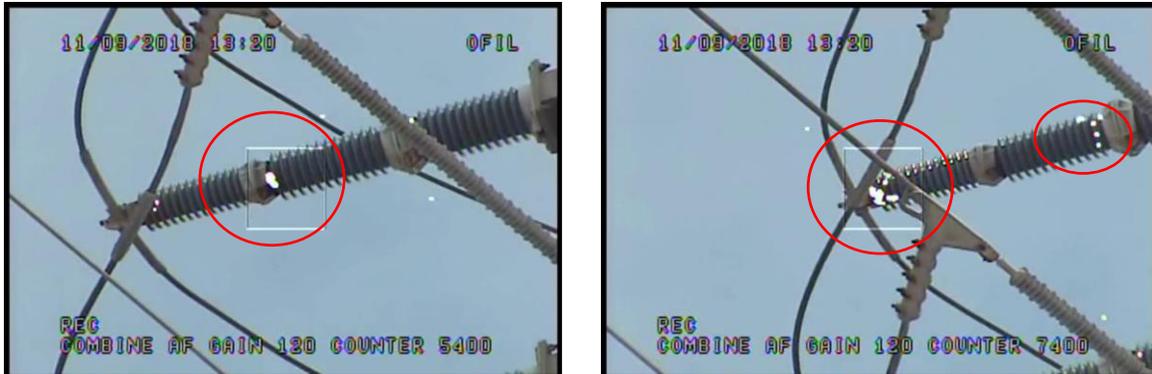
The photos in Figure 7 show corona activity on ceramic insulators. It is also possible that we are seeing dry-band arcing caused by surface leaking current due to pollution accumulation. Notice, however, that the arc-distance has been significantly reduced, especially on the right image.

**Figure 7: shows examples of corona detected on ceramic stand-off insulators at the bolted joint and the live-end mechanical shoe attachment**

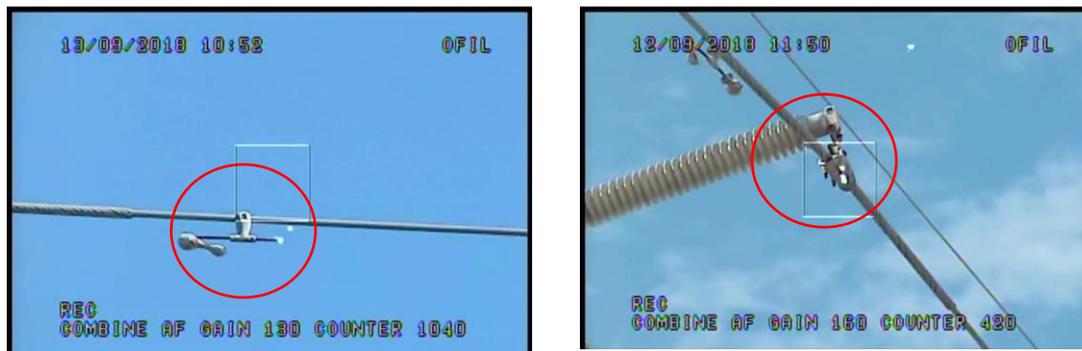
The photos in Figure 8 show corona activity on the point of where a line vibration dampener weight used to be (left photo). While not a critical threat to the system, the corona camera easily identified the damaged component, which is designed to control wind generated oscillations and reduce stress on conductor strands. The photo on the right shows corona activity on bolt ends on a line shoe. Again, not an immediate threat to the system, but the mild acids generated from corona will accelerate the oxidation process on hardware.

**Figure 8: shows examples of corona detected on pointed ends of anti-vibration weight support and bolt ends on conductor shoe**

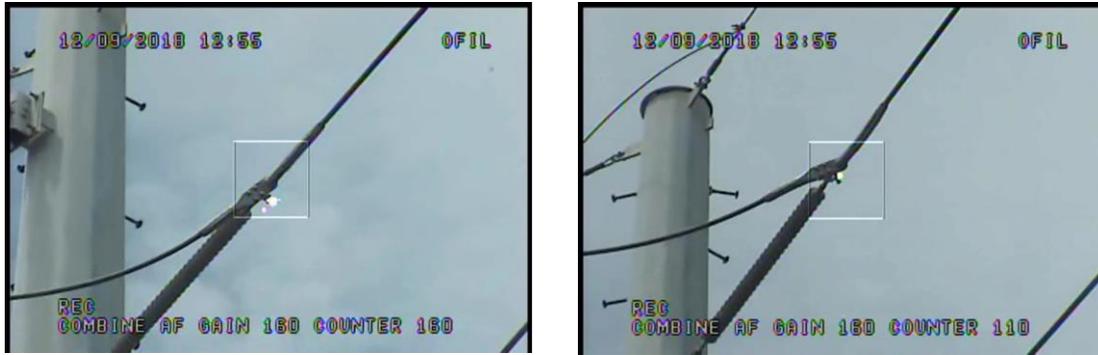
The photos in Figure 9 show corona activity on a bolt-pin that holds the line shoe to the dead insulator. Close inspection showed that the cotter pin that prevents the bolt-pin from backing out and dropping the lines was almost completely deteriorated through long-term exposure to corona activity.

**Figure 9:** shows examples of corona detected on cotter pin connections at the live end of the end-end inspector.

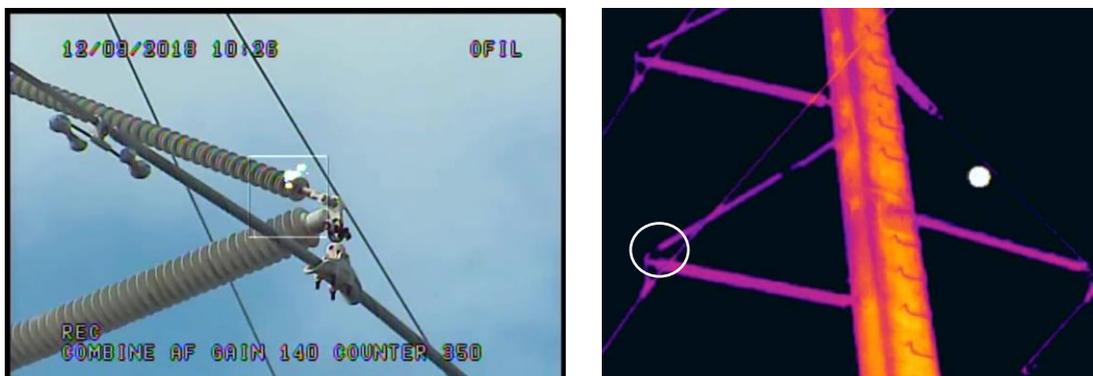
In most instances, findings made with the corona camera were not detected with the infrared camera. Figure 10 is a good example of where corona was detected on a live-end of a 45-degree brace insulator but was not detected with infrared. These two images were taken on the same day, but hours apart. It is possible the corona activity had ceased and thus was not detectable with the infrared camera. It is also possible and more likely the corona activity was not strong enough to produce a detectable heat signature. In this case, the starburst observed with the corona camera was intermittent, and not as strong of a signal as observed on insulators with advanced stages of corona damage.

**Figure 10:** shows an example of corona activity that was not detectable with the infrared imager (white circle on thermogram is location of corona). The large white spot in the background of the thermogram is the moon.

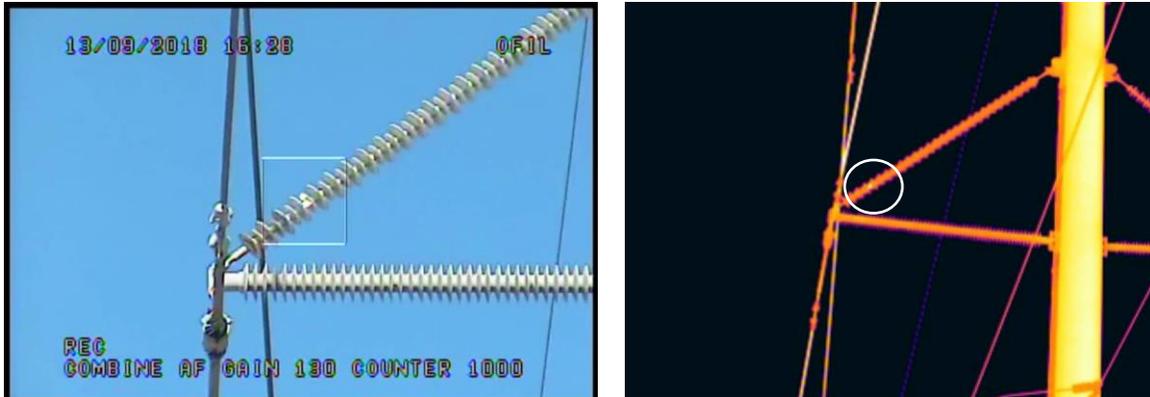
Corona was detected with infrared in a few cases where the activity was strong and provided a persistent signal when viewed through the corona camera. Figure 11 is a good example showing the heat signature of corona, but note that the signature is small and not obvious, lending itself to be easily missed to the untrained eye.

**Figure 11:** shows examples of corona detected with the solar blind corona camera with a heat signature that was detectable with the infrared imager (white circle shows small hot spot).

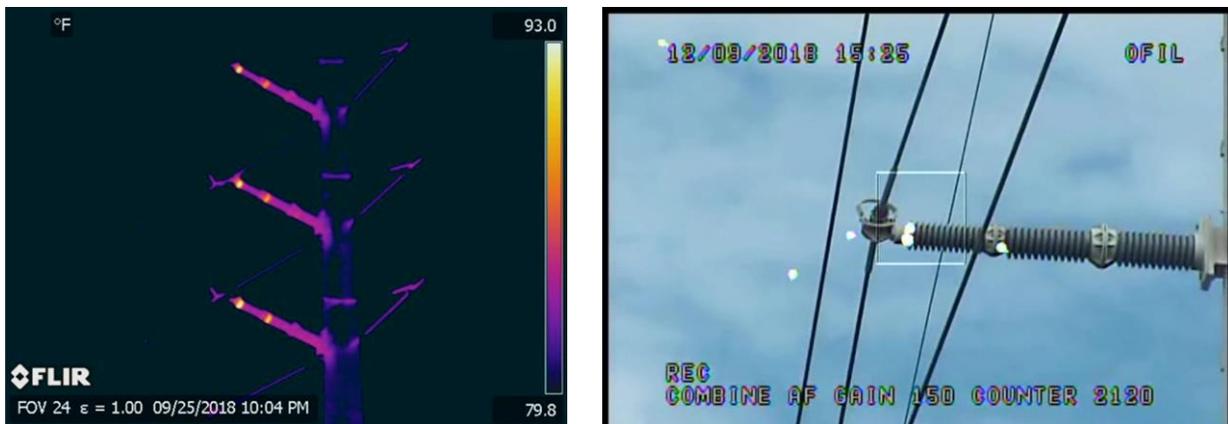
Corona activity and possibly dry-band arcing on ceramic insulators was readily seen with both the infrared and UV camera. Figure 12 shows typical patterns seen with the infrared corona camera on ceramic insulators with discharge.

**Figure 12:** shows examples of corona / dry band arcing detected on ceramic insulators

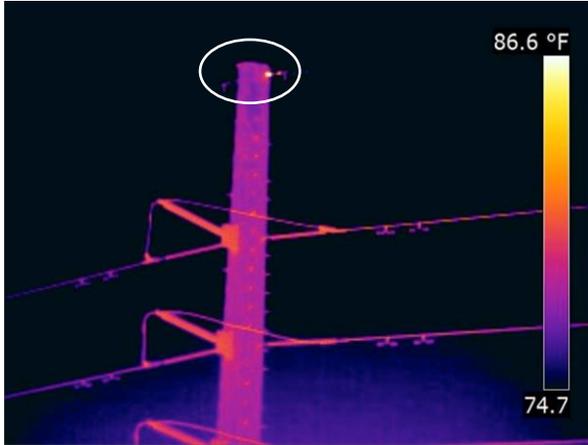
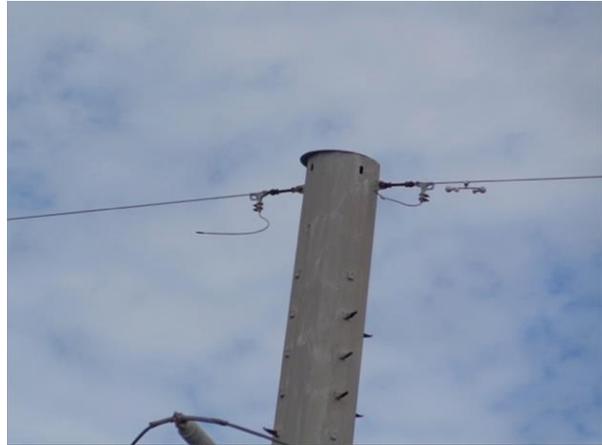
Detecting corona activity was the main focus of this inspection; however, ancillary problems were detected with infrared that were not seen with UV camera. One such problem was a hot spot detected at the dead-end connection of a static line jumper to a metal pole (Figure 13). The jumper wire is broken making the pole a ground point for lightning strikes. The hot spot is manifested by current flow generated from static electricity along the high line meeting resistance at the pole connection.

Figure 13: shows a hot spot detected on a static line connected via a dead-end to a metal pole. Note that the jumper wire is broken and causing the pole to be a new established grounding point.

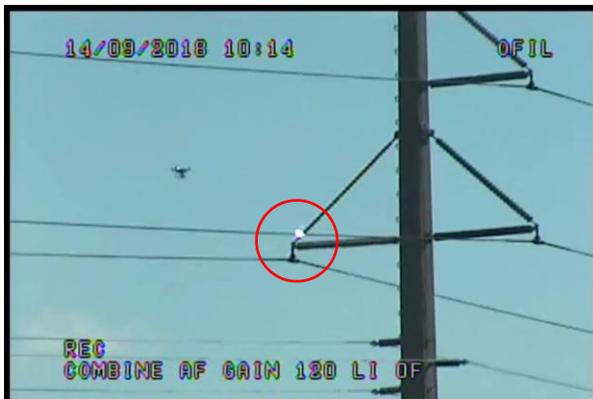
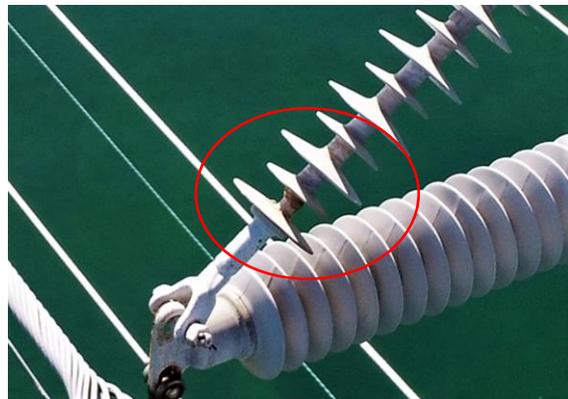
The use of drones on this project was to collect visual photographs of corona damage found on structures that were not easily accessible. The left photo in Figure 14 shows a drone capturing photos of corona activity on a pole that is several hundred yards out over water. The use of a boat to collect this information would have taken several hours and tied up valuable resources from the Utility. The drone accomplished this task in less than ten minutes and provided information that ultimately led to the decision to replace the insulator the following day.

Figure 14: Left photo shows drone capturing visual images of where corona activity was detected on an insulator. Right image shows severity of damage with the fiberglass rod exposed and allowing water to infiltrate the interior of the insulator.
