Infrared Thermography to Detect Refractory Damage in a Fluid Catalytic Cracking Unit

Robert K. Weigle
Infraspection Institute Certified Infrared Thermographer 6175

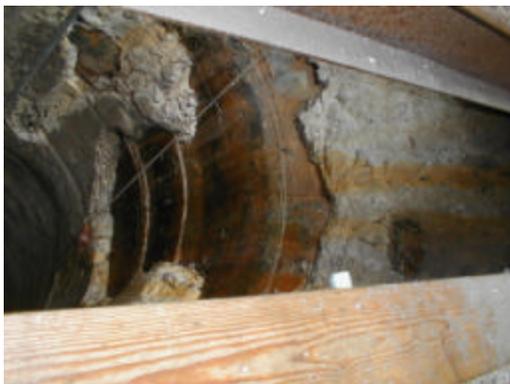
Refractory damage within Regenerator Cone

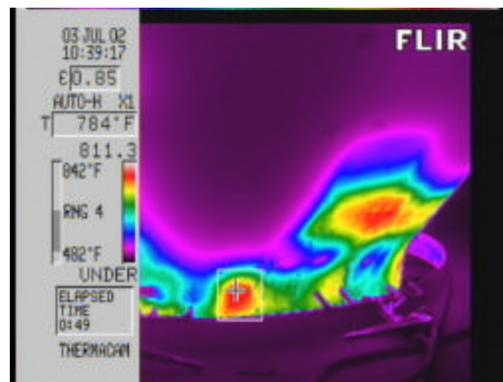
Hotspot caused by refractory damage within Regenerator Cone

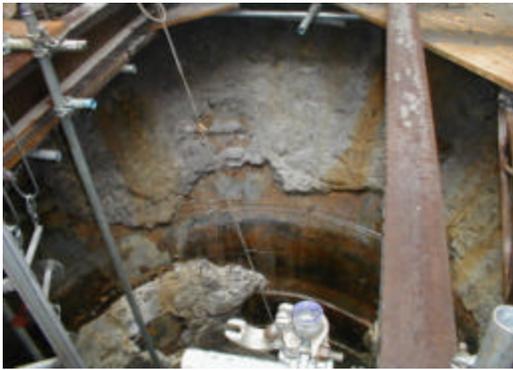
Refractory damage within Regenerator Cone

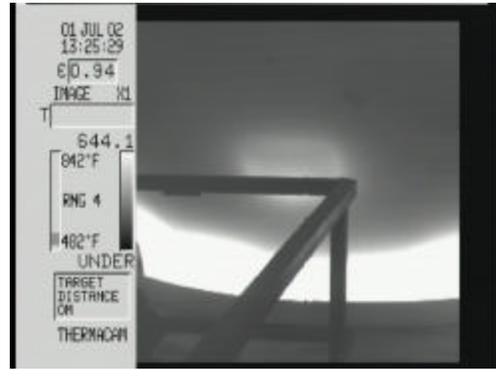
Hotspot caused by refractory damage within Regenerator Cone

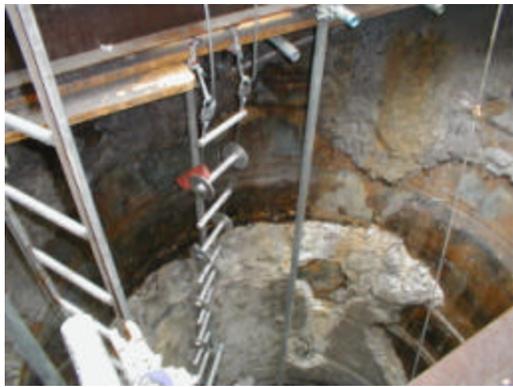
Refractory damage within Regenerator Cone

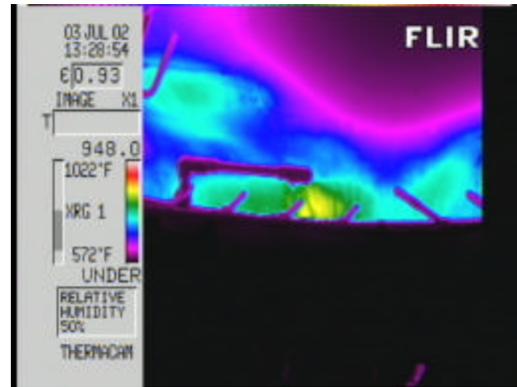
Hotspot caused by refractory damage within Regenerator Cone

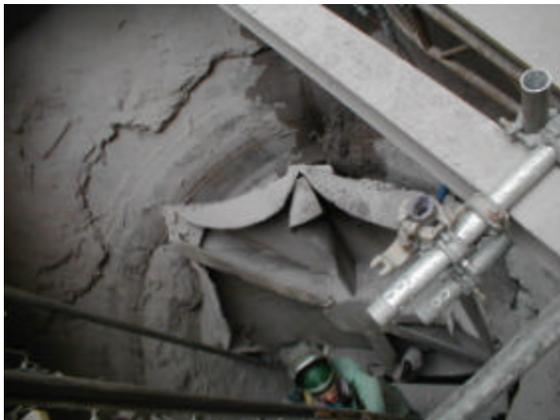
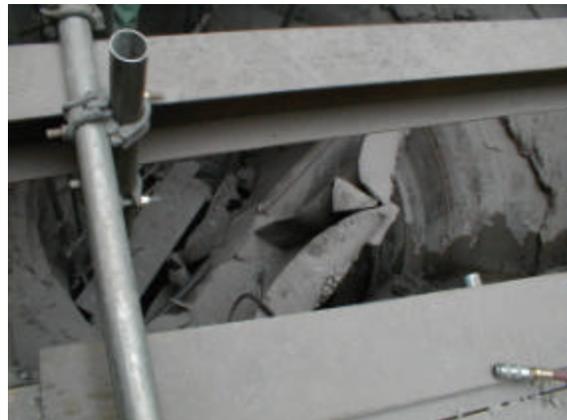
The source of the loud clanking was found to be a deflector plate which had broken away from its steel supports within the Regenerator Cone. This deflector plate, which weighs approximately two tons, had been banging into the sidewall of the Regenerator and had caused extensive damage to the refractory lining. The deflector plate eventually settled into place in the cone.

Photos show detached deflector plate lying inside of Regenerator Cone

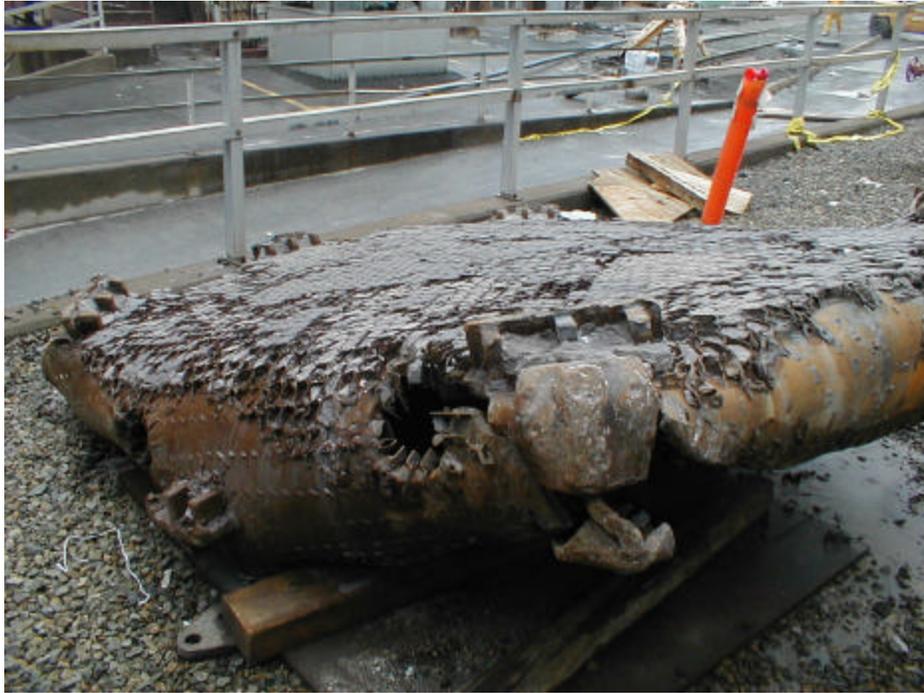
Damaged deflector plate after removal. Note normally straight edges of 4000 lb. steel plate have been rolled over.

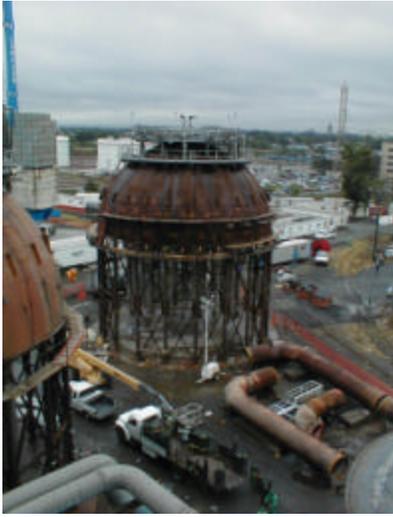
New Regenerator section prior to installation

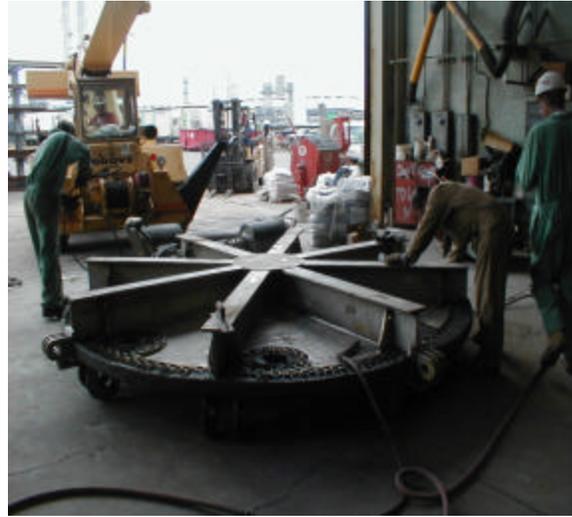
New deflector plate prior to installation
