Corona and Tracking Conditions in Metal-clad Switchgear Case Studies

James Brady, Level-III Certified Thermographer
Brady Infrared Inspections, Inc.
935 Pine Castle Court
Stuart, FL 34996
Tel: 772-288-9884
jbrady@bradyinfrared.com
www.bradyinfrared.com

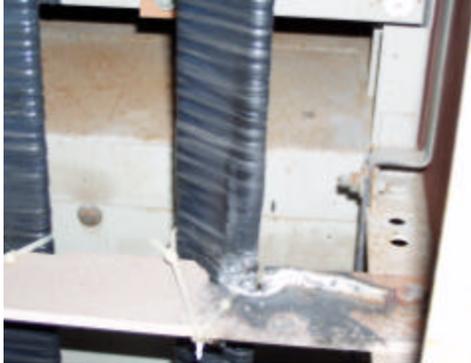
Once corona becomes active, it leaves behind a conductive “tracking” path on surfaces and also creates a very conductive cloud of air around itself. A flash-over can occur once a tracking pathway is completed from phase to phase or phase to ground (Fig. 1). It can also occur from the conductive cloud of surrounding air once it finds a path to ground.

Figure 1: Advanced stage of carbon tracks on insulation board and insulated tape wrap on 4160V bus

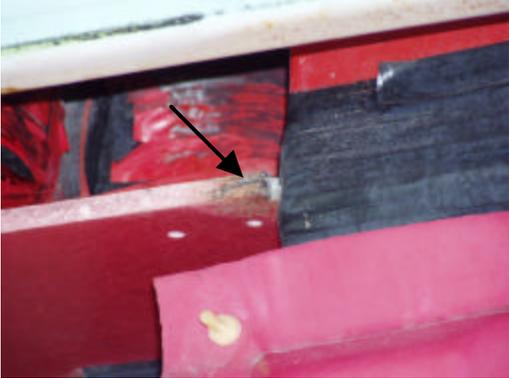
Spatial factors include small air spaces between conductors, insulation board, and switchgear cabinet components. This may result from: 1) conductors being tie-wrapped together; 2) conductors touching insulators, conduit, and edges of cabinets; 3) non-shielded cables in contact with grounded surfaces; 4) bus bars in close proximity to fiber-resin supports and insulator material (Figure 2).

Figure 2: Corona tracks on insulation board close to 13kV bus bars

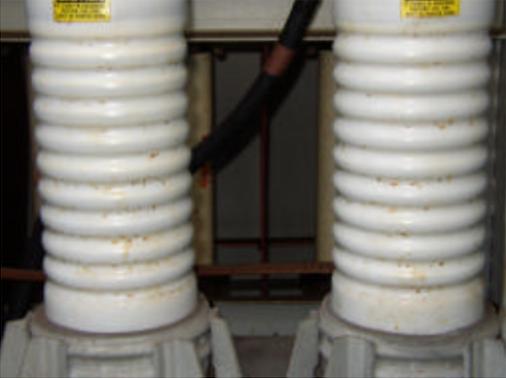
Finally, contamination in the forms of dust, oils/fluids, and other particulates on conductors and insulators will create corona (Figure 3). Corona conditions are exasperated by humid and wet conditions.

Figure 3: Contamination on ceramic bushing caused corona discharge to form

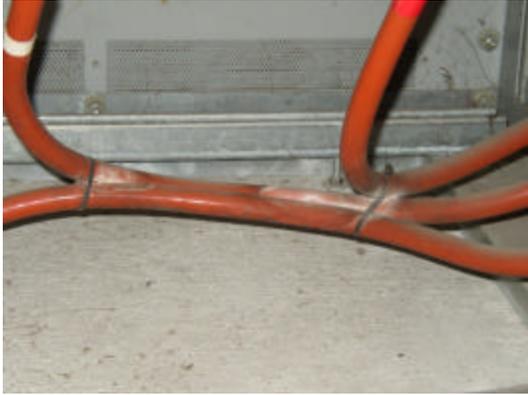
Typically, the effects of corona on rubber-based insulators, tape, and insulation board will leave a white, fibrous power residue or dust (Figure 4). This dust is the physical breakdown of the material.

Figure 4: White powder/dust residue formed on 13kV power cables that are tie-wrapped together, forming tight air spaces between each other; ideal locations for corona to form.

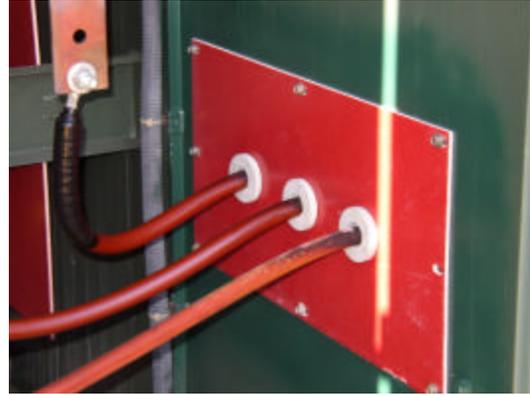
Figure 5: Non-shielded 23kV cables in contact with grounded porcelain collars produce corona conditions. Note discoloration of cable in foreground.

Others indicators include discoloration and pitting on cable insulation (Figure 5). Usually, dull finishes and micro-crack stains on cable insulation will be noticed. In worst case scenarios, cables will be severely deteriorated (Figure 6).

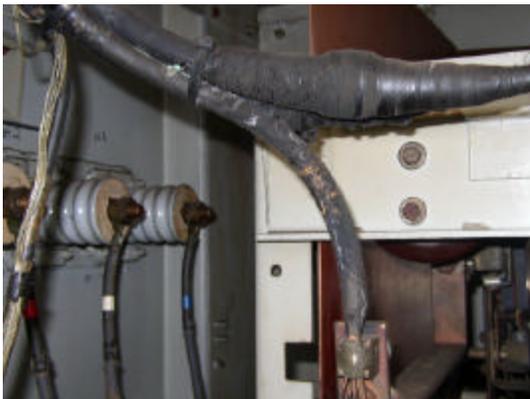
Figure 6: Severely deteriorated power feed cable in 4160V switchgear cabinet displaying white power and carbon tracks

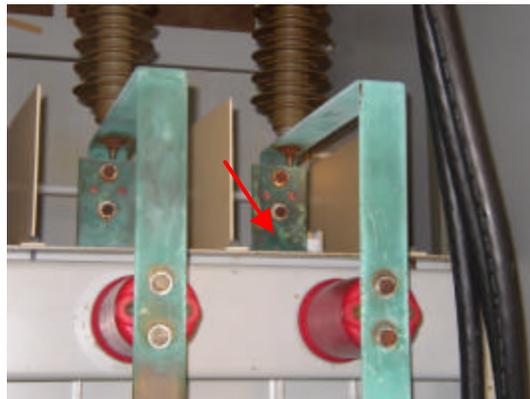
Unusual weathering patterns on copper bus and conductors are also good indicators of corona (Figure 7). Humid and wet conditions inside switchgear cabinets will allow nitric acid to form which attacks the copper surface, leaving unusual weathering patterns. Cabinets lacking heaters, cabinets with poor weather seals, and those next to wet industrial processes are especially vulnerable to these conditions.

Figure 7: Unusual weathering pattern on 13kV copper bus under attack by corona produced nitric acid

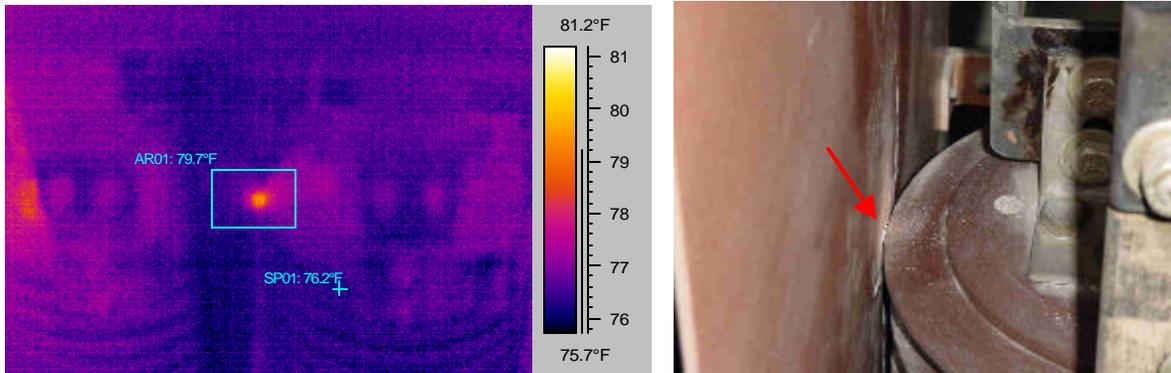
Figures 8a & 8b: A temperature rise of 3 F degrees observed on a 13kV bushing that has corona activity between itself and bakelite board insulation. Note white power on insulation board.

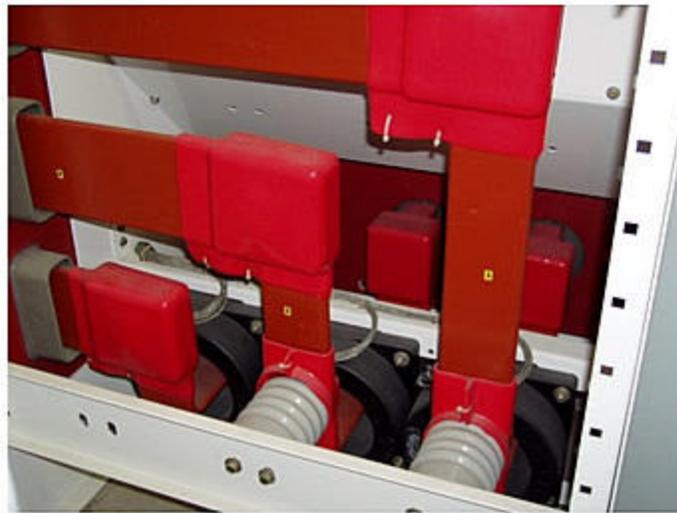
Comments: The most logical explanation for the tracking condition is that the problem that caused the initial flashover is still present. The presence of carbon-rich flash residue will only exasperate the situation by providing very conductive material for tracking paths.

DESCRIPTION OF PROBLEM: Tracking detected on contacts – carbon present from recent failure. No load on equipment during survey.

Back side of cabinet showing stationary contacts

Priority 1 – Take Out of Service

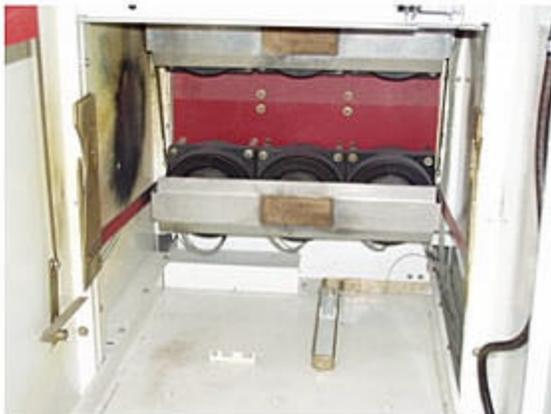
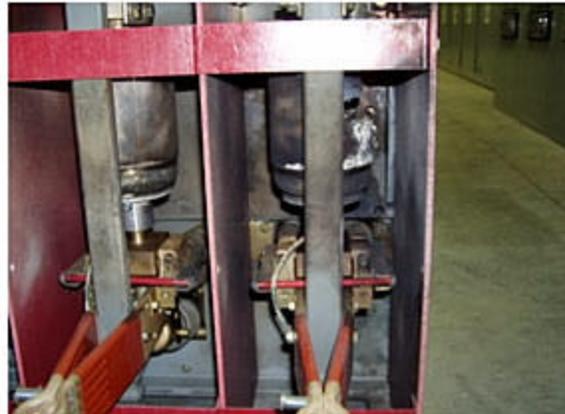
Front side of cabinet with carbon residue and electrical flash-over on breaker

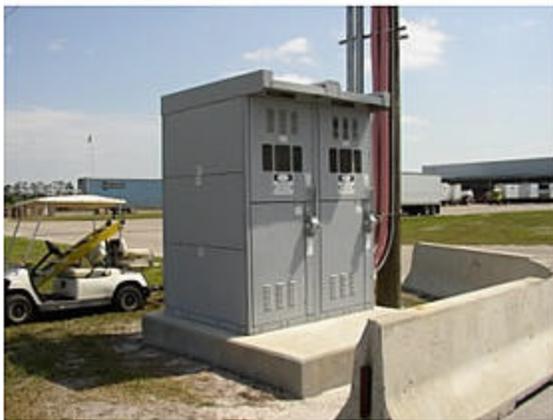
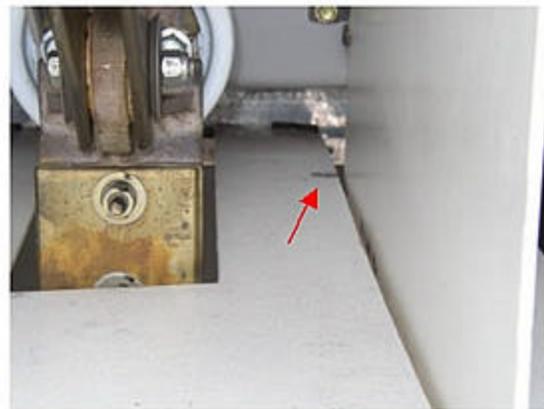
Ultrasound detected a very strong signal characteristic of tracking conditions. The 13kV switch was de-energized and opened for visual inspection. Carbon tracks were discovered on the insulation board separating the B- and C-phase fuses.

DESCRIPTION OF PROBLEM: Tracking conditions detected. No load on equipment during survey

13kV Load Interrupter Cabinet / Carbon tracks on B-phase insulation

Comments: Fortunately, this condition was found just in time. This switch was scheduled to be brought on-line with load shortly after the inspection and would have undoubtedly failed soon thereafter. Maintenance personnel replaced fuses, cleaned all metal parts and installed new insulation board. Once repairs were complete, the switch was energized and a follow-up ultrasound scan was performed, confirming repairs were successful. The switch was then brought on-line with load. Ultrasound and infrared were performed, again confirming that repairs were successful.

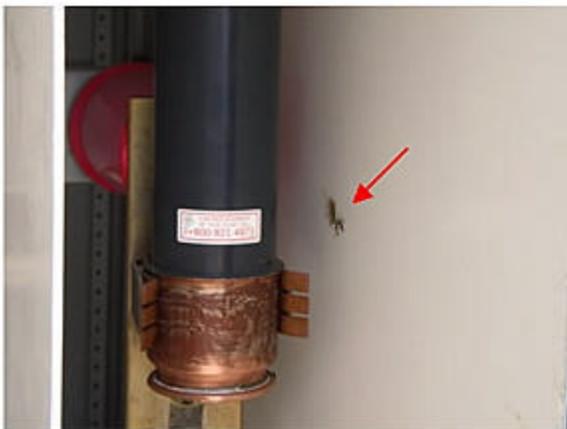
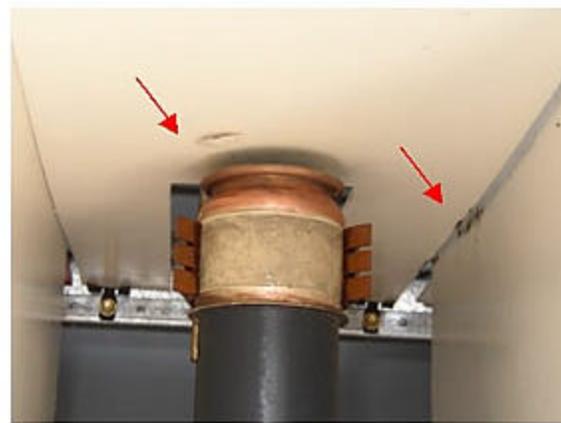
Carbon tracks on insulation between B- & C-phase fuses

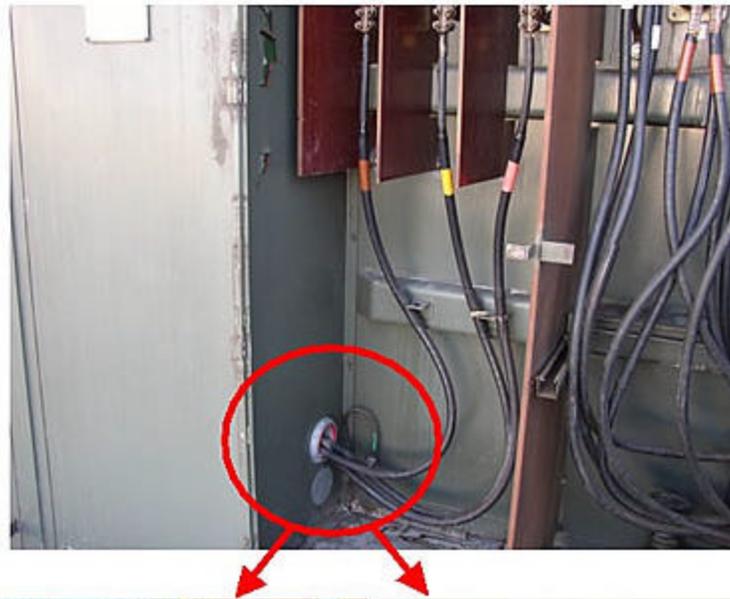
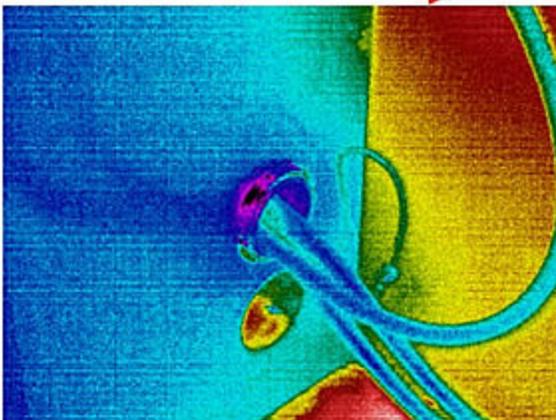
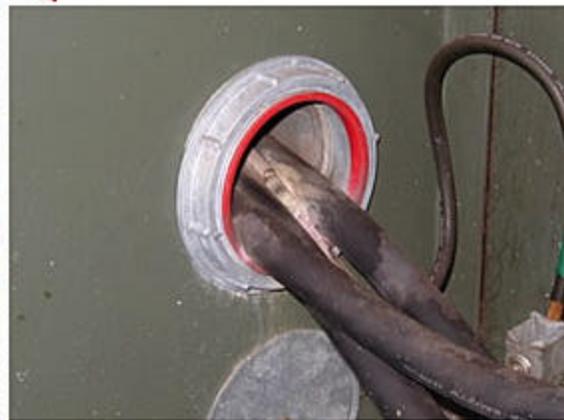
Comments: A visual sign of the corona was white residue power in the small air gap spaces between the cables and the conduit.

DESCRIPTION OF PROBLEM: Ultrasound detected presence of corona on feed lines. Non-shielded cable in contact with ground.

IR image shows no thermal anomaly. Dust / residue on cables from breakdown of insulation

Priority 2 – Correct ASAP

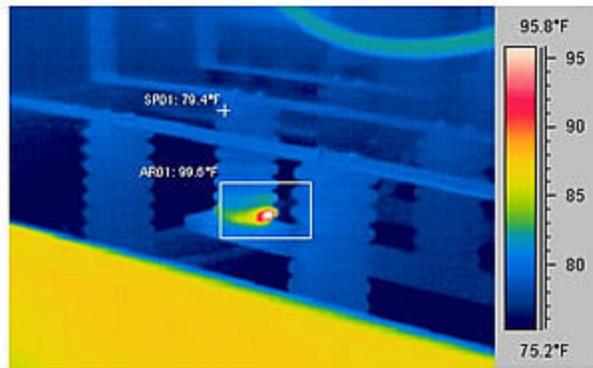
Background: During an inspection two years ago at a telecommunications provider for South America, the 23kV main switchgear cabinet for the facility was inspected with infrared and ultrasound. Infrared results showed a small hot spot on one of the ceramic support bushings for the B-phase bus. Ultrasound found advanced stages of corona at the same location.

DESCRIPTION OF PROBLEM: Sustained arcing within corona powder on bushing

Delta-T of 20 F degrees on bushing hot spot

Priority 2 – Correct ASAP

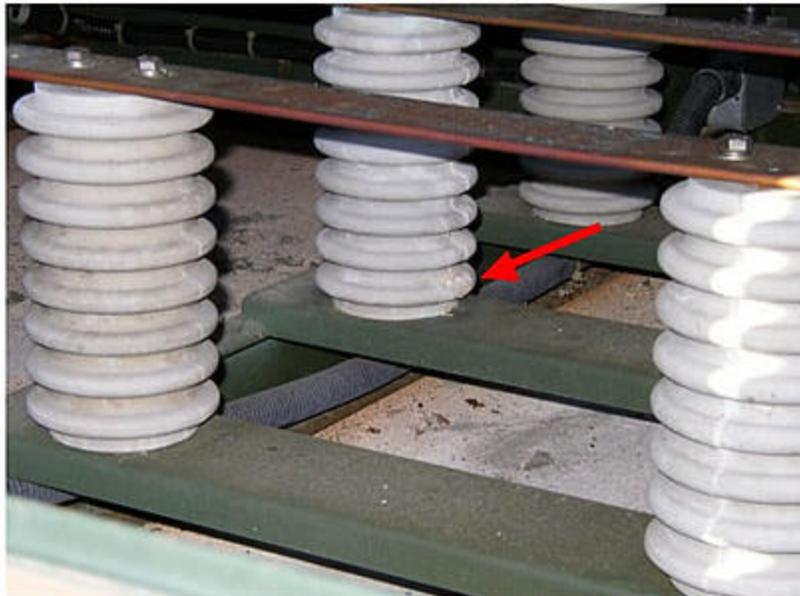
Comments: A visual sign of the corona was white residue power at the same location as the hot spot. Communication with Dan Ninedorf of Ox Creek Energy Associates, Inc. about this unusual hot spot revealed that arcing conditions can be supported within the white power dust of corona.

Conductive corona powder / dust on bushing supporting arcing conditions
