# **Using Ultrasound and Infrared Technologies for Metal-Clad Switchgear Inspections**

Adrian Messer, Manager of US Operations  
UE Systems, Inc.

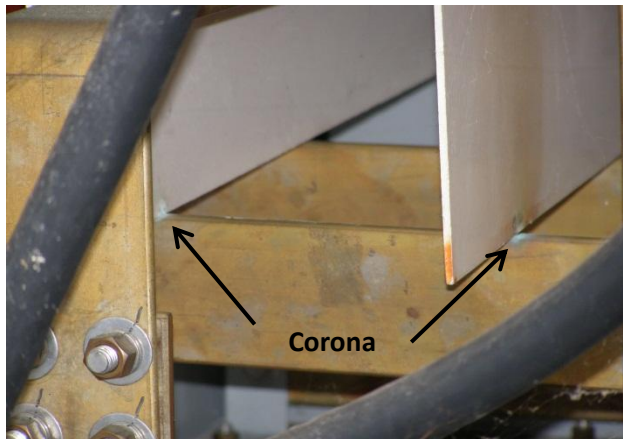
**Figure 1: Corona activity advancing to the tracking stage on insulation board resting on 13kV bus. Notice the carbon deposits and light brown discoloration of the insulation board on the right.**

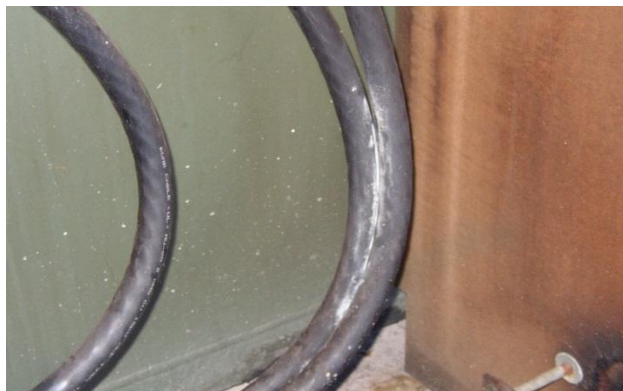
**White powder & discoloration on cables**

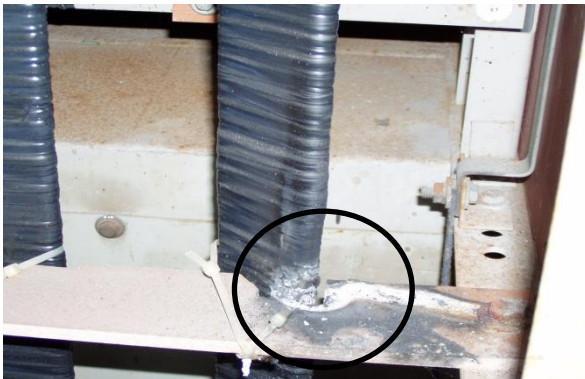
**Undetected corona can lead to a further deterioration of the insulator and lead to tracking and eventually flash over**

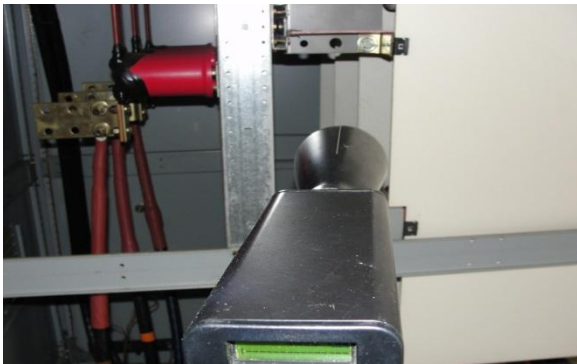
The following images show findings from an ultrasound inspection on a metal-clad piece of switchgear. Ultrasonic noise was detected from the B-phase and was further investigated.

**Limited direct line of sight– ultrasound showed noise originating from B-phase fuse stall**

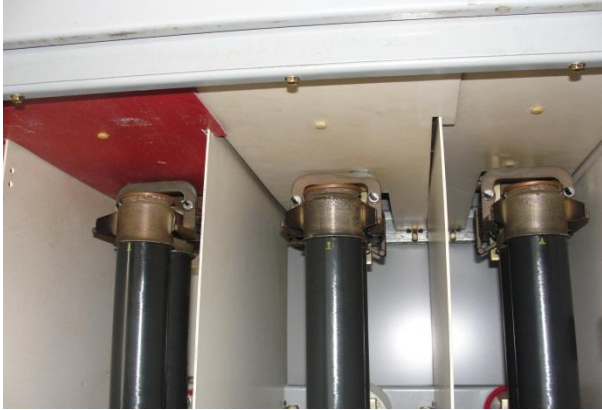
**Further investigation noted that the B-phase, top fuse holder was touching the insulation board**

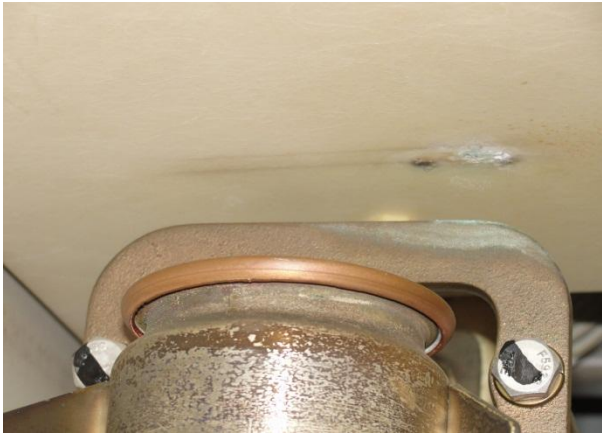
**Tracking with early stages of arcing was discovered**
