Thermography Detection of Previous Water Intrusion

Prof. Kenneth Ripberger, Department Chair, Delgado Community College
Level I Certified Infrared Thermographer

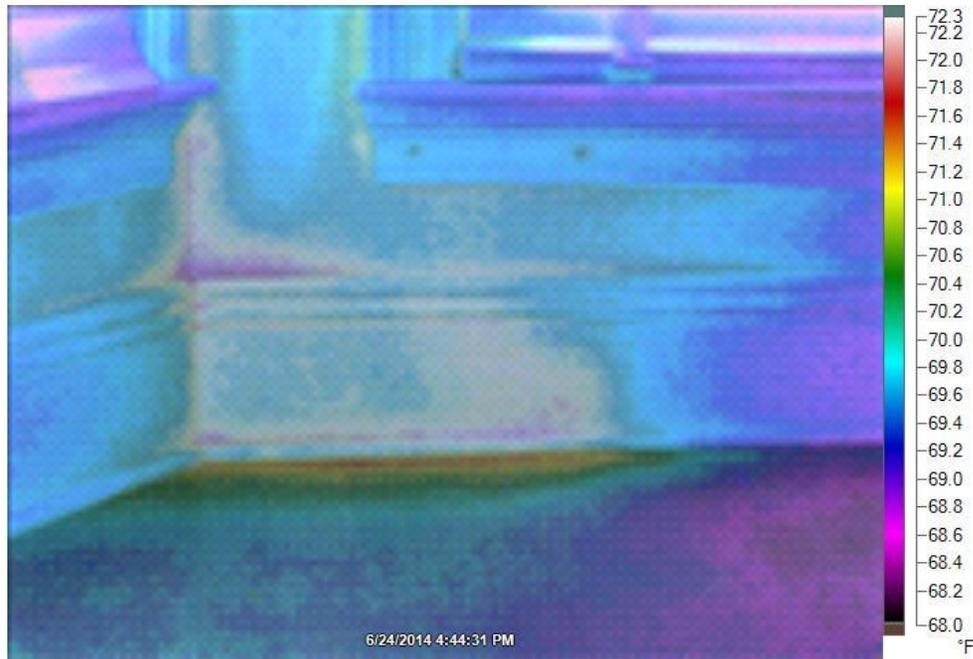
In this inspection, we have a good example of a straight-up bulk moisture wetting problem at a window flashing. It had rained heavily the day before, and the sun was directly warming the wet wall the next morning.

Sycamore A: Typical meandering bulk water IR pattern

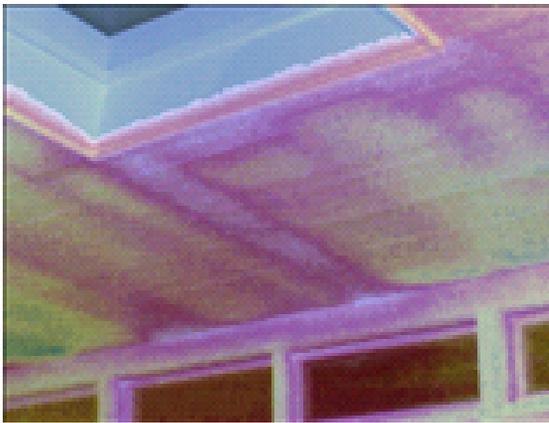
Bancroft

In this inspection, the client personally observed the water damage event, which involved a rainstorm occurring during an incomplete roofing repair job. The purpose of the IR imaging months later, after the roof was finished, was to ascertain the extent of any water intrusion into a beadboard roof-ceiling structure, for demolition decisions. I instructed the client to run the air-conditioning system non-stop for three hours before the inspection, and then shut it off a half hour before the scheduled inspection time. This created an apparent temperature shift for some active thermography, and worked quite well as the photos show. The ceiling was removed in its entirety and the fiberglass was loaded with mold. No moisture or temperature differences were measured directly on the ceiling wood surfaces during IR, nor was any wet insulation found during demolition. This was strictly due to material degradation of the wood.

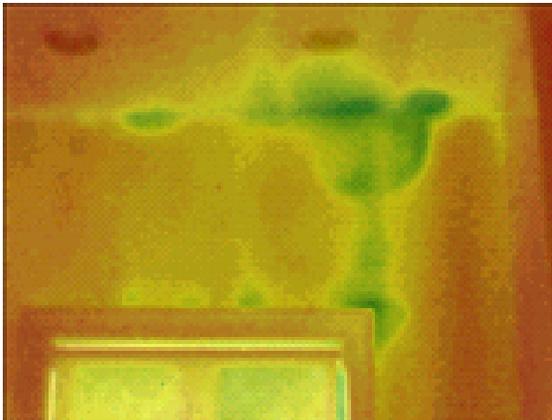
The source turned out not to be the assumed rain water. Noticing the unusual anomaly on the left picture, showing up for no reason, I pursued this with a negative blower door test, since moisture patterns typically won't change with infiltration, but will become more well-defined under airflow as stated before. The second picture shows the true source spot on the sheet rock still wet above, under a leaking drain line, feeding the moisture at the wall. The outside humidity slowed the drying of the outer wall only.

I surmised that the sheetrock material in the first picture had its emissivity altered by repeated wetting, but was not currently wet. Would you have caught this?

Uptown: Before Blower Door

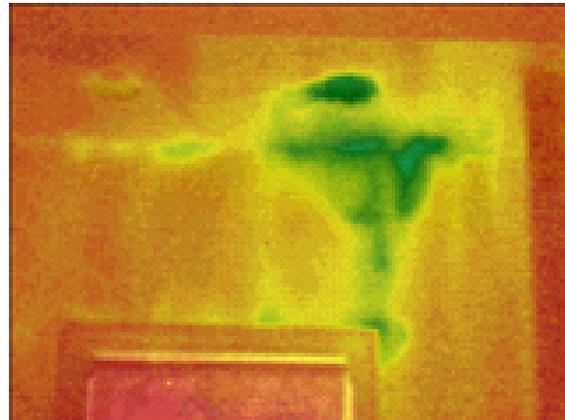
Uptown: After one hour of Blower Door

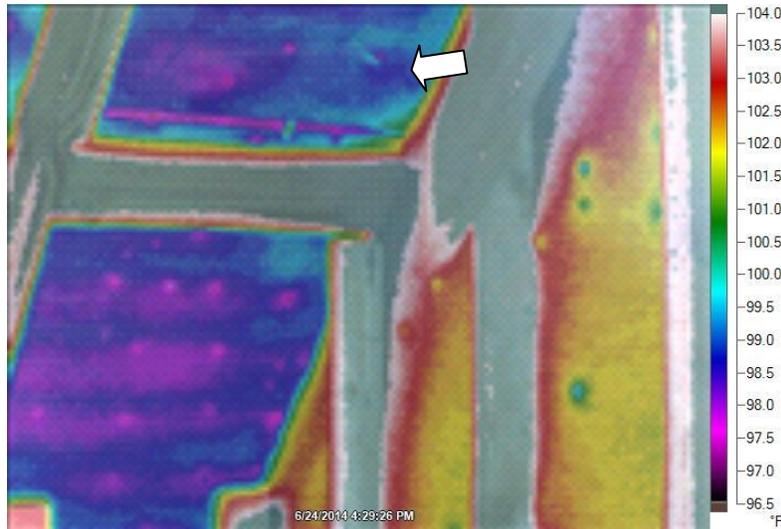
A home that had roofing repairs, yet had seal-tab shingles blow off during a mild rainstorm a year later. The plywood showed a distinct IR pattern in this 10/12 pitch roof. On closer inspection, this area under the deck was measured as completely dry, but a faint stain pattern matched the IR pattern. When physically pressed, the plywood was very soft, which explains why it wouldn't retain the shingle nails.

Sycamore B: Now in this case, an actual surface temperature difference of 1.1 F, due to change of density of material. Still no moisture measured.

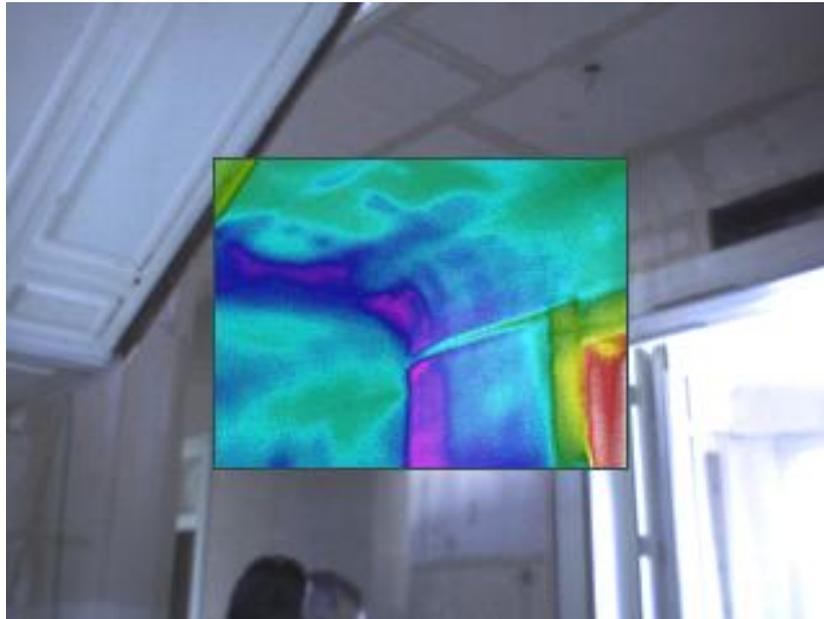
In this case a major plumbing leak on the floor above saturated the plaster lathe ceiling and walls. The initial photo is two days after the event. Fans and commercial dryers were set up immediately. Three weeks later the second photo was taken, with no moisture detected in the plaster. Yet, a residual IR pattern at a low span range, still remained on some areas that had been soaked.

Spencer: Before drying

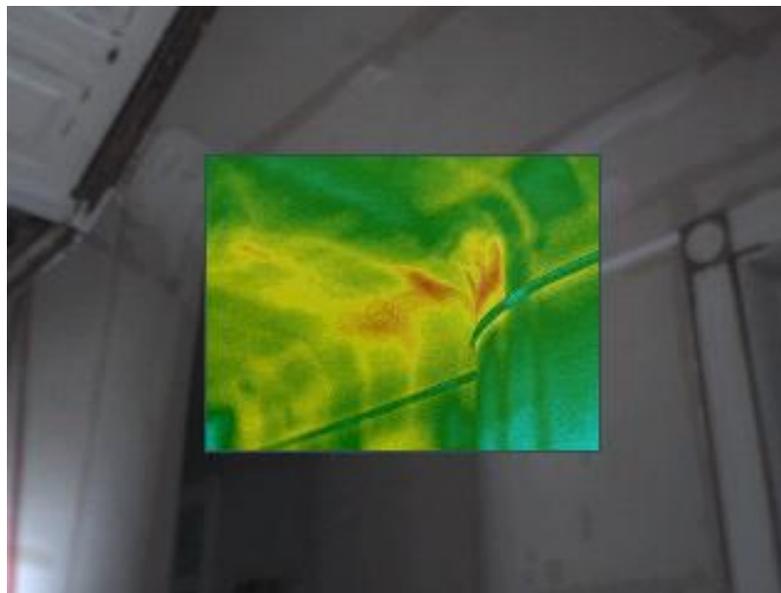
Spencer: After drying
