Infrared Inspection of Electric Utility Equipment: Documenting Common and Not-So-Common Thermal Exceptions

James Brady, Level III Certified Infrared Thermographer
Brady Infrared Inspections, Inc.
935 Pine Castle Court
Stuart, FL 34996
Ph: 772-288-9884

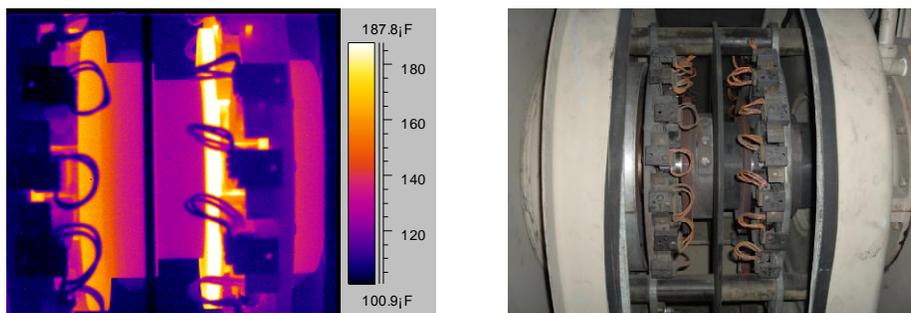
Figures 1a & 1b: An example of elevated heating on the right electro-ring on a field exciter

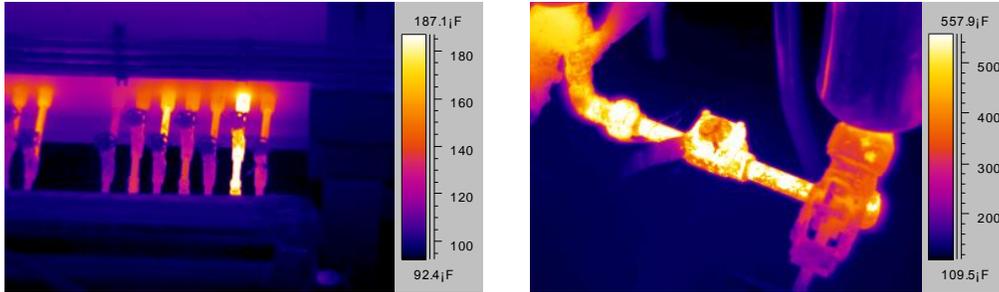
Figures 2a & 2b: Examples of steam blowing by a failed valve (2a) and a steam trap (2b). Both of these problems were confirmed with ultrasound technology

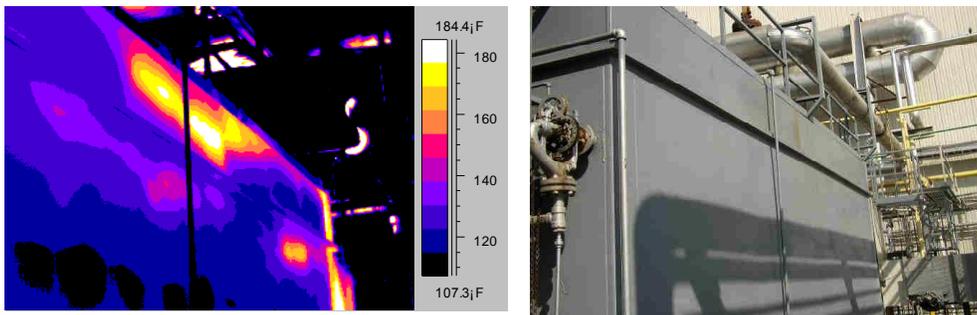
Figure 3a & 3b: An example of degraded refractory on the side of a co-generation unit

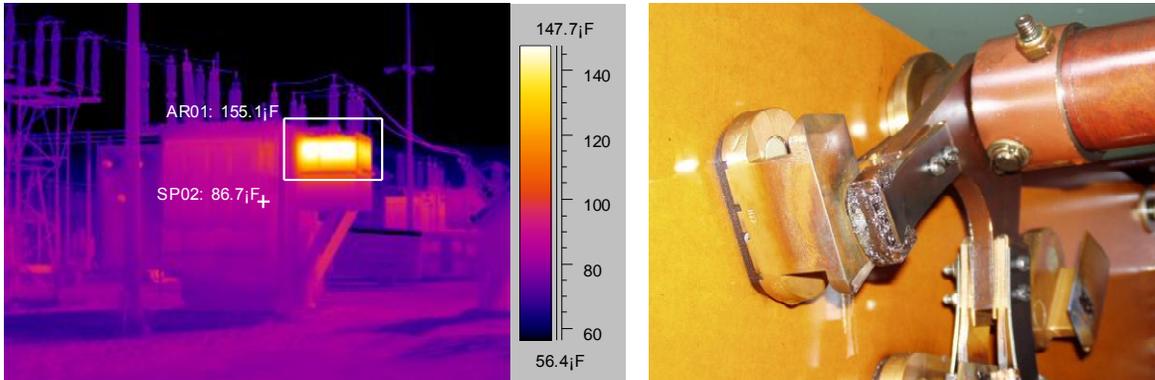
Depending on the type of transformer being used, a load tap changing (LTC) compartment, attached directly to the side of the transformer, may be present that is used to adjust voltages as load demands change. This is accomplished through a series of movable taps inside the compartment that occasionally fail and cause

catastrophic damage to the transformer (figures 4a & 4b). If the transformer lacks an LTC compartment, then voltage regulators are present that perform the same duty. These are stand alone, oil-filled tanks located on the low voltage side of the transformer and closest to the outgoing circuit lines.

Figure 4a (left) shows a typical thermal pattern of a load tap changing compartment that has an internal problem. Figure 4b (right) shows the source of the heating on a movable contact that has been arcing.

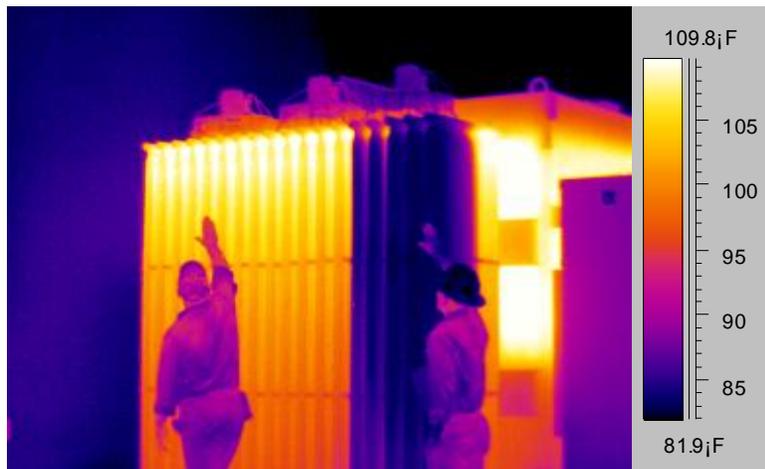
Another not-so-common transformer problem that I have encountered involves the exterior cooling fins that promote proper oil circulation inside the tank. Normally, a warm to cool thermal pattern should be seen from top to bottom on the fins. Cold fins from top to bottom indicate either low tank oil levels or blocked fins that retard circulation (figure 5).

Figure 5: Shows a thermal pattern of cold circulation on the fins on the right side of this transformer.

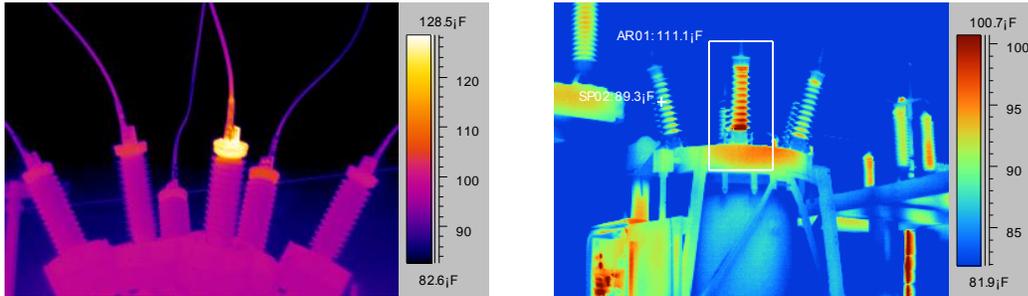
Figure 6a shows a heating pattern on the top side of SF₆ breaker bushing and end cap.

Figure 6b shows a heating pattern on an oil-filled breaker bushing with a bottom side connection problem internal to the tank.

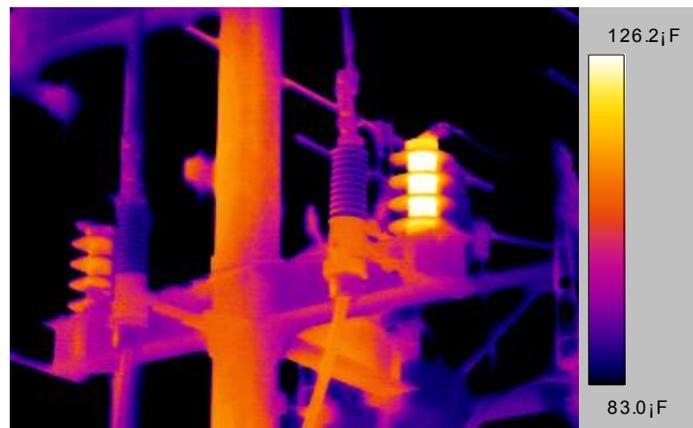
Figure 7: A warm arrester that protects a 13kV feeder circuit exiting the substation. This arrester failed and brought down a substation feeding a citrus juice plant.

Lightning arrestors play an important role by dissipating harmful current surges due to lightning strikes. Arrestors are located on the high-voltage line entrance side of the substation and on the low-voltage circuit feeder side. One of our clients has witnessed station arrestors fail to complete destruction and consequently bring down a substation (figure 7). Any arrestor inside a substation that shows a temperature rise should be documented and flagged for replacement as soon as scheduling permits.

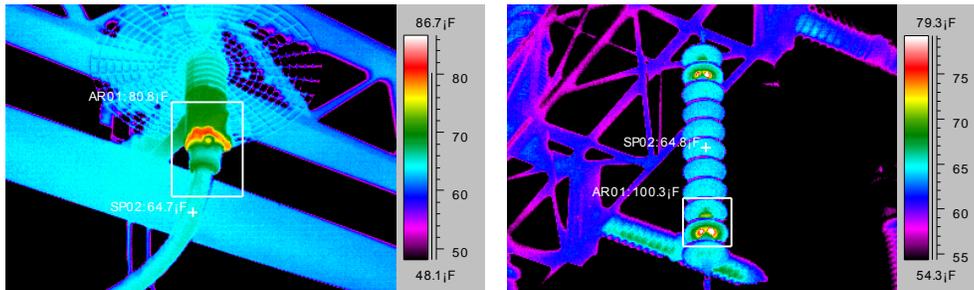
While most of the infrared inspections I have performed at substations have been conducted during daylight hours, scanning at night reveals new types of problems. Corona and tracking conditions are excellent examples. In most cases the delta-temperature observed when viewing these problems is small. The heating patterns can occur as ring shaped designs on insulators (figure 8a) and potheads and can also show up as hot spots between the bells on insulators (figure 8b).

**Figure 8a (left) shows corona on a 13kV pothead
Figure 8b (right) shows tracking on the skirts of a bell insulator**

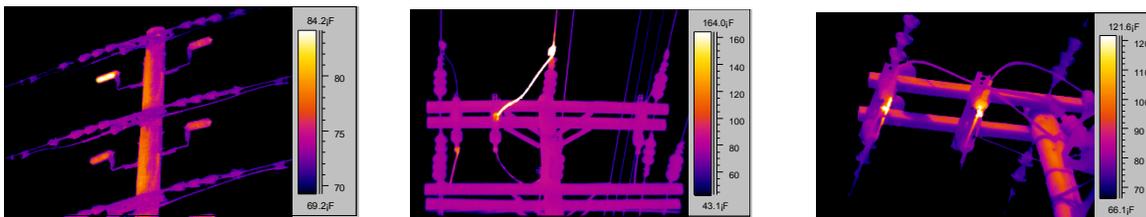
Figure 10a (left) shows a failed lightning arrestor
Figure 10b (center) shows heating on a bolted connection and jumper wire
Figure 10c (right) shows heating on a switch receiver / jaw contact

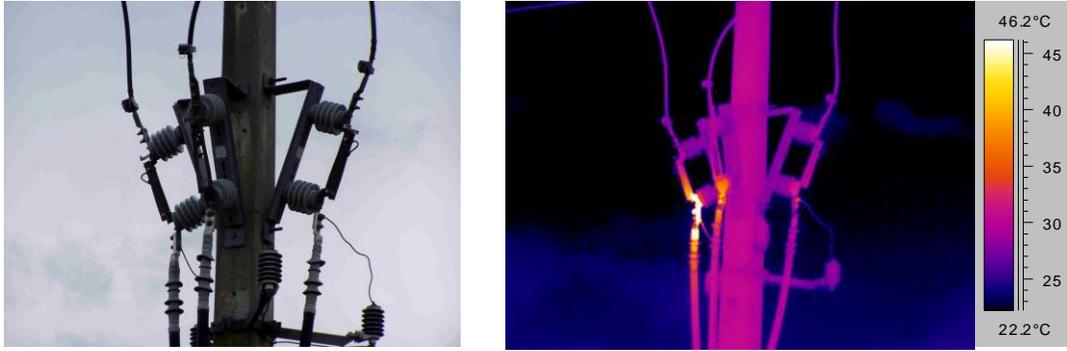
Another specialized project we performed for a large utility company involved the infrared inspection of nearly two hundred 13kV and 25kV get-a-way poles. A get-a-way pole is the first switch pole of a feeder circuit as it exits a substation. In many cases, the circuit travels underground for up to two miles from a substation before it makes an appearance to start an overhead feeder (figure 11a) . The results of our inspections revealed a repeated pattern of heating on two-hole pad conductor connections to vertically mounted switch frames (figure 11b). Initially, it was thought that torque specifications on these connections were not followed, but this was ruled out when newly installed connections using specified connection torques were showing up hot. The utility eventually contacted the manufacturer and found that the beveled holes on the switch frames were not being milled deep enough to allow the proper seating of the washer and bolt, even when the proper torque requirements were being met.

Figure 11a (left) shows a typical Get-A-Way pole consisting of vertically mounted switches, potheads that terminate the conductors and lightning arrestors. Figure 11b (right) shows an example of a repeated heating pattern discovered at the pad connection between the conductor pothead and the switch frame.

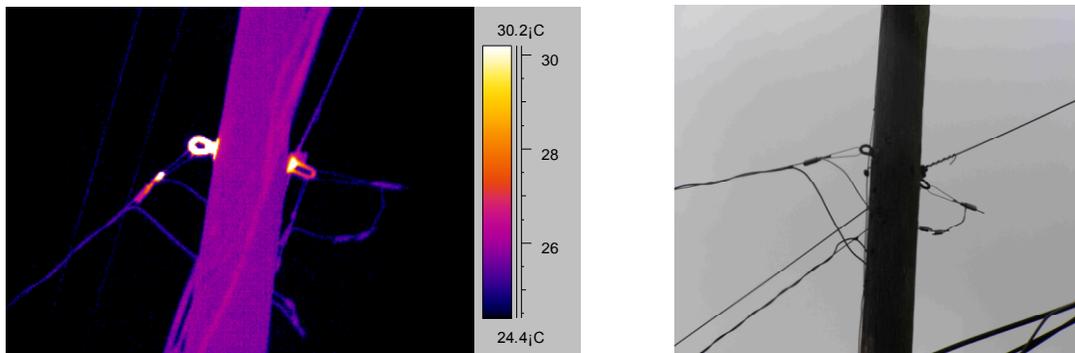
Finally, there are those not-so-common problems that a thermographer stumbles upon every so often. For me it was this past summer during a delta-temperature scan on a 13kV feeder. I happened to see an eye-bolt supporting a neutral line on a lateral feed in a neighborhood that had a temperature rise of over 65 F degrees (figures 12a and 12b).

Figures 12a and 12b show a hot eye-bolt on a power pole that supports a neutral line.

It was discovered that the bolt was hot because of an open neutral that was causing the return current on the circuit to be rerouted from the neutral pathway to a grounded object; in this case the eye-bolt.

Having an open neutral is a dangerous situation that should be corrected as soon as possible. The ground is now energized and can cause injury to someone coming in contact with any bare metal that is intended to be grounded. Not only did the discovery of this problem save unknown amounts of time to locate, it also prevented possible serious injury to an unsuspecting utility worker.
