Using a Building's HVAC Systems and Infrared Technology to Solve Water Intrusion Problems

James Brady
Level III Certified Infrared Thermographer

Brady Infrared Inspections, Inc.
935 Pine Castle Court
Stuart, FL 34996
Ph: 772-288-9884

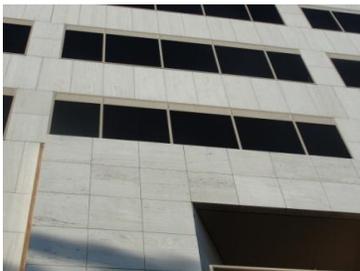
Figure 1(left): Photo of exterior walls showing alternating windows and pre-cast panels with attached limestone tiles.

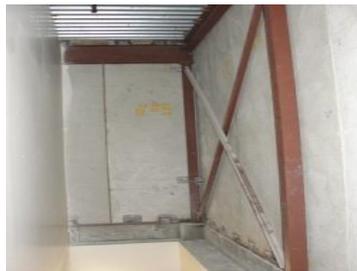
Figure 2 (middle): Interior view of pre-cast concrete panel showing welded attachment plates and vertical seams filled with foam backer rods.

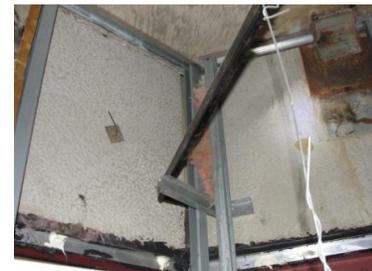
Figure 3 (right): Interior side of pre-cast concrete panel viewed from the plenum space of the fifth floor. Black adhesive caulk was used to seal the connection at the window frame. Also shown are metal tabs used to weld the panel to the concrete ceiling and metal framework of the building. From this photo, it is apparent that water could enter and travel along various pathways, making it very difficult to track down the exact entry point.

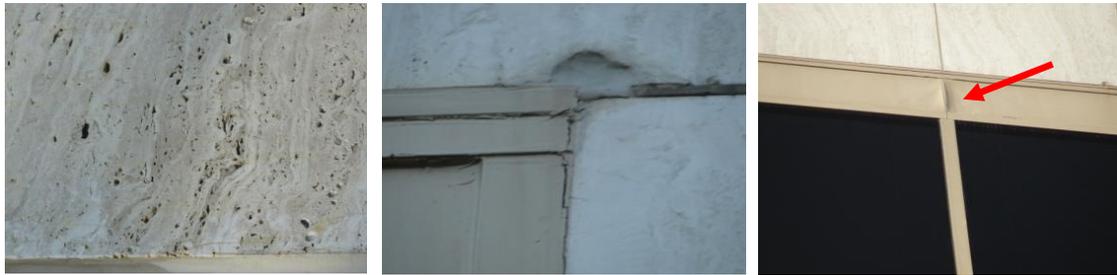
The limestone tiles are polished in some places and very rough and porous in others. Deep cavities are present that appear to propagate through the entire thickness of the tile (Figure 4). The caulk between wall tiles and window frames is very narrow in places, and as such does not provide a strong adhesion to either surface (Figure 5). Open gaps are present in several places.

The building's window frames show some surface rust and slight bulging at panel seams (Figure 6).

Figure 4 (left): Close-up view of an exterior building tile showing alternating layers of smooth and rough limestone. Some of the dark cavities are deep and may penetrate the entire thickness of the tile.

Figure 5 (middle): Window frame showing rust and deterioration from water intrusion.

Figure 6 (right): Caulk around window frame showing signs of shrinkage and cracking.

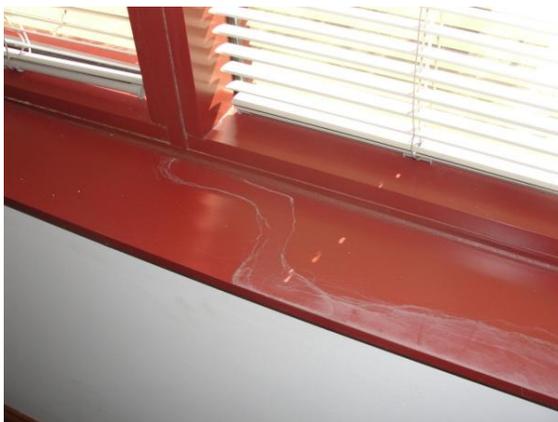
The building's interior is typical office space construction; metal studs filled with fiberglass batt insulation and covered by drywall. Evidence of water intrusion is evident in several places; water stained window sills, and damaged dry wall and ceilings on mid-story office space (Figures 7 and 8).

Figure 7 (left): Water stains on window sill.

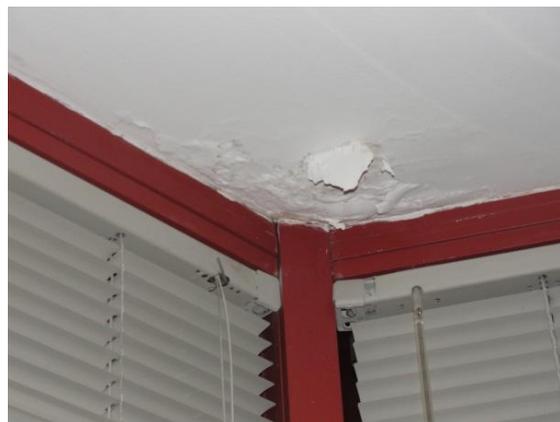
Figure 8 (right): Damaged ceiling on a mid-level floor of the building.

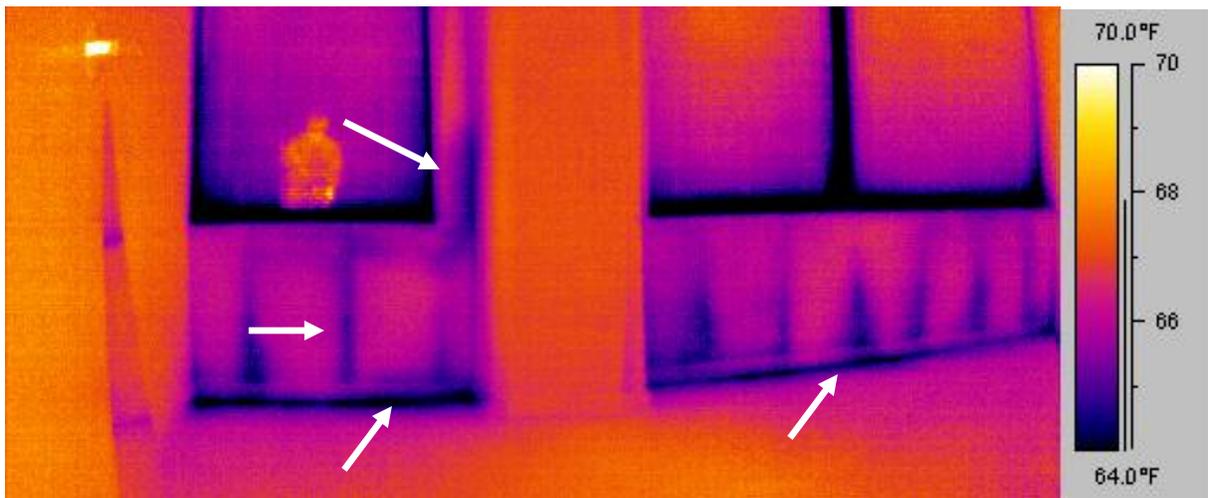
Cold anomalies occurred around window frames, main building columns, baseboards and other structural attachment features in the wall construction. Also observed was thermal bridging of steel wall studs in contact with the pre-cast concrete panels. Figures 12, 13, and 14 show a few examples of what was observed.

Figure 12: Thermogram of an interior office space showing cold air leaking around main column and baseboard. Also note thermal bridging on steel wall studs.

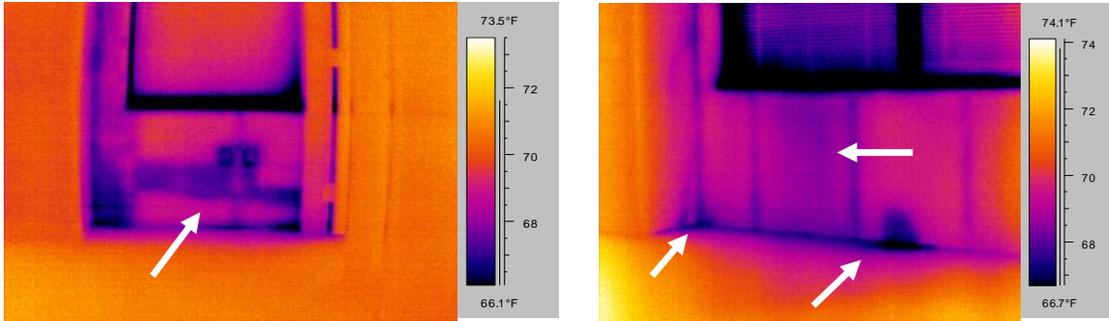
Figure 13 (left): Cold air leaking around metal panel fasteners on 4th floor.

Figure 14 (right): Cold air leaking into building along baseboard and below window.

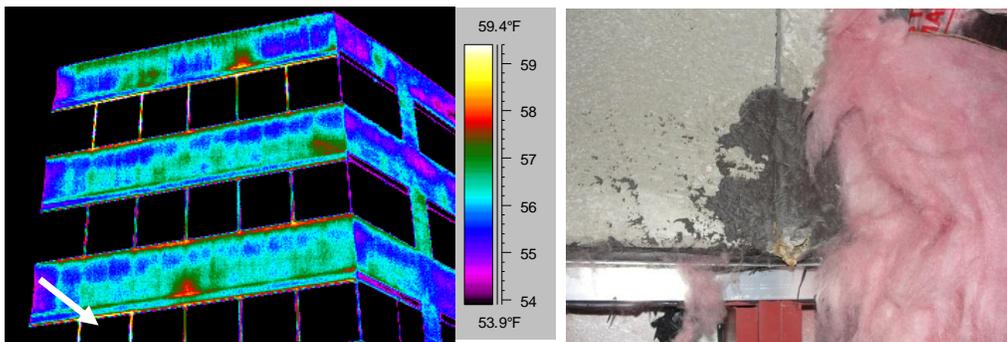
- Vertical anomalies that parallel window frame and limestone tile caulk seams (Figure 15)
- Horizontal anomalies that parallel window frame (Figure 16)
- Wide, diffused anomalies that correlate to rough and porous bedding layers on limestone tiles (Figure 17).

Figure15: Thermal image, at left, showing air leakage around a vertical caulk seam;

Photo right shows old repair and evidence of water leakage along pre-cast concrete panel on inside of building.

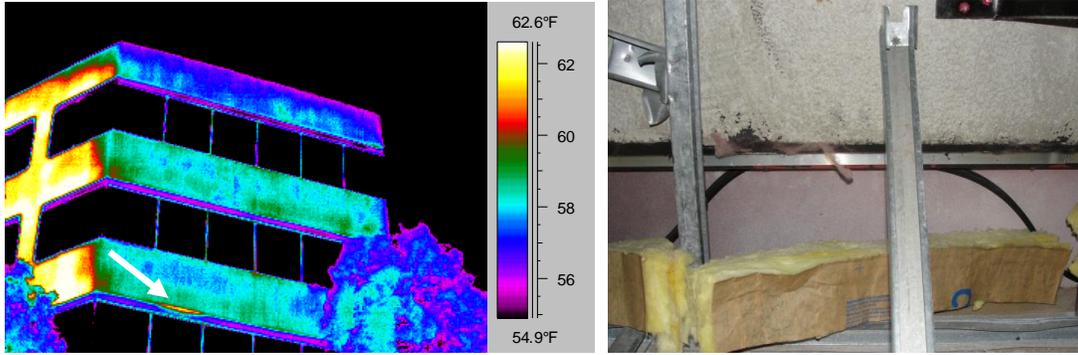
Figure 16: Thermal image at left, showing air leakage around window frames; and photo at right, showing a displaced window seal gasket.

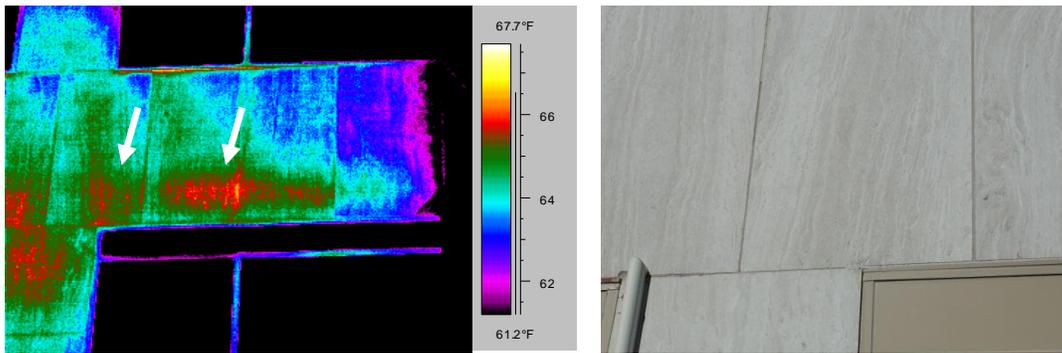
Figure 17: A close-up thermal image showing a warm thermal pattern of escaping warm air that mimics the bedding layers in the limestone. These areas on the tile may be contributing to water infiltration.

The anomalies observed on the faces of the limestone tiles, as shown in Figure 17, may be a function of:

- the porous nature of the tiles in that area allowing air to escape (and conversely allowing some water to enter)
- The attachment between the limestone tile and pre-cast concrete panels may not be uniform, and as such allows warm air to travel between the two materials where voids are present.
