Case Study of a Hotel Missing Insulation

Tom Mayfield, CIRT, CIAQT
Mayfield Thermography Consulting Services, Inc.
1805 Glengarry Drive
Carrollton, Texas 75006
Ph: 972-323-0058

Abstract

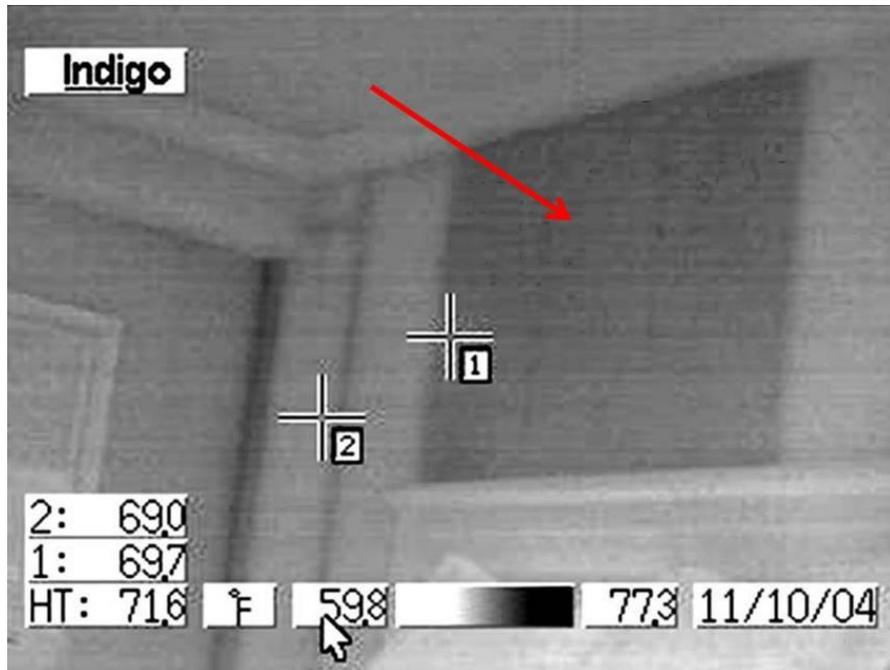
Figure 1. Thermogram showing missing insulation

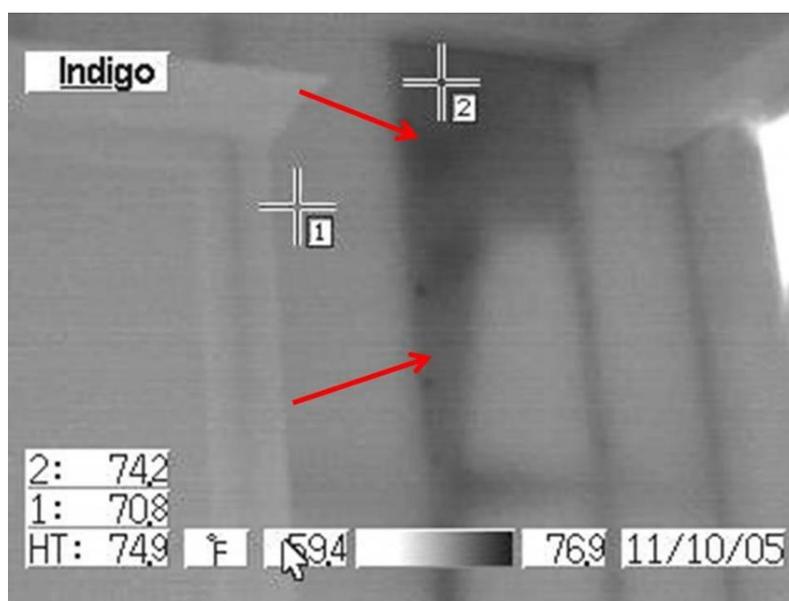
Figure 2. Thermogram showing incomplete insulation

The rooms averaged a failure rate of 85%, meaning 85% of the rooms surveyed had at least one problem requiring repair (see Figures 2, 3, 4, & 5). The problems ranged from missing insulation to moisture issues (mostly from overflowing bath tubs) and a few condensation problems.

The GC was definitely responsible for not meeting the specifications and for making the repairs. The hotel had proof positive of the deficiencies, and because all the walls were documented, they knew exactly where the repairs had to be made. After each report was submitted, the general contractor was required to schedule complete repairs on the same block of rooms which were taken out of service for the IR testing. This was a two day process for each room as they would remove the sheetrock, replace the missing insulation, and repair the sheetrock on the first day. On the second day, they would finish the sheetrock, and paint or wallpaper the repaired areas. In order to help the acoustical issues, the repairmen also air-sealed the rooms during this process. They were only able to accomplish this for 100 or 200 rooms at a time owing to large repair crews of between 50 and 100 workers.

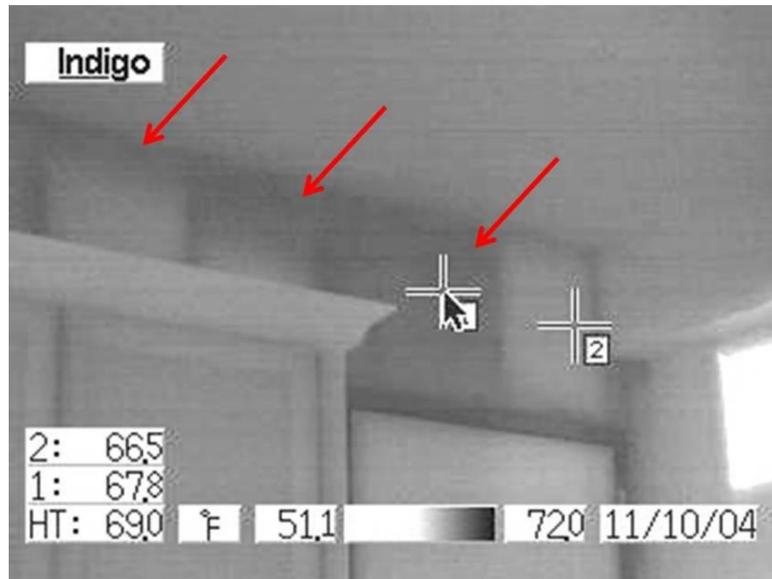
Figure 3. Thermogram showing missing insulation in partition wall

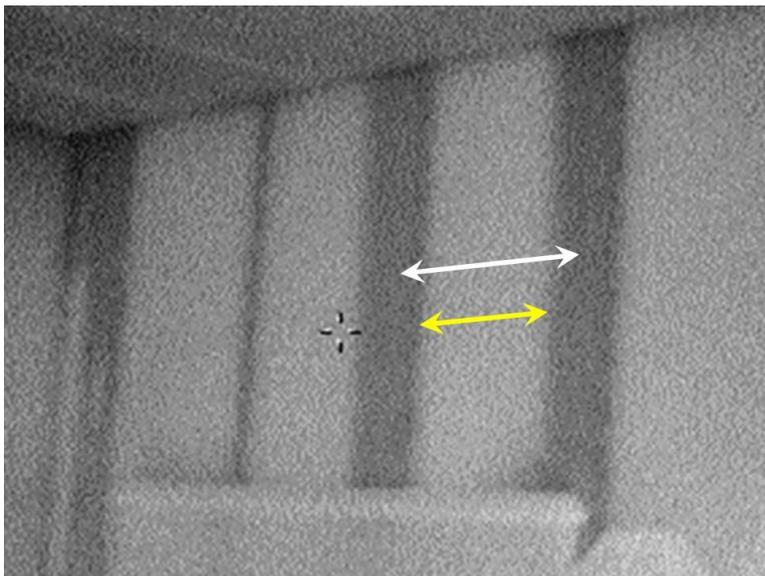
Figure 4. Raw thermogram showing installation of a 16" batt (yellow arrow) in a 24" stud space (white arrow)

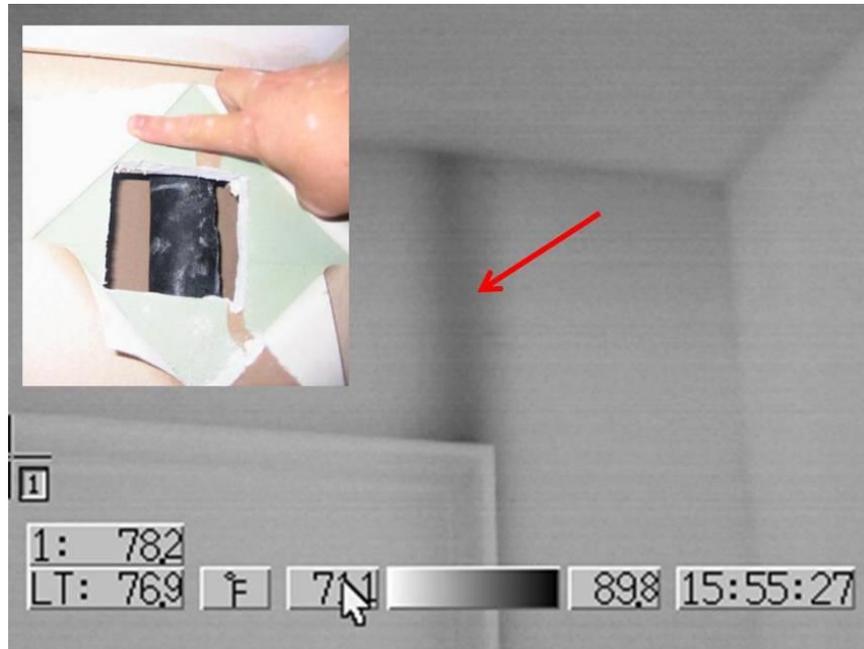
Figure 5. Thermogram showing evidence of an uninsulated pipe chase on a bathroom wall. Inset is a photograph taken after IR testing
