# THERMOGRAPHY IN FOCUS

## Pay Attention or Pay a Price

*For professional thermographers, conducting a thermography survey is a proven, cost effective way of early identification of electrical faults and, therefore, saving the asset owner downtime, lost production, anxiety & frustration. Unfortunately, there are times when due attention has not been paid to the thermography survey report.*

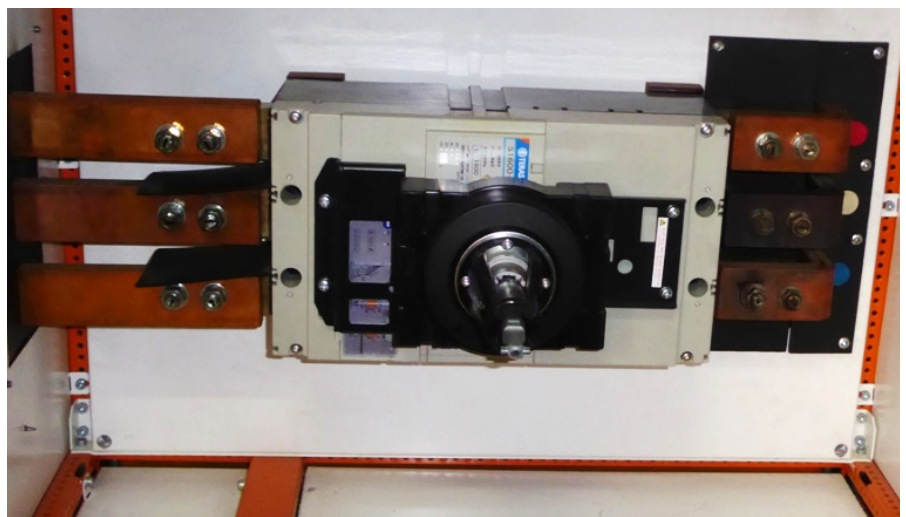
*The MCCB seven days before the explosion and switchboard fire showing the discoloured and scorched middle white phase busbar on the RHS of the MCCB*

The thermal patterns around the centre white phase were indicating an anomaly which was originating from inside the MCCB. The apparent temperature of the exception had risen from the previous survey by approximately 30°C. There was also visible discolouring & scorching on the RH copper busbar connected to the MCCB. Given the history, this was now a

Priority 1 fault and needed immediate action for rectification.

The maintenance manager was informed of the P1 thermal anomaly immediately and we did emphasise the importance of a rapid response by his maintenance team. The thermography inspection report was compiled the same night and emailed to the maintenance manager. A subsequent email was sent to confirm that he had received the report, again emphasising the criticality of the fault.

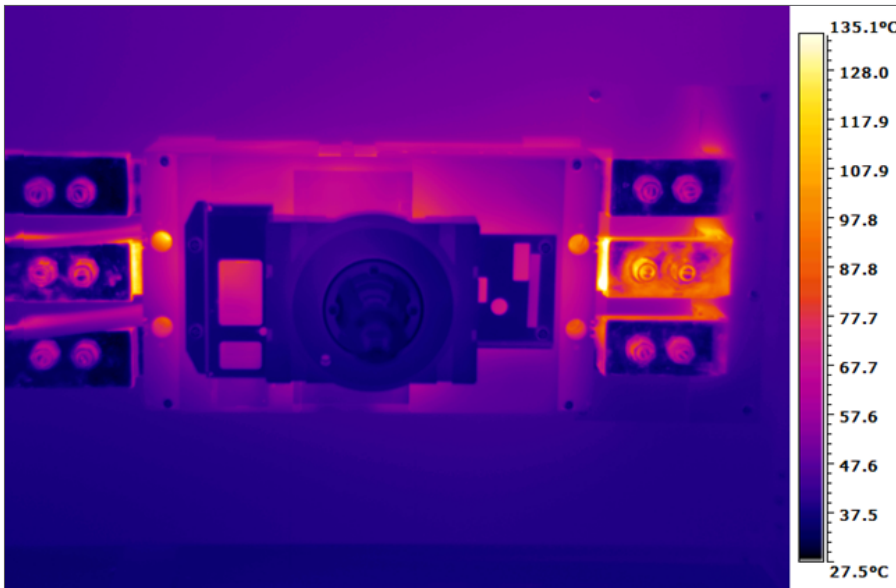
When this last survey was conducted it was approximately 2 years after the original MCCB had been replaced. The abnormal thermal patterns & apparent temperature rise on the MCCB had been reported after each survey so I was alarmed when we opened the panel and felt the extreme heat emanating from inside the MCCB cabinet.

Depending on the type of exception, it is impossible to predict a failure based on temperature. However, training and experience over many years of conducting thermography inspections and looking at thermal anomalies, alerted us to the fact that we had identified a very serious issue in the MCCB.

*Thermogram of the MCCB before it exploded and caused a fire. Apparent temperature on the RH white phase near the body of the MCCB was 147°C. Apparent temperature on the LH white phase near the MCCB body was 136°C*

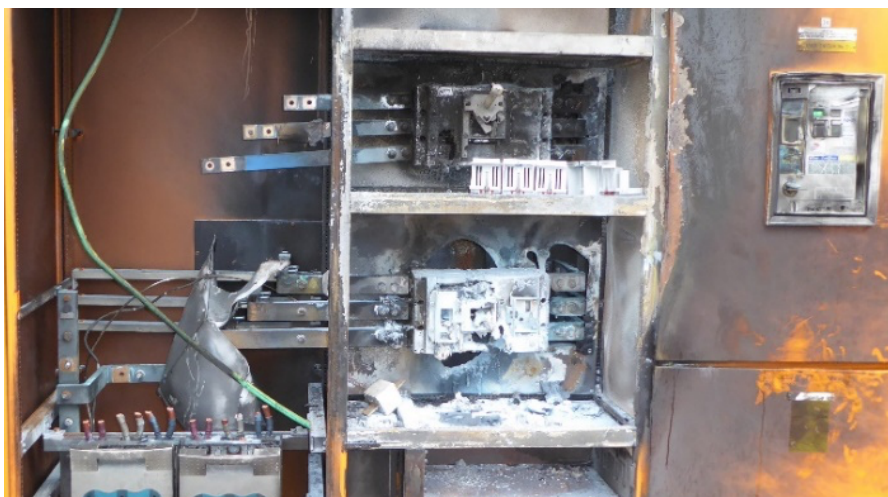
*The switchboard was destroyed by the explosion and fire*

Appropriate action was not taken immediately and 6 days after the report was submitted the MCCB exploded, destroyed the switchboard, and the plant was shut down.

Rectification cost and production losses were substantial and the ramifications of such a preventable failure were also measured in job losses at the plant.
