Using Thermal Imaging to Detect Moisture Intrusion into a Cold Molded Boat Hull

John (Jack) N. Allinson, II BSc, AMS®
Level III Certified Infrared Thermographer

This year's presentation will demonstrate how the Standard was used to detect moisture intrusion in a Sixty-Six (66) foot custom convertible wooden cold molded sportfishing boat.

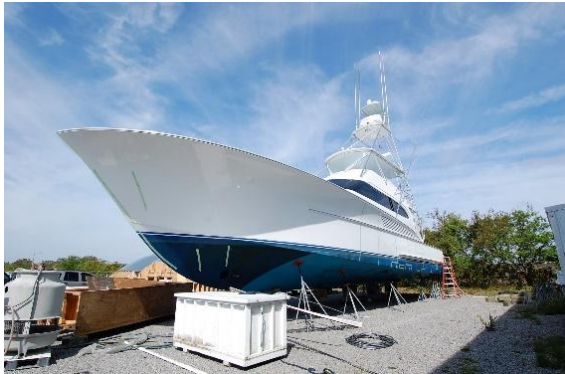
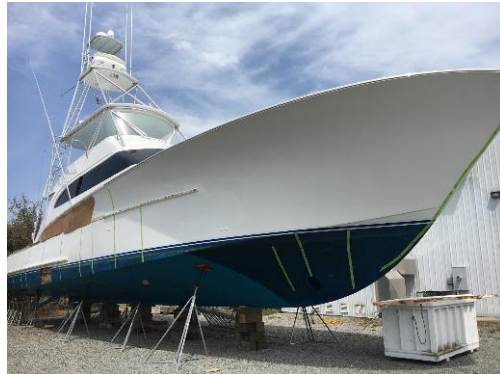
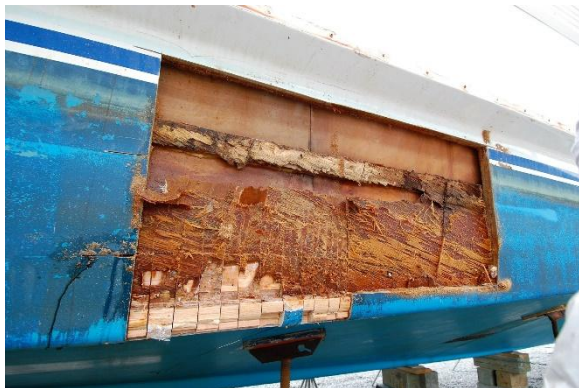
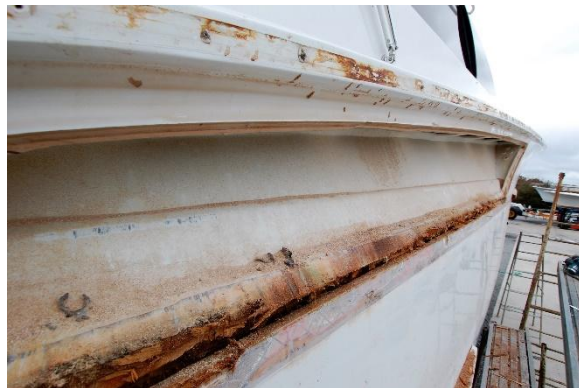
The subject boat below was completed in 2009 by a company that is no longer in business. During the haul out process, an aft STARBOARD section of the hull side gave way when stressed by the straps on the travel lift. A visual inspection of the damage concluded that the structural integrity of the hull had been compromised by wood decay from water intrusion.

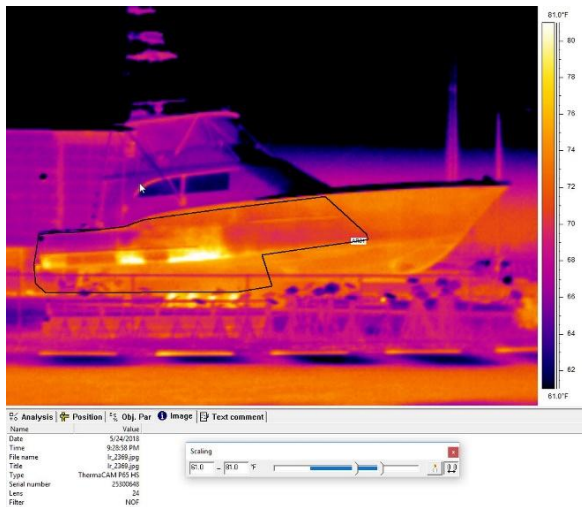
- the boat construction,
- moisture meter readings both within and outside of the documented margins of the thermal pattern anomalies (Figures 2, 3, 5, and 6),
- select destructive testing followed by installation of a moisture barrier and evidence of water condensation on the interior of the moisture barrier and taking into consideration (Figures 7-11),
- the general morphology of the thermal anomalies,
- the absence of visual exterior catastrophic damage in the areas showing thermal anomalies and wet moisture meter readings,
- and the discoloration of wood surfaces in exposed interstitial areas of the wooden hull construction

Figure 2. Infrared thermal pattern anomaly within the black border observed in the evening

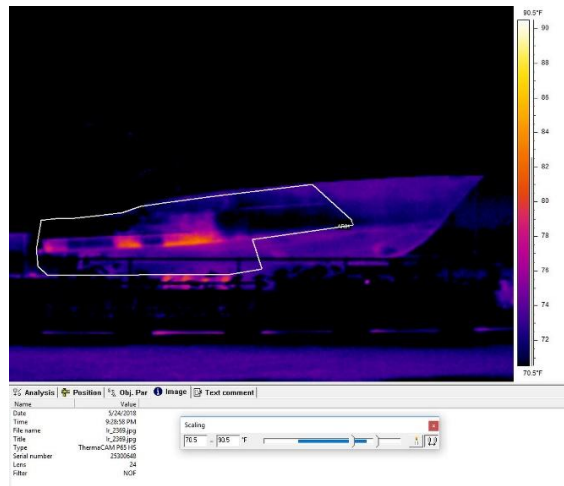
Figure 3. Same image as Figure 2 with temperature span adjusted, color of border changed to white.

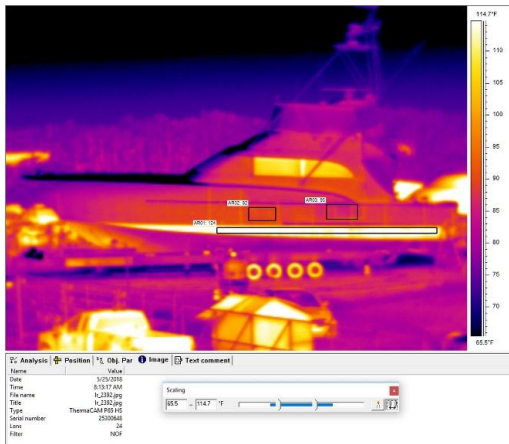
Figure 5. Infrared thermal pattern anomaly on PORT side during the morning. Temperature within the bottom border is much hotter than bordered areas of the hull above.

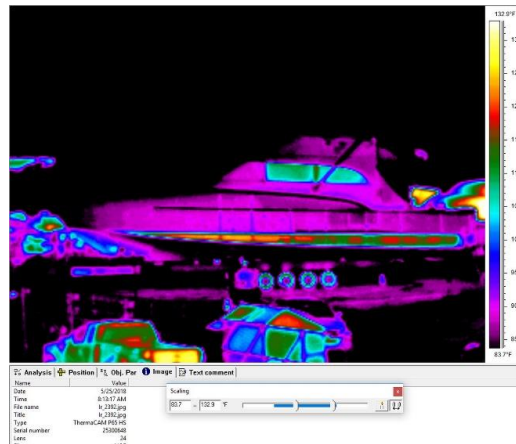
Figure 6. Same image as Figure 5 with temperature span adjusted and different color palette.

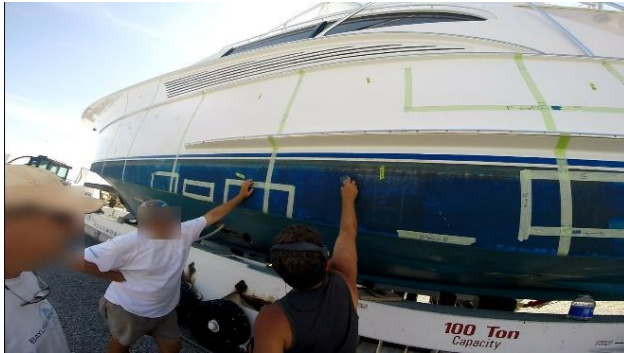
Figure 7. "WET" moisture meter reading to confirm where to cut coupon in hull.

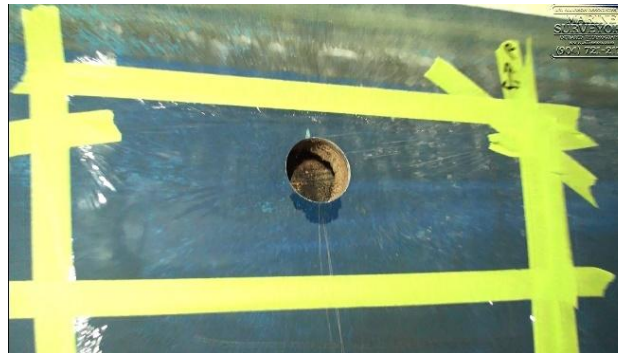
Figure 10. Evening check of clear plastic barrier showed moisture accumulated behind clear plastic barrier.

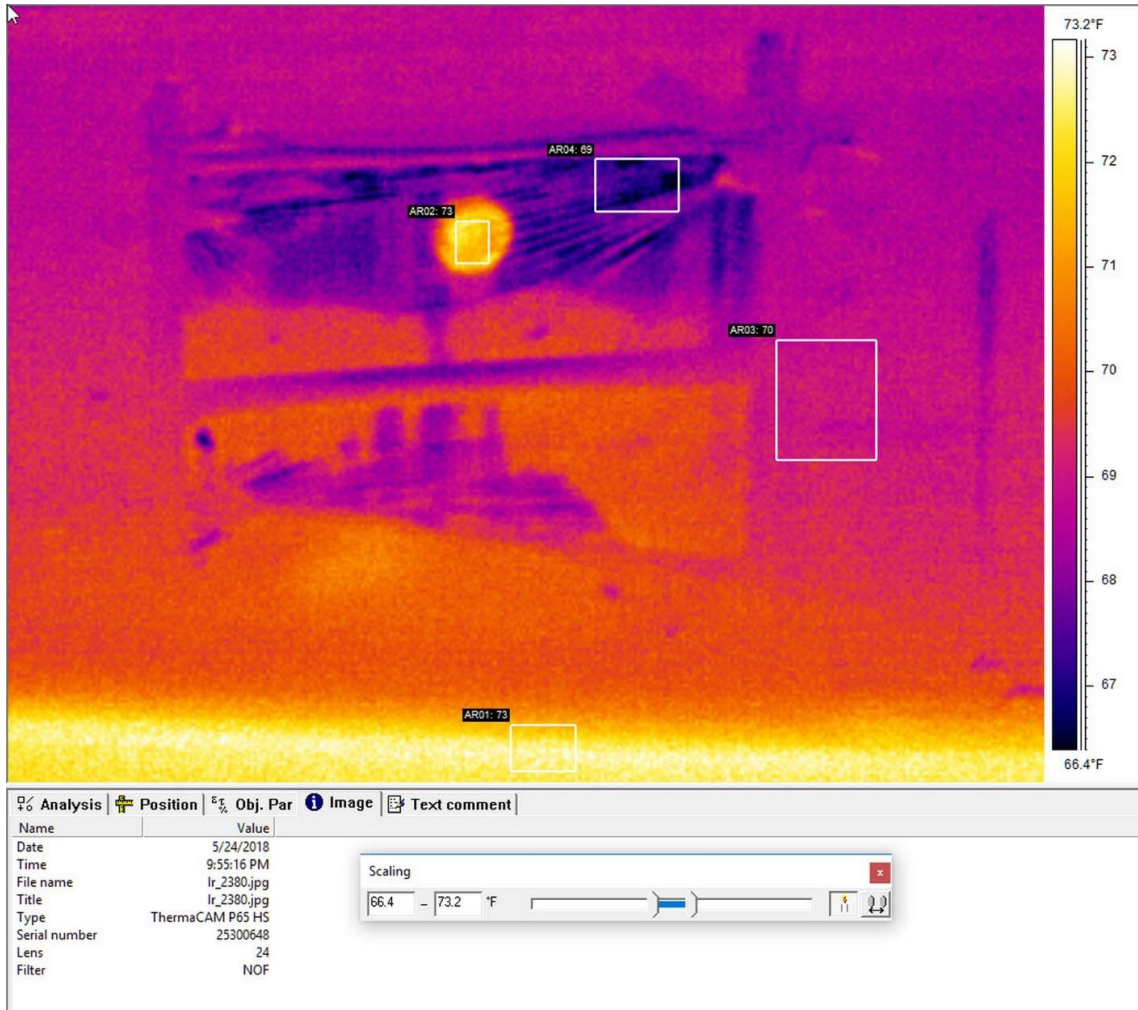
Figure 11. The above infrared thermal pattern shows how hot moisture vapor traveled upward and accumulated behind the clear plastic barrier where it condensed and fell to the bottom of the plastic. J.N. Allinson Associates, Inc. opines that this cyclical evaporation and condensing of water occurs within all of the air cavities in the hull construction of this boat that are isolated from air conditioning. Under favorable environmental conditions the wood surfaces that are not treated to prevent moisture intrusion will develop wood destroying organisms (WDO) leading to “structural” hull damage.
