Applying Infrared Thermography to Marine Surveying ... A Review of Ten Years of Case Studies

Case Study: Water Intrusion

Prepurchase Survey of a "Limited Production" 2008 SANTA CRUZ 37 racing sailboat.

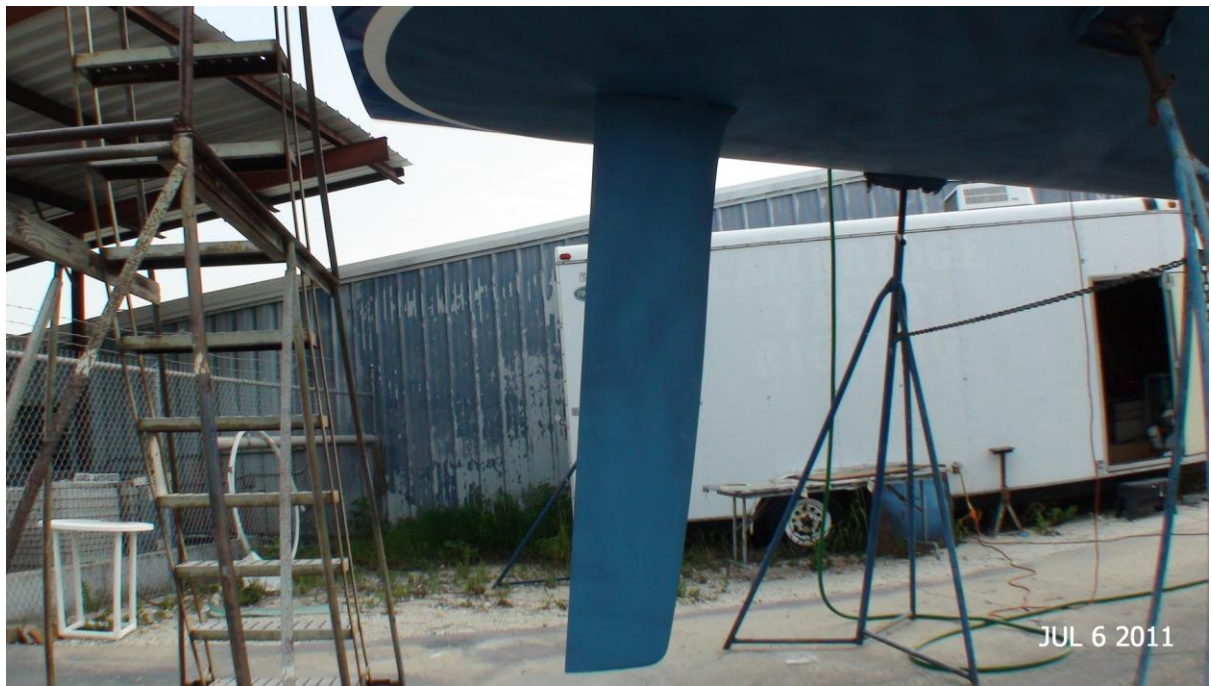
Spade style rudder checked for moisture intrusion and delamination

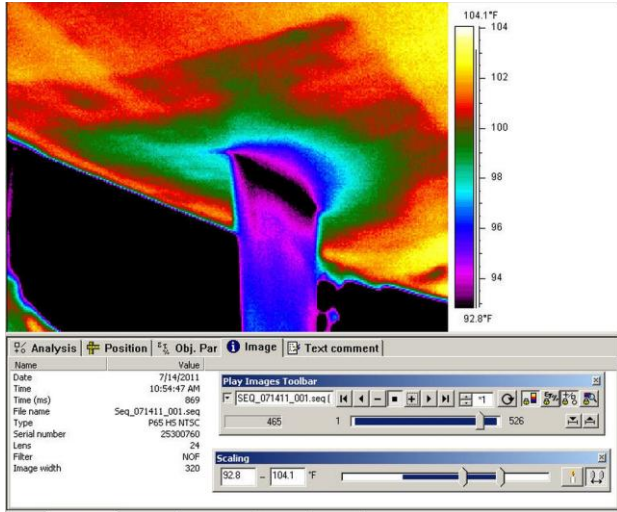
FINDING: During the normal course of survey elevated moisture meter readings were found on hull bottom. Thermal imaging of hull bottom revealed patterns consistent with moisture intrusion. Destructive testing confirmed moisture intrusion.

Thermal pattern of hull bottom around keel attachment shows pattern suggesting water intrusion

RECOMMENDATION: Remove wet coring and repair areas affected by moisture intrusion.

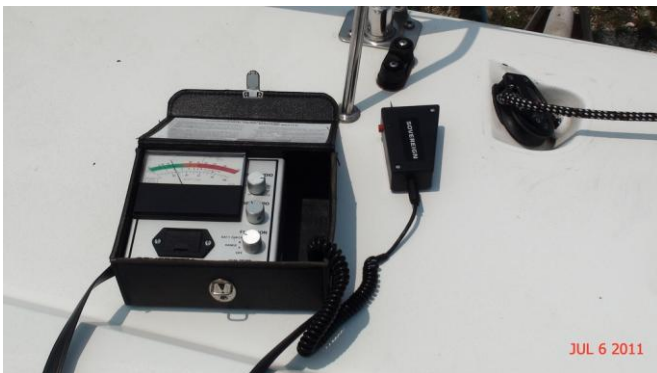
Suspect water intrusion from thermal image detected using capacitance style analog moisture meter

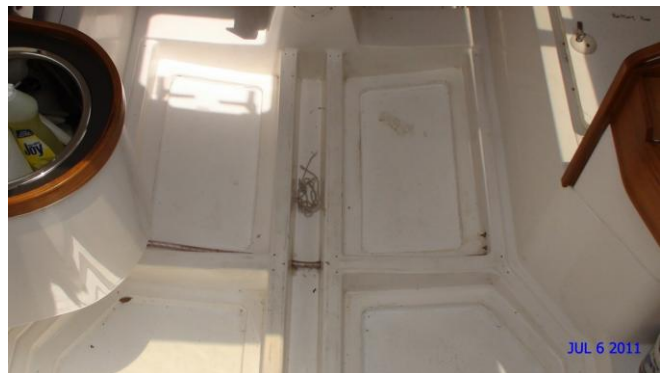
Internals of vessel showed that bilge area above the suspect thermal pattern and elevated moisture meter readings was clean and dry

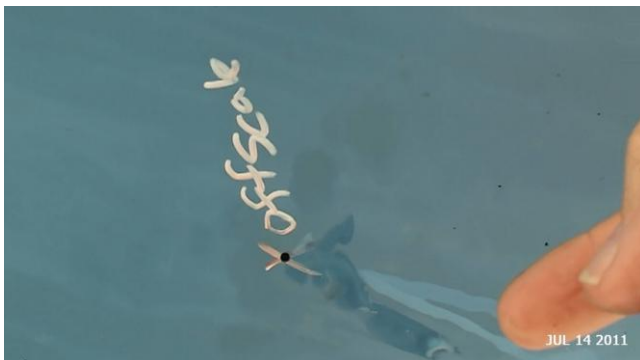
Drilled pilot hole into hull bottom leaked water

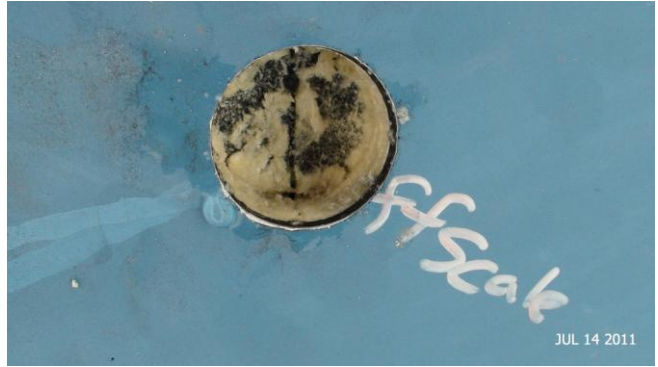
Core sample pried out. No disbonds between laminates of KEVLAR reinforced fiberglass and high density closed cell foam core
