IR Thermography and Related NDT Technologies for Detection of Damage to Boats Constructed with FRP and Composite Materials

John (Jack) N. Allinson, II BSc, AMS®
Level III Certified Infrared Thermographer

J.N. Allinson Associates, Inc.
222-2 University Blvd. North
Jacksonville, FL 32211
Ph: 904-721-2177

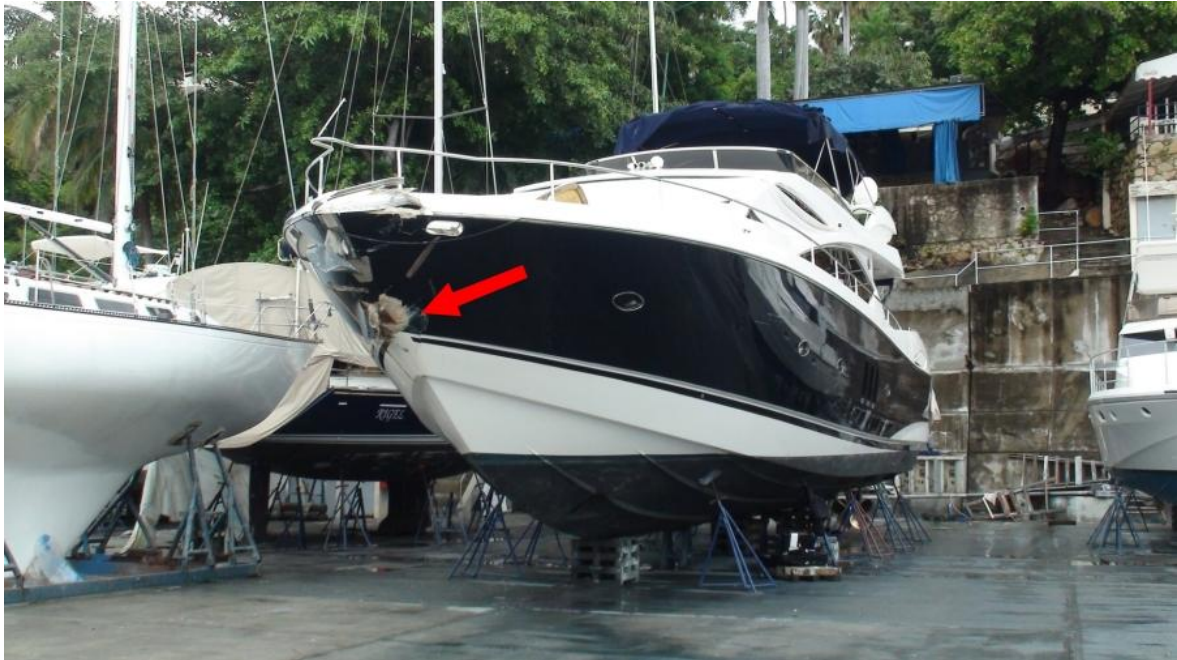
Visual damage at bow

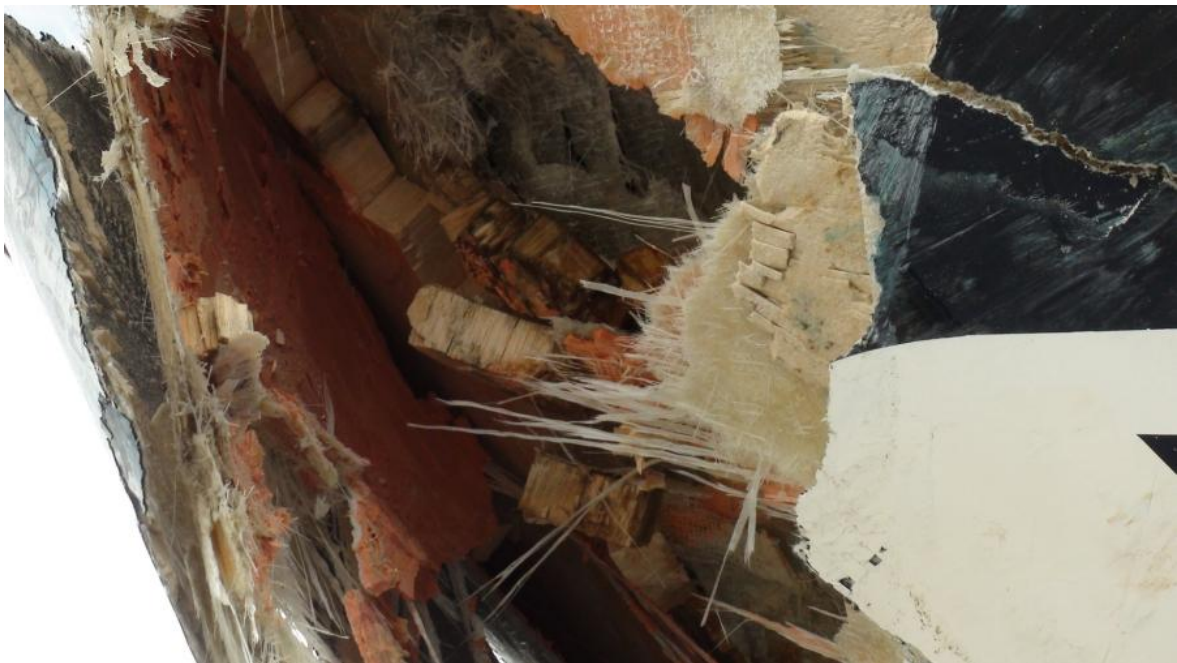
Visual inspection showed topsides were a FRP cored laminate composed of gel coat, layers of fiberglass mat and cloth, bonding paste, balsa core, and layers of fiberglass cloth

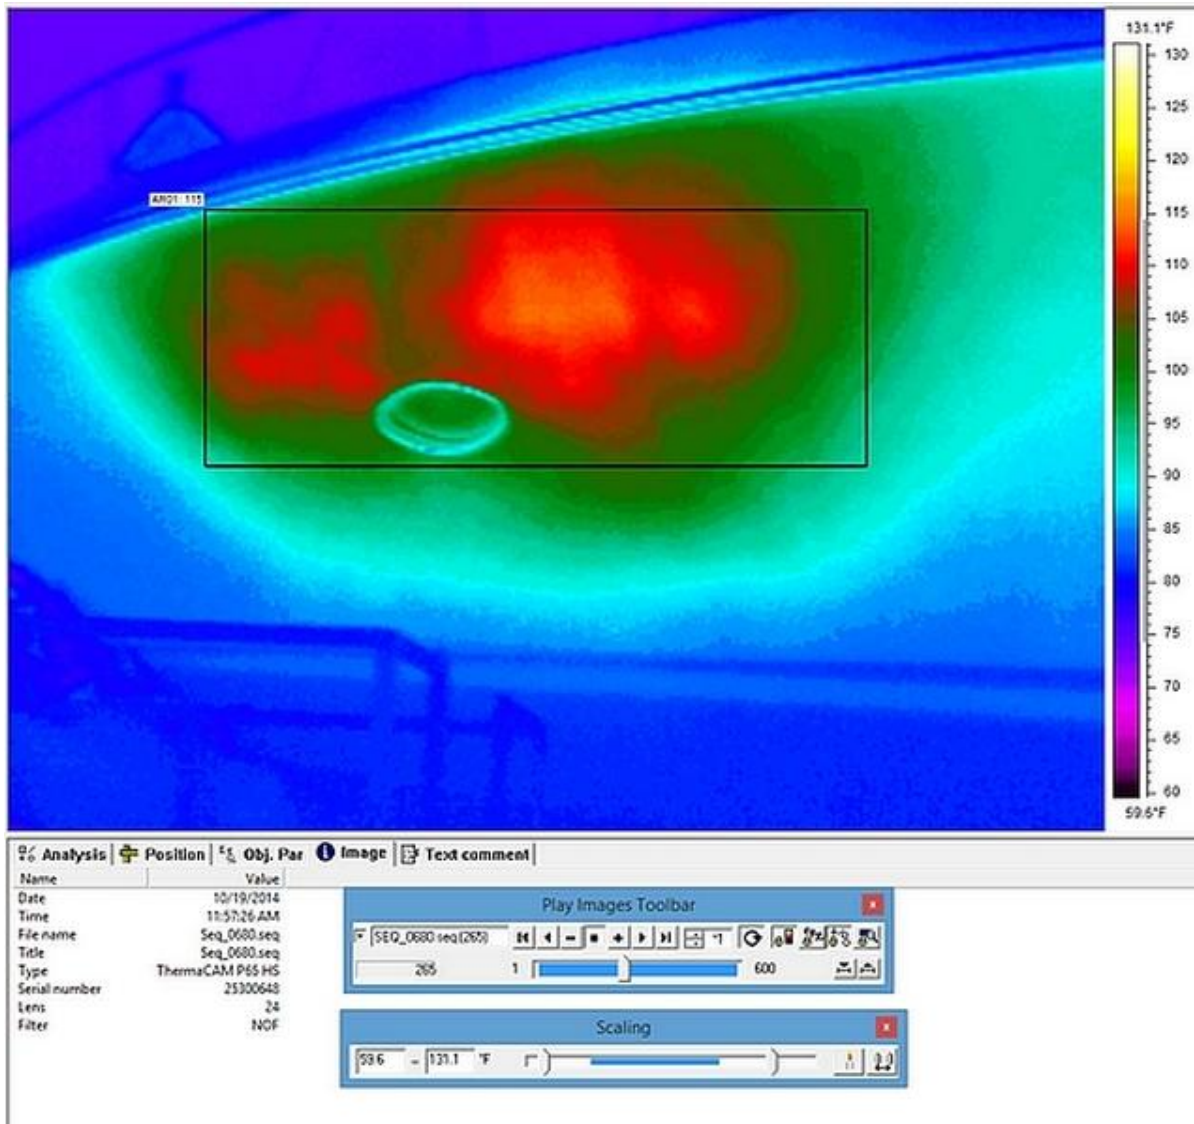
IR image showed thermal anomaly on PORT topside near bow

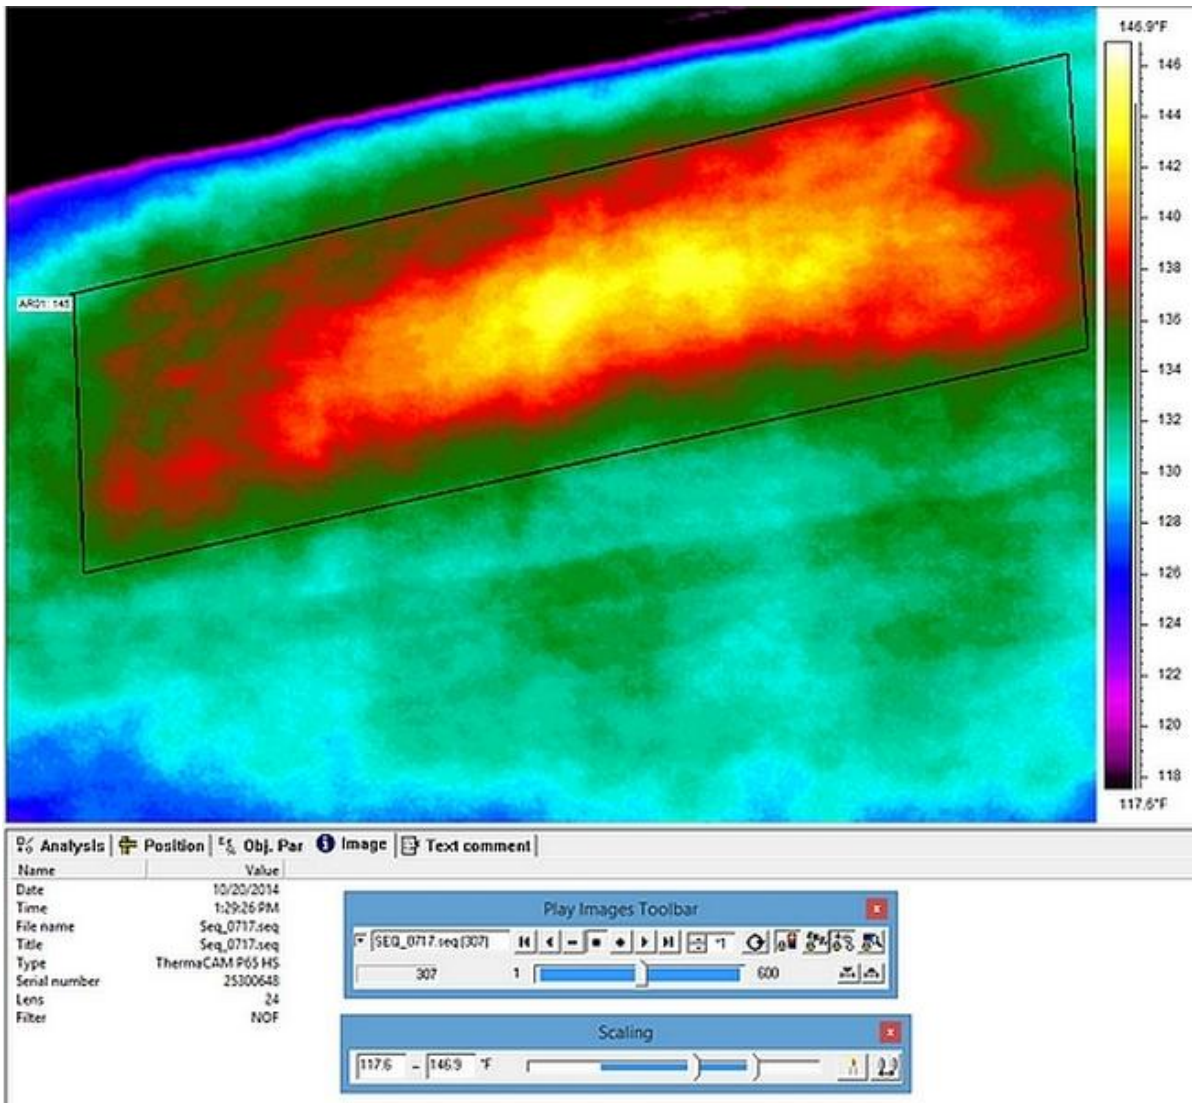
IR image showed thermal anomaly on PORT topside aft

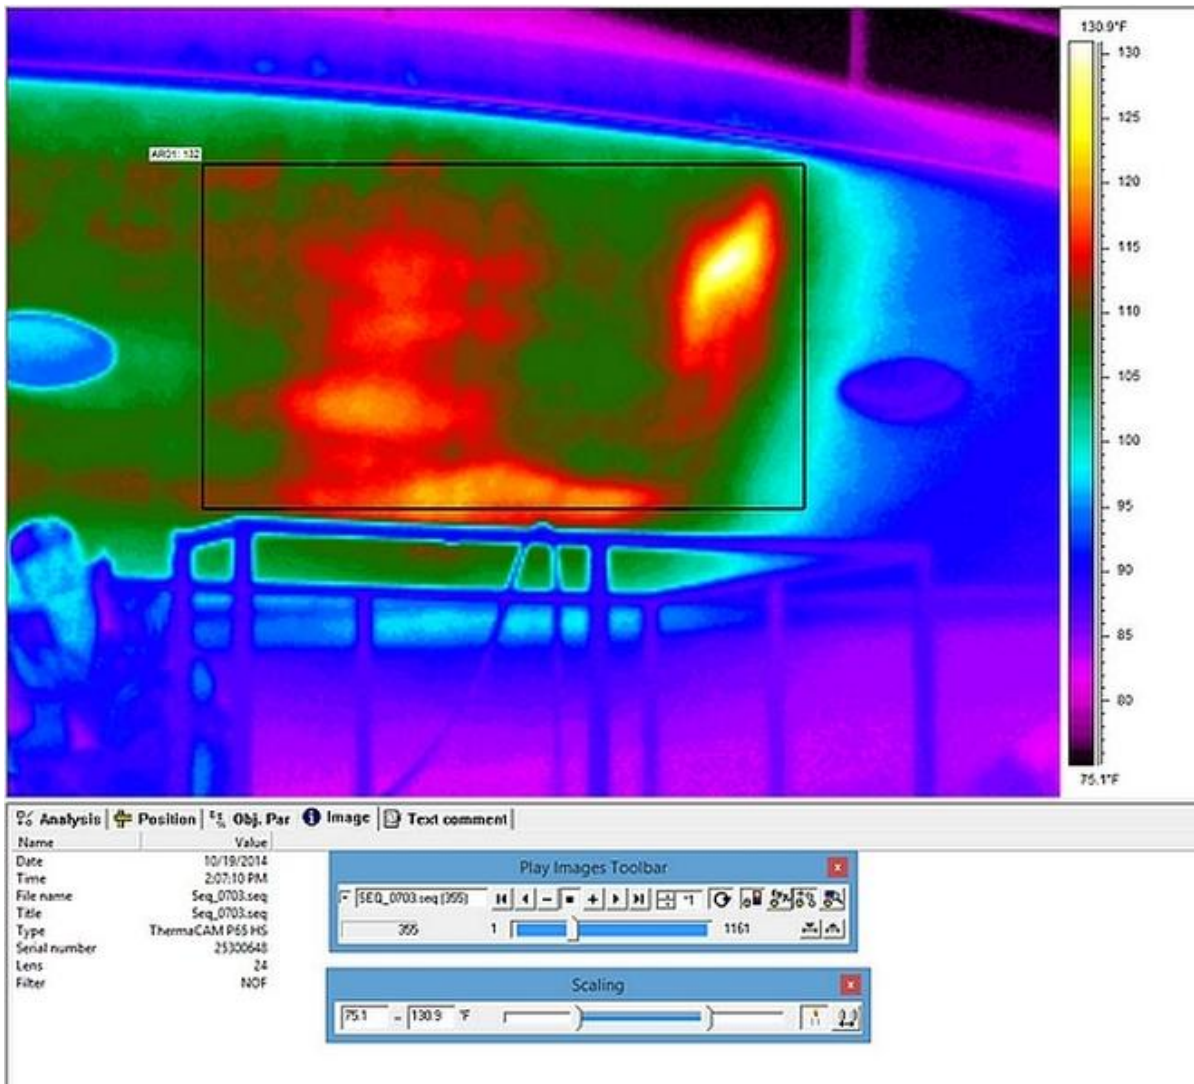
IR image showed thermal anomalies on STARBOARD topside near bow

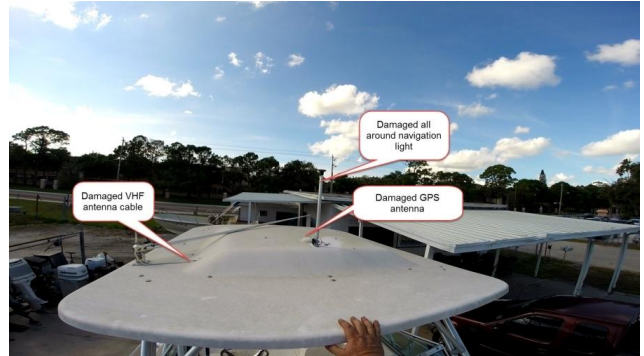
Visual image shows hard top and evidence of entrance of lightning strike

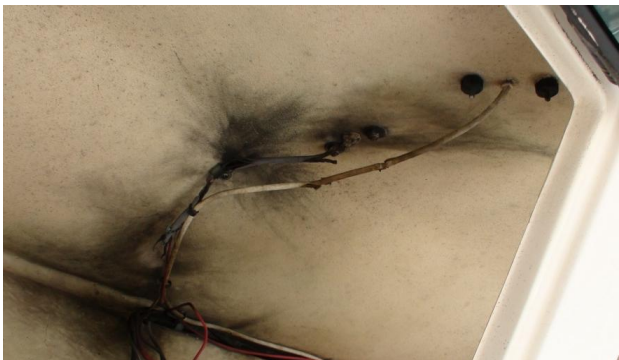
Visual image of storage compartment beneath hardtop shows burnt electrical wires and evidence of lightning strike

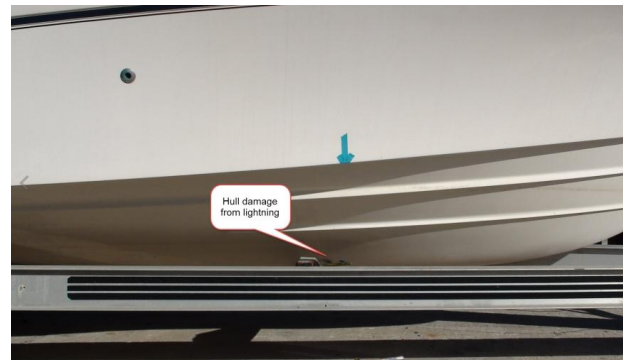
Visual image of STARBOARD exterior side of hull bottom shows location of lightning exit point

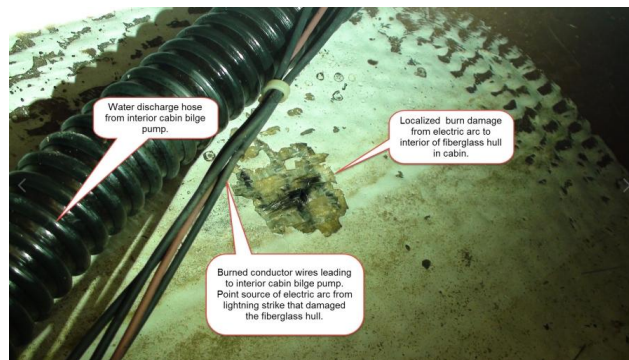
Visual image STARBOARD interior side of hull bottom shows location of lightning as it left electrical wires to the fiberglass hull

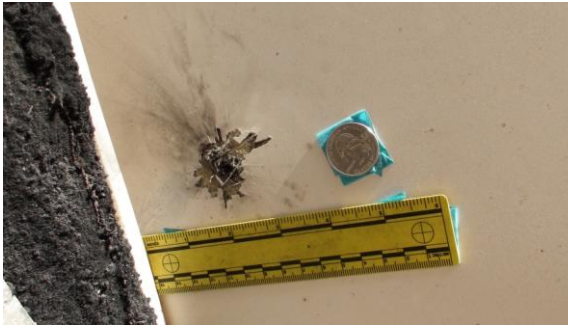
Close up visual image STARBOARD exterior side showed size of burn mark on surface of fiberglass laminate from lightning exit point

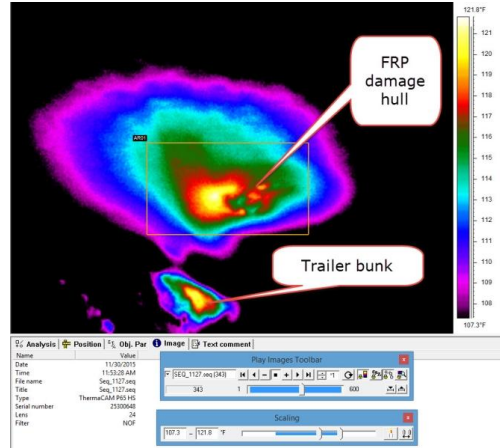
IR image showed thermal anomalies in fiberglass laminate around lightning exit point

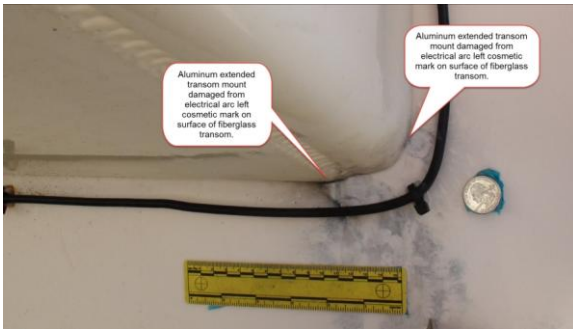
Visual image shows burn mark on fiberglass laminate at junction between fiberglass laminate and extended aluminum transom

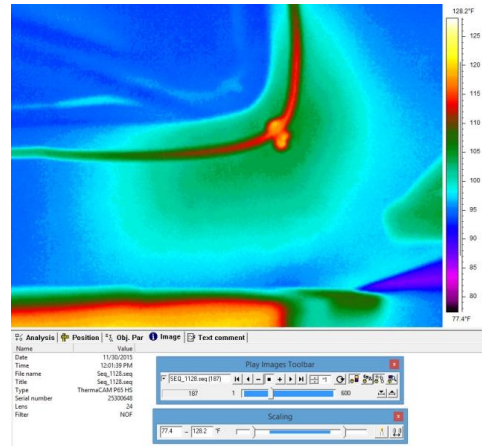
IR image did not show thermal anomalies in fiberglass at junction between fiberglass laminate and extended aluminum transom

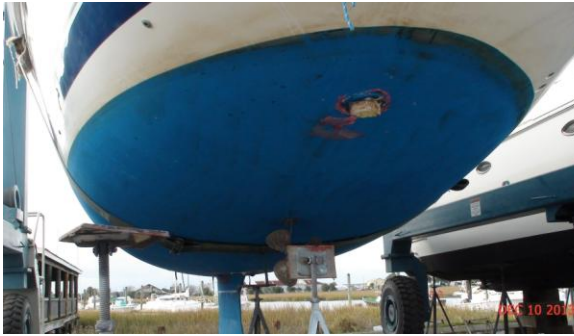
Visual image shows where the rudder was sheared off the vessel, leaving a stub of the composite rudder post

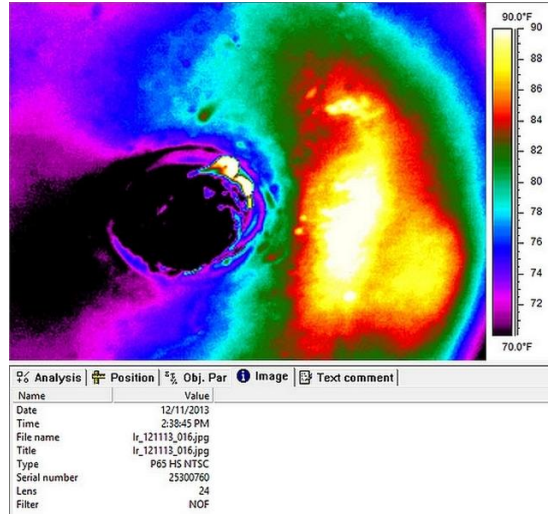
IR image shows thermal anomalies on the exterior STARBOARD side of the fiberglass hull next to the rudder post

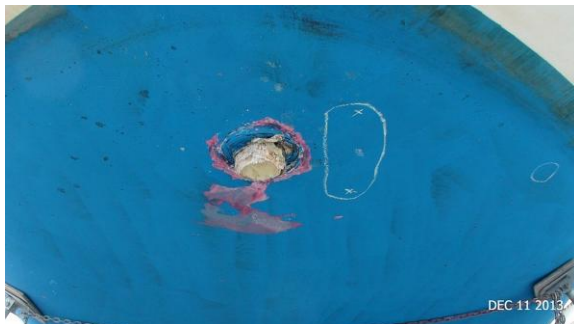
Visual image shows a chalk outline made of the thermal anomaly

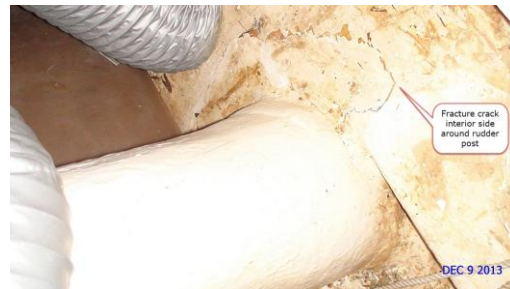
Visual image of interior side of fiberglass laminate surrounding the rudder post shows evidence of fracture cracks, corroborating thermal anomaly
