Thermography Inspection of In-floor Radiant Heating Systems - Case Study

Wayne Swirnow, President
Level III Certified Infrared Thermographer

Case Background

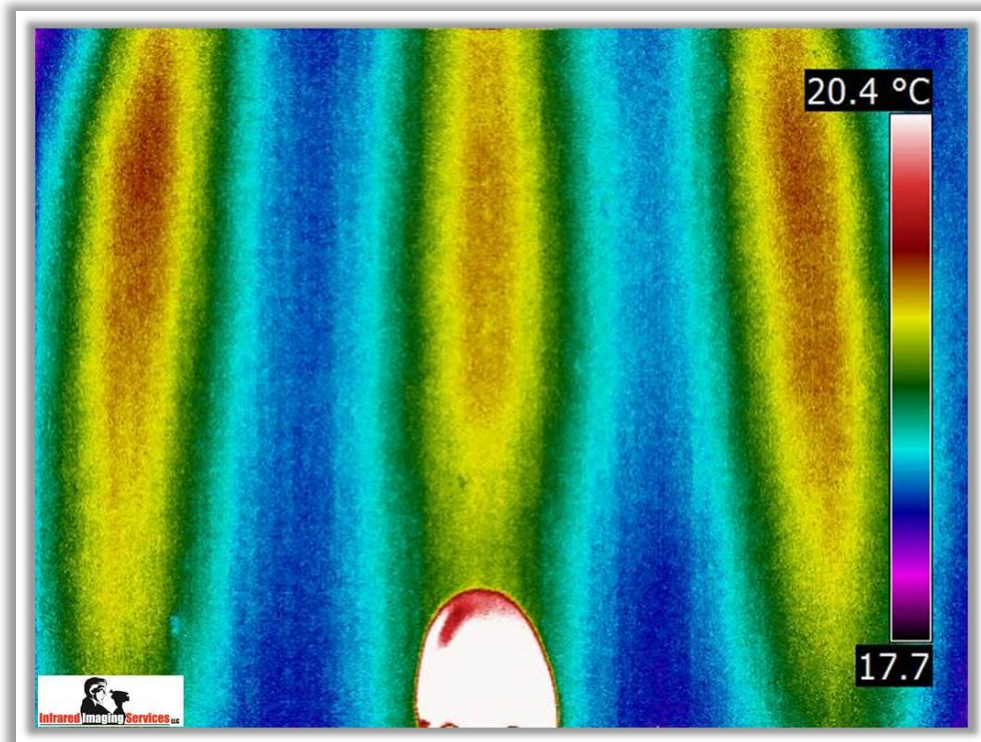
In Figure 3 the floor heat has been on for approximately 3 hours and is just becoming warm. Note how wide the initial signature is due to heat spread from the thicker floor. A size 11 work boot is shown for scale; total temperature span in Figure 3 is only 2.7°C.

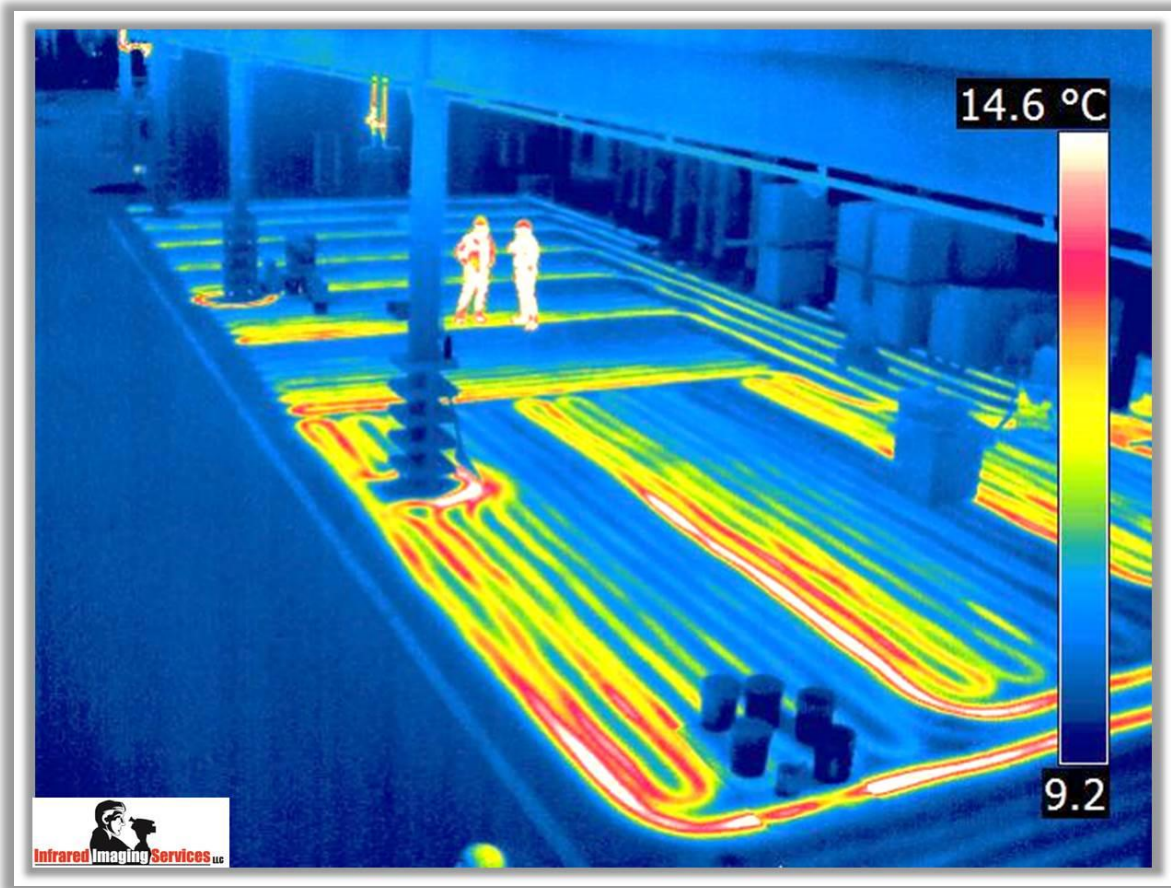
Figure 4

The image below (Figure 4) is an overview of the area. At the foreground you can see three loops running front to back with the supply side of each loop on the left and the return side to the right of each loop. Note that the supply end of each loop is warm and the heat signature slowly fades as it reaches the end of the loop when the heating fluid has given up all its energy to the cold concrete. From the middle of the image and to the top, there are 7 more loops running left to right. The loops at the top of the image are the ones furthest away from the supply header and there is very little heat in the beginning of the loop because the concrete on the way to that loop has extracted all the heat from the pipe.

At the top of the image are the heating loops farthest from the supply header. Along the right hand side of the image are the supply lines to those loops. Notice how the heat penetration down the length of the lines decreases with distance.

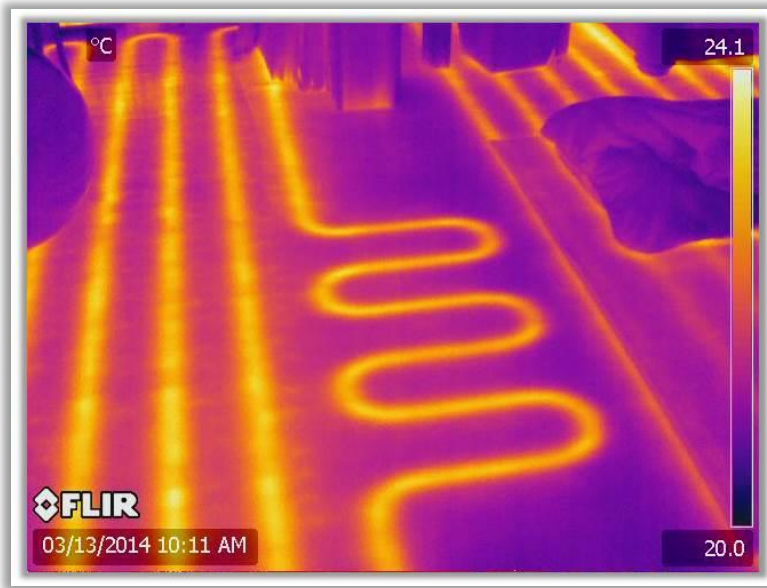
Figure 8: Wood floor

The two images below are thermograms taken of thin substrate residential floors. The top image, Figure 8, is a wood surfaced floor and the bottom image is ceramic tile. Although the heat has been on for several hours the wood floor, which is less conductive than the ceramic floor, still shows well-defined thermal signatures. In the ceramic floor (Figure 9) the heat signature has spread a little wider because of the increased thermal conductivity of ceramic tile, but shows a reasonably well-defined heat signature. Even for areas near the center of the Figure 9 thermogram where two heating lines are spaced close together, it is possible to make a very good estimation of where the pipe center is located.

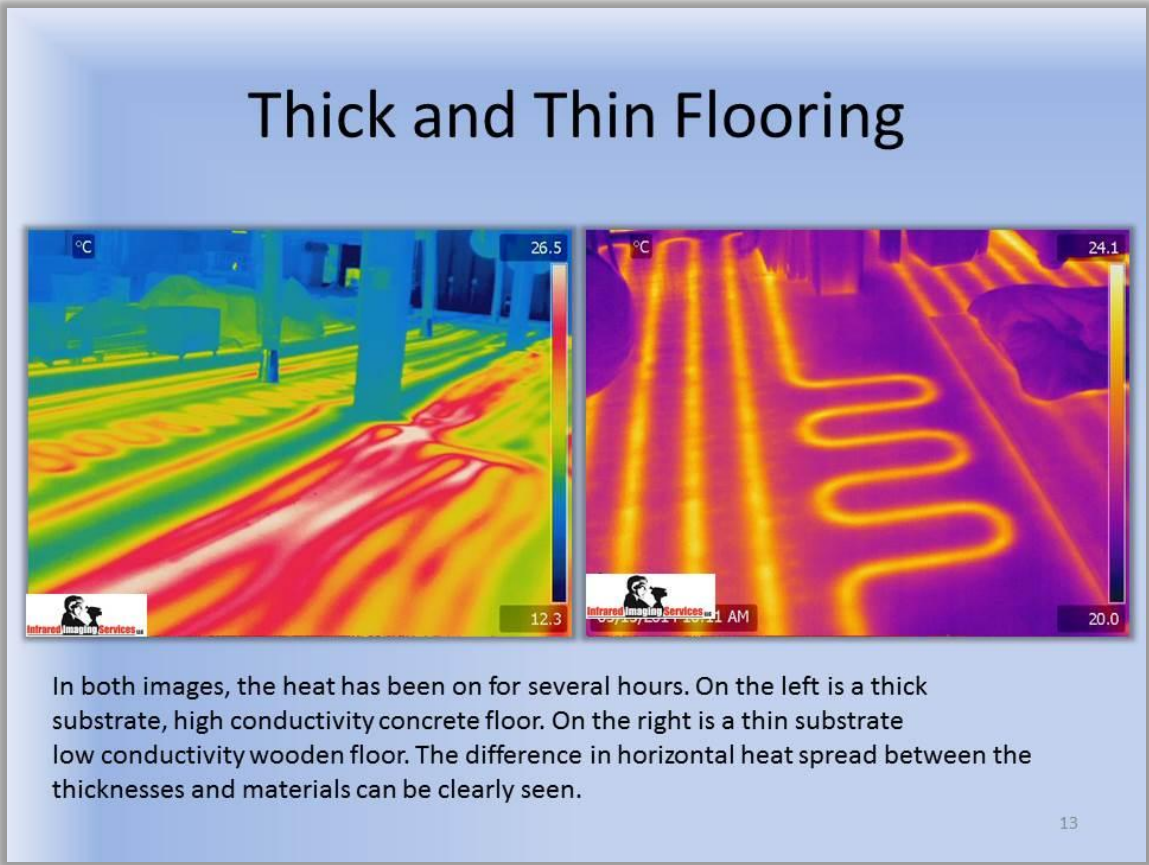
Figure 12 shows two thermograms. On the left is a thick substrate floor and on the right is a thin substrate floor. Note the difference in definition of the heat signatures between the two flooring types. In both cases, the heat has been on for several hours.

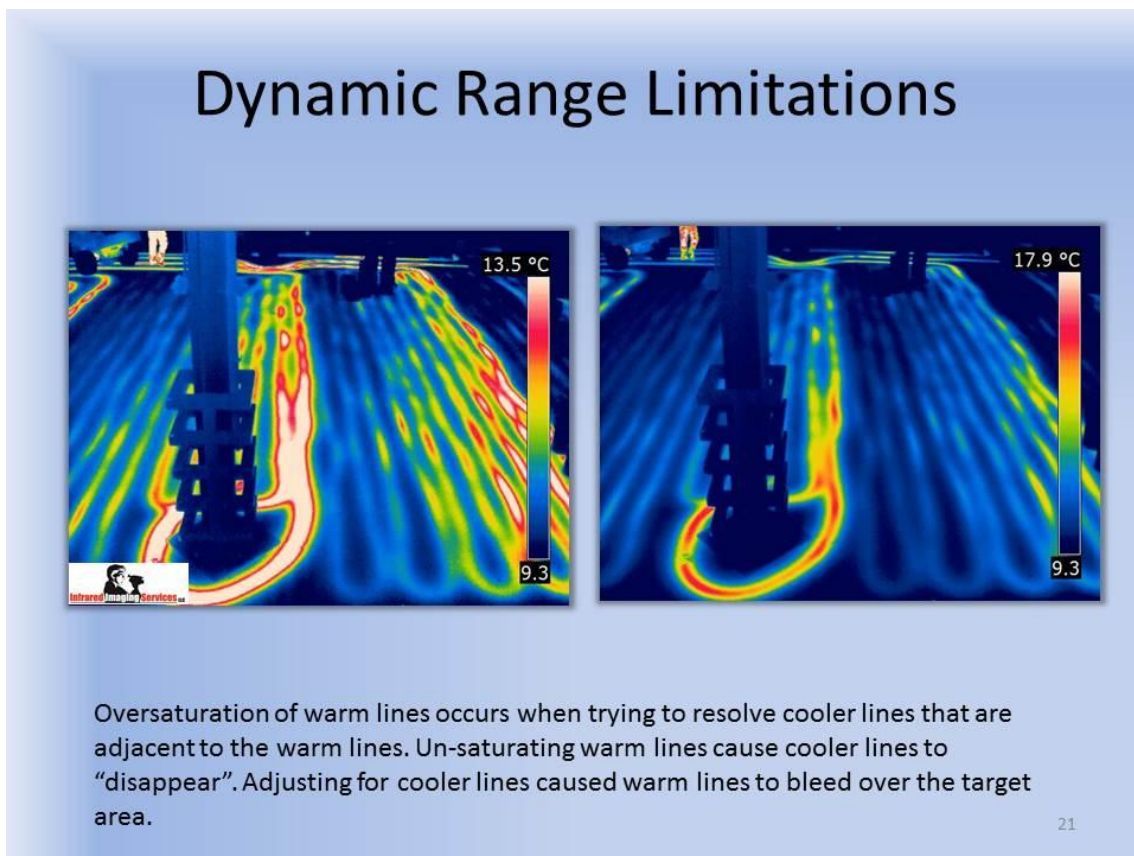
Figure 13

When imaging adjacent objects with significantly different temperatures where one is at the threshold of detection and the other is clearly visible, the imager may have difficulty resolving both objects at the same time. When adjusting the imager to clearly show the warmer heating loop without saturation, the cooler loop was not visible at all. Conversely, adjusting the imager to accurately pick up the cooler loop to identify the pipe center location caused the heat from the warmer loop to “bloom” and over saturate the imager’s viewing screen. In Figure 13, note how the warm supply side of the loop to the left of the center of the image bleeds into the cooler ending loop just to the right of it when adjusting the imager to resolve the cooler loop. In the right image when adjusting for the warmer loop, the cooler loop is not visible.

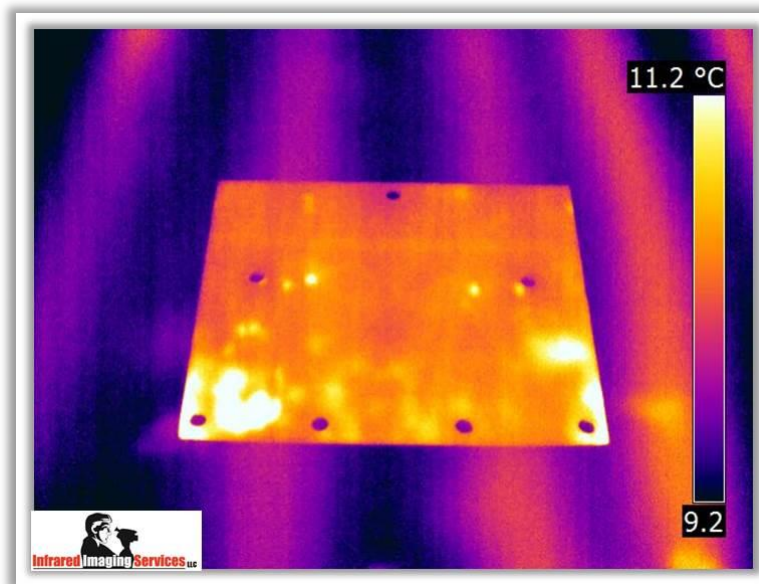
Figure 15: Thermogram of template on floor

Looking at Figure 15, you will note how wide the signatures are even though the floor is just beginning to warm from ambient temperature after three hours. The horizontal spread of the heat signature as it travels up through the thick subfloor material makes it more difficult to isolate exactly where the center of the heat pipe is. Also noticeable is how close the mounting holes are to the heating signatures.

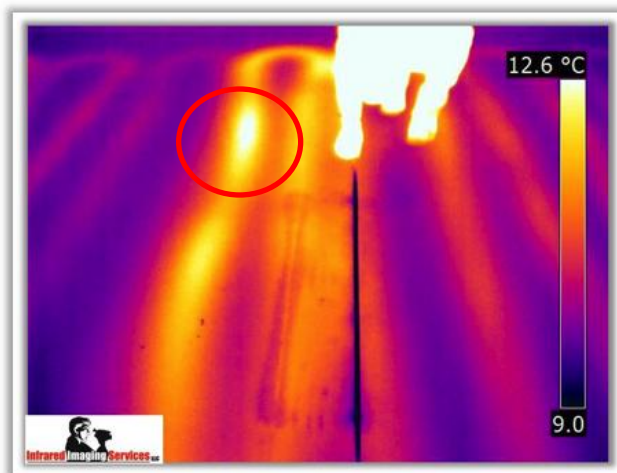
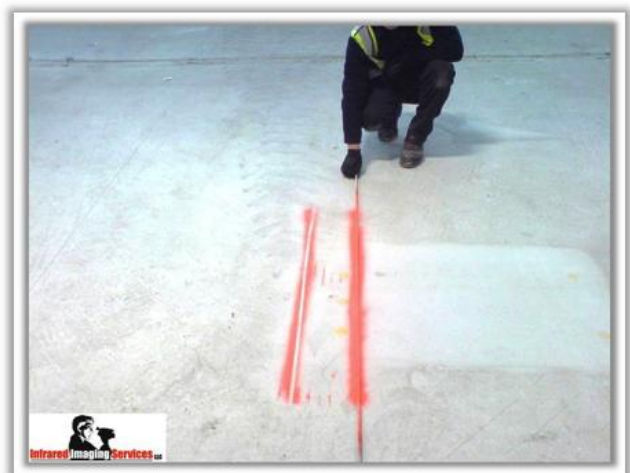
The two images below, Figures 16 and 17, show the qualified assistant holding down a piece of rebar which we then sprayed over with marking paint to leave a clean line on the floor located over the center of each heating pipe.

Notice in the left-hand side of the thermogram (red circle) that the warm area is the beginning of the loop and it is located directly next to the colder end of the adjacent loop. Adjusting the thermogram to effectively image both was impossible. Here, the settings are adjusted to best show the warmer beginning of the loop and the line we are working with. Tuning the imager for the cooler loop would have resulted in oversaturation of the warm loop and caused it to bleed across the imager view screen.

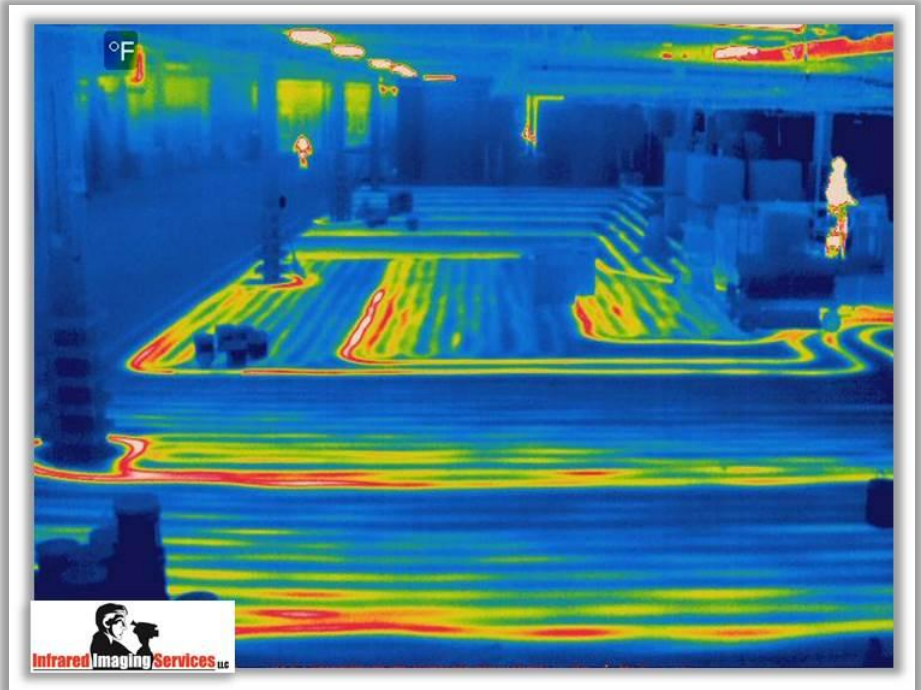
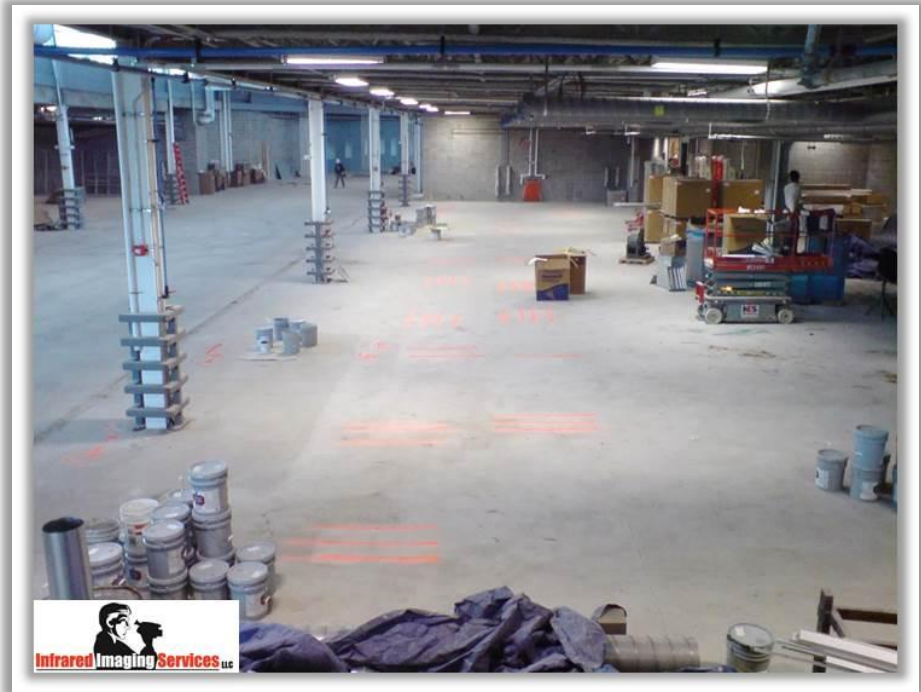
Figures 18 and 19 show an overview of the entire area with the multiple loops in the thermogram and the orange paint in a visible light image showing the areas where lift support columns are to be mounted.

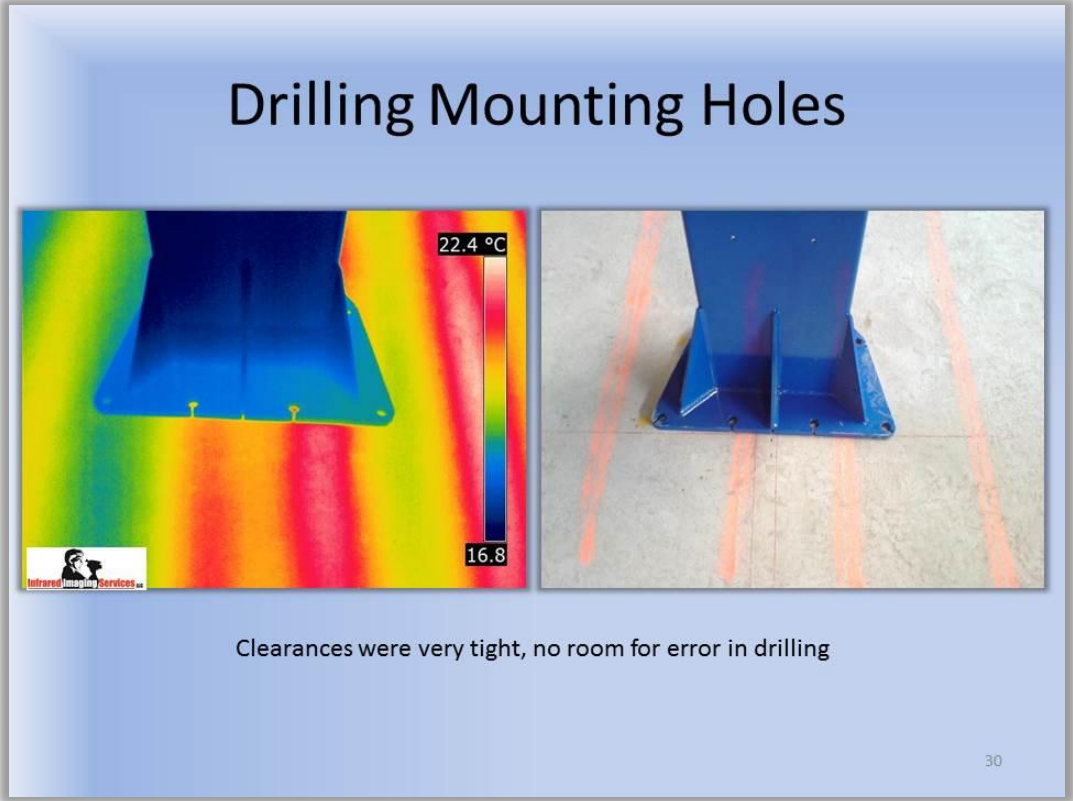
Figure 20 shows the thermogram and daylight image of the support columns and how closely the holes were aligned to the markings on the floor. The thermogram was taken on the second day when the floor had not cooled off sufficiently from the night before and the heat was again turned on in the morning prior to imaging. This resulted in even less thermal contrast between the heating lines than the previous day. When combined with the horizontal spread, it created a significant challenge in confirming the floor markings of the prior day. However, confidence was high on the prior day's floor markings so they remained the primary guide for drilling.
