Detection and Classification of Surface and Subsurface Structural Deficiencies Using Mobile Infrared Thermography and High-definition Visual Imaging

Kyle Ruske, Masato Matsumoto, PE, Int. PE, Shuhei Hiasa, PE

NEXCO-West USA
8300 Boone Blvd, Suite 240
Vienna, VA 22182

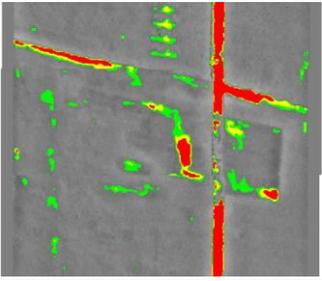
As seen on the left-hand side of Table 1, the LSC imagery was used to proof the heat signatures and observe cracking. In the case of row #1, there was heavy cracking accompanying a subsurface delamination. Visualizing and analyzing both occurrences can be helpful in fully diagnosing the issue at hand, and can be helpful in decision making for repairs. In some cases, patchwork and discoloration caused by black gum spots set off the automatic detection, because the temperature differential of these

materials was a couple degrees different from the surrounding sound concrete. These instances must be carefully reviewed alongside the visual image, then disregarded if found to be false detections. A good example of this can again be found in row #1, where patches along the joint, white lane striping, and a large patch on the deck all caused false detections. Regarding the true detections, no significant discolorations were found, and could therefore be classified as potential delamination.

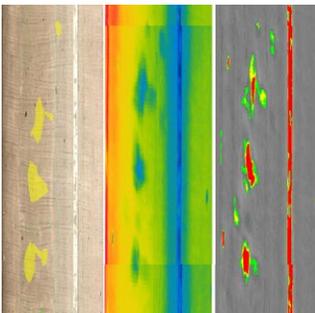
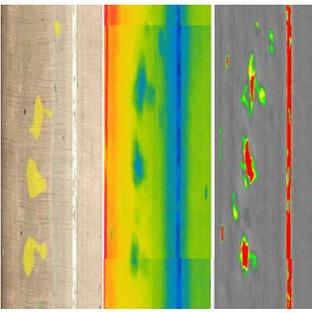
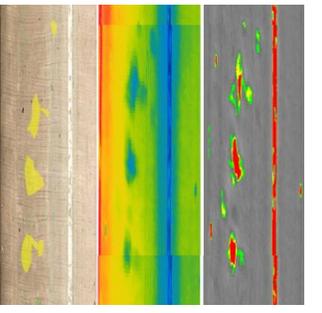
3

A very representative thermal gradient was observed on the shoulder of the deck. This can be seen quite clearly in the raw IRT image in row #3, with a warm left-hand side (towards the parapet wall) fading to a cooler right-hand side (into lanes of traffic). When the gradient reached the white striping, which tends to cool much faster than the rest of the concrete deck, there was a relatively large drop in temperature (as evidenced by the blue beam-like pattern). The software was still able to extract the gradient and denote only locations where the temperature distribution was steep. This did inevitably include the stripe itself, which can be disregarded.

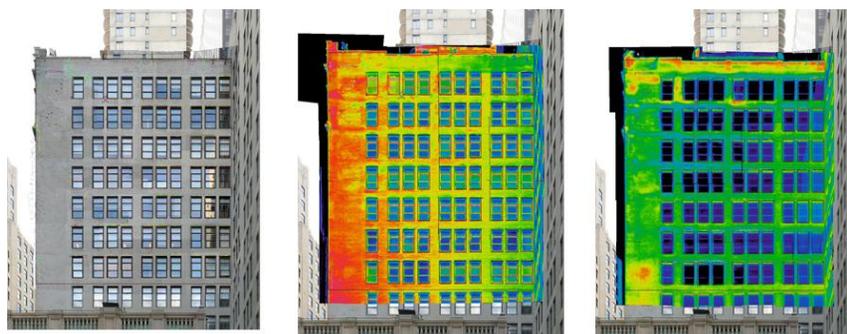
Figure 12: NY building façade visual, daytime, nighttime scans

Both daytime and nighttime scans were taken. Two very different thermal patterns were observed at the different times of day. Figure 12 below shows how an overarching thermal gradient stretched from the left side of the building wall to the right. The left side had more direct exposure to sunlight, and therefore heated faster. At night, there is a natural tendency for the top of the building to be hotter, as heat rises, but the remainder of the façade was much less dynamic in comparison to daytime. In Table 2, some examples of deficiencies are listed.

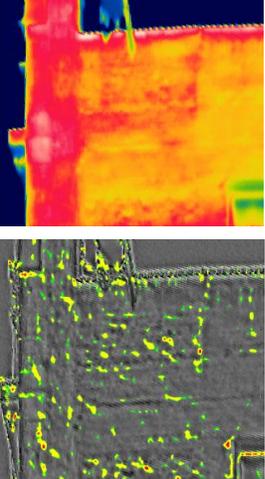
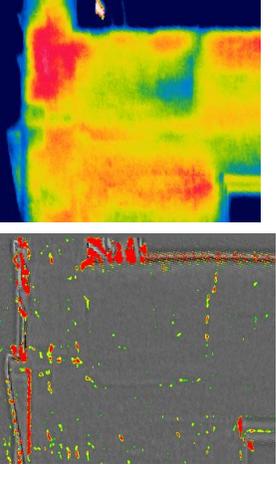
In the case of row #1, a vertical crack could be seen in both the day and night images, much more clearly at night (rightmost image of row #1). It is irregular to see a cool spot so large in the top of the building, so this may be indicative of more damage under the crack. Row #2 shows an example of a potential deficiencies only apparent at night - a hotspot below a windowsill, and a cool spot above a lintel. As opposed to rows #1 and 3, the automatic detection for these spots was not too successful, even though the anomalies were clearly seen in the raw images. Another crack-like occurrence was seen in row #3, which could be clearly identified in both raw and IRT images.
