How a Fenestration Professional in New England Benefits from Use of Infrared Thermal Imaging of Doors & Windows

Jay Ray, founding member of IFSPA and R. Olsen
Maine Infrared Solutions
40 Orchard Lane
Otisfield, ME 04270
Ph: 207-749-2741

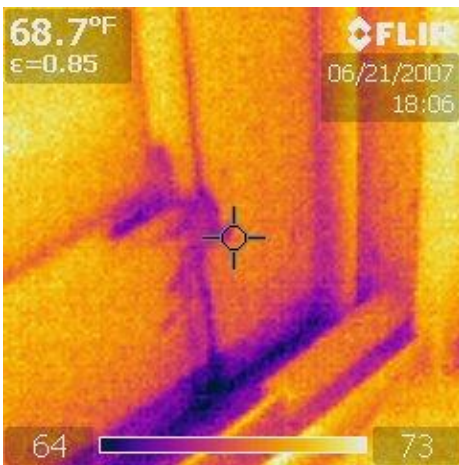
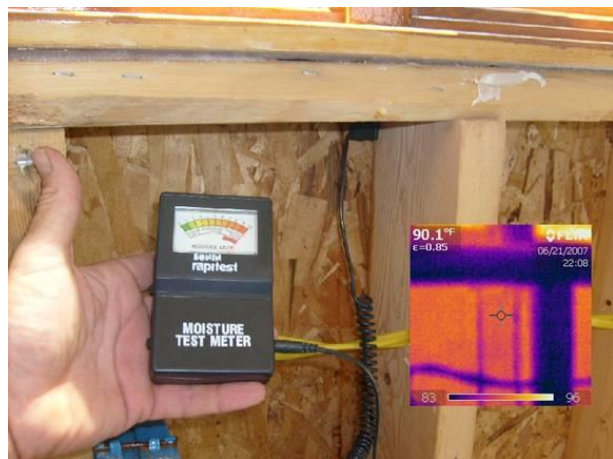
This is easy to discover and the repair / remediation process is standardized by the factory. The thermogram that follows shows a glazing juncture failure where water is coming around the bottom of the insulated glass unit (IG) on a door.

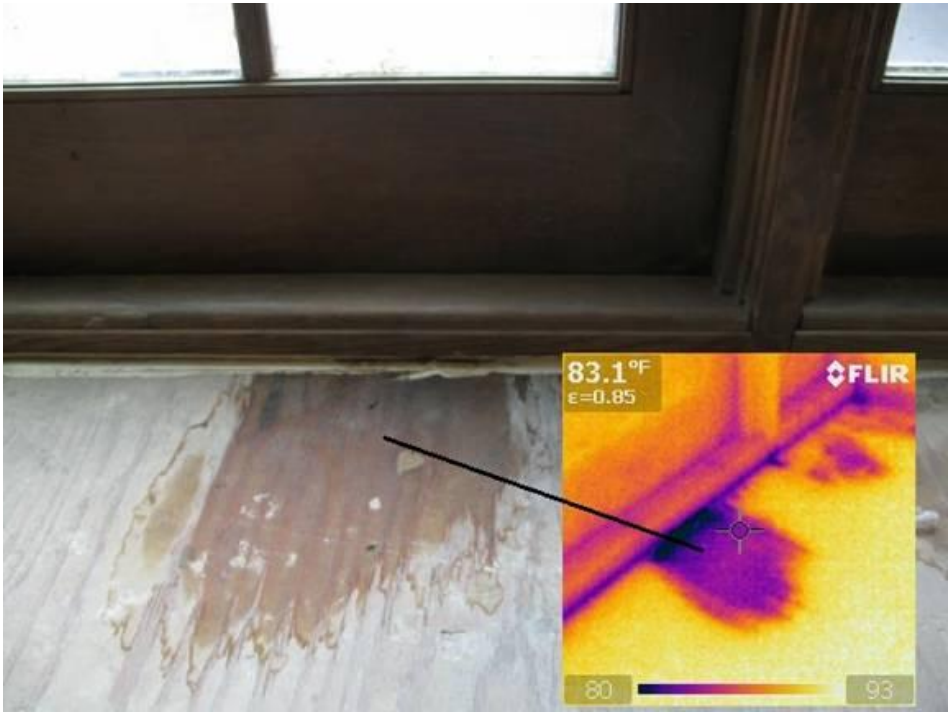
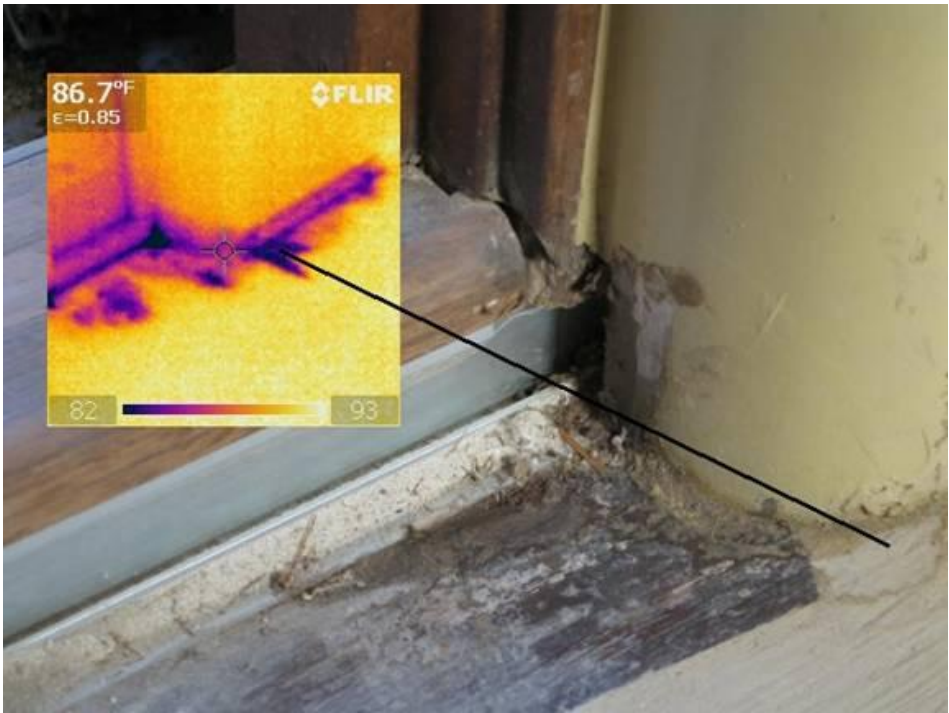
Infrared thermography makes the process very simple. We only have to look where we see a thermal anomaly typical of water intrusion around or under the subject unit.

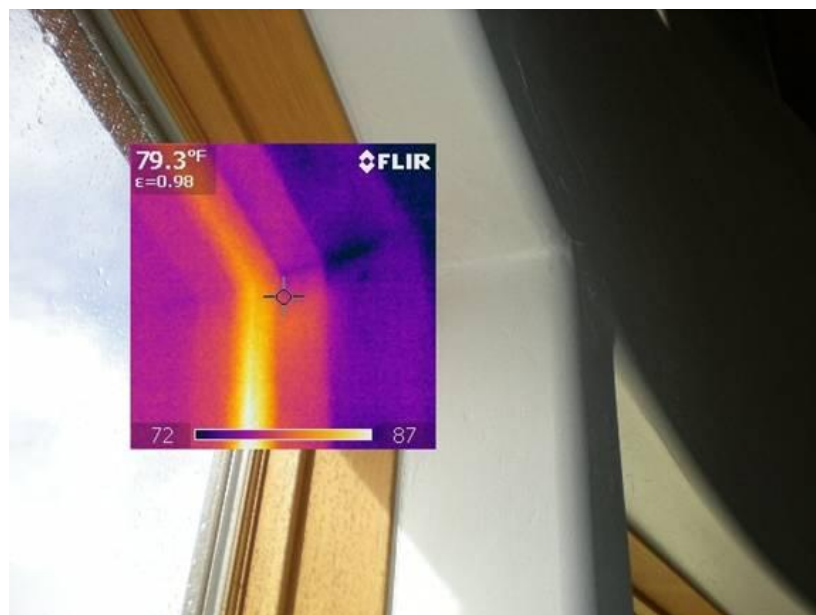
The spacer of an IG is the only place that conductive heat loss or gain can occur. The only place on an IG unit where infrared thermography can be of use is observing and recording the heat transfer at and near the IG spacer.

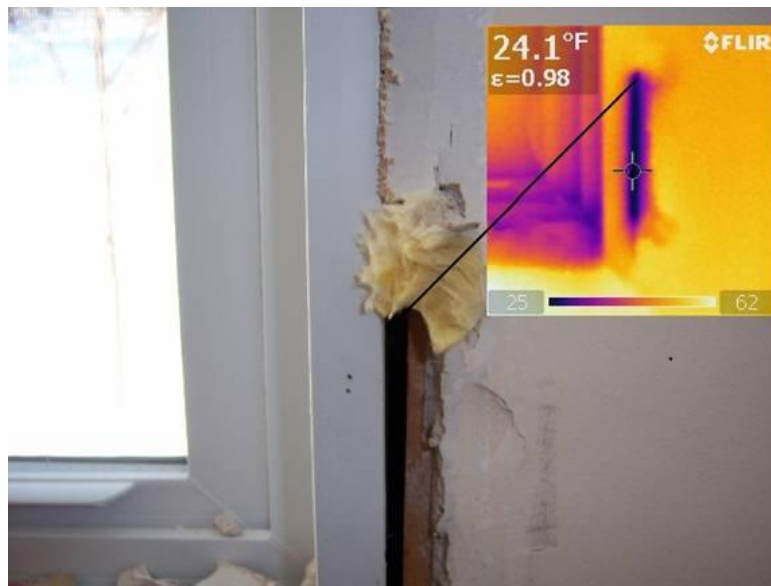
The unit above was found to have a void in the insulation at the bottom of the rough opening. The initial scan showed a cold anomaly and removal of the casing proved this.
