# **Demystifying the Art and Science of Finding Moisture in Buildings Using Thermal Imaging**

Peter Hopkins, Level II Thermographer

United Infrared  
8472 Adams Farm Road  
Randleman, NC 27317  
Ph: 888-722-6447, Direct: 760-593-2339

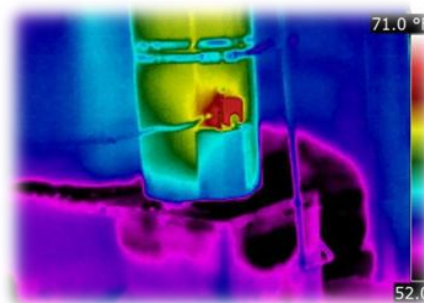
Leak at a water heater

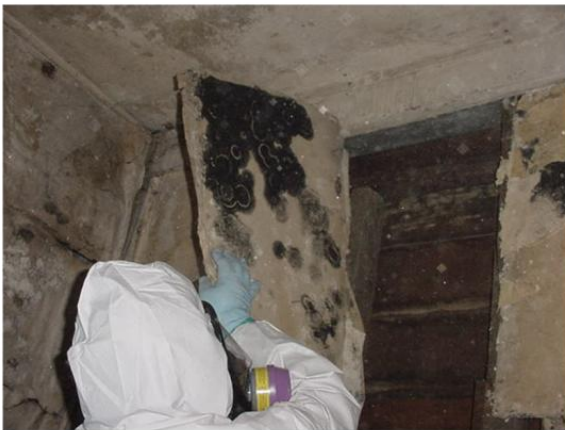
**Mold damage**

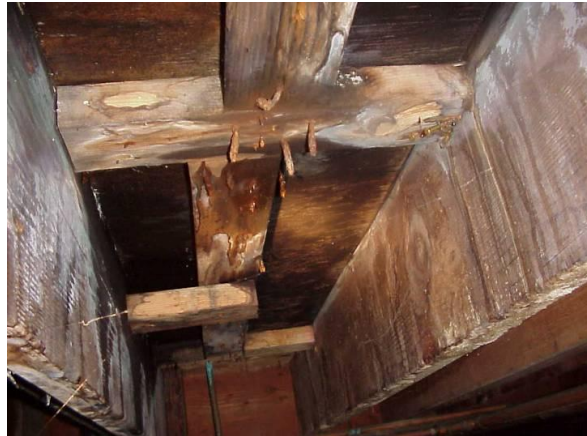
**Subfloor damage due to leak**

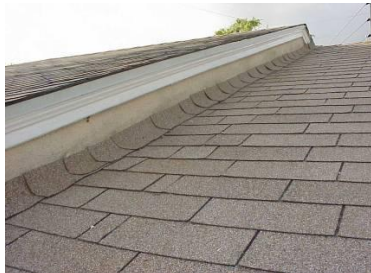
**Roof with no proper counterflashing**

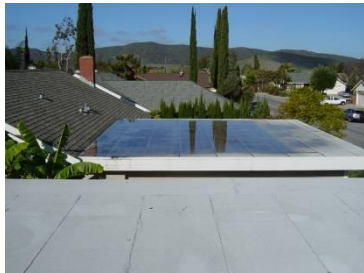
**Roof not pitched properly to drain (holding water)**

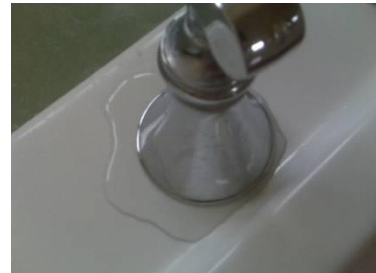
**Plumbing fixture leak**

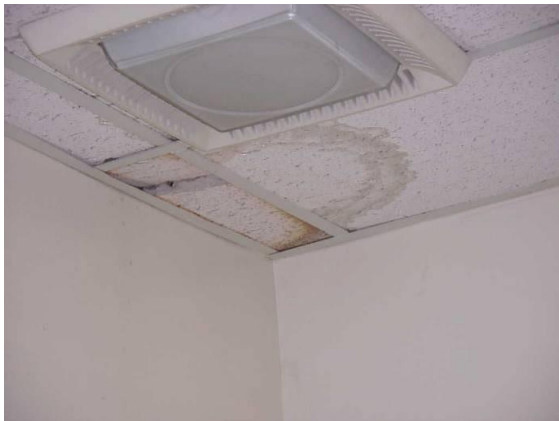
**Ceiling stain**

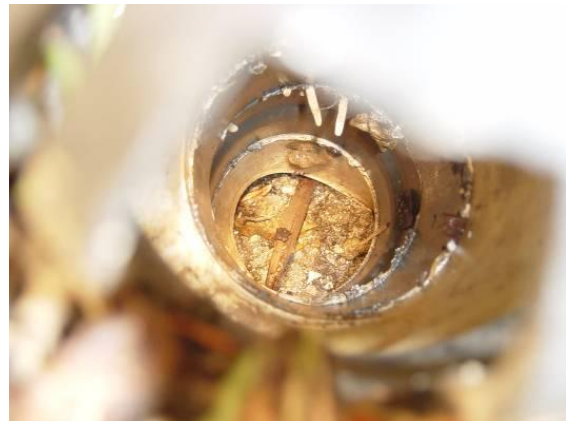
Upon review of the exterior and moisture mapping the interior of the unit, we were able to identify the root cause of the moisture: The exterior drainage system was improperly designed and was clogged at the time of the inspection causing leakage and excessive water at foundation. The soil was allowing water to build up against the structure and the waterproofing was failing.

**Clogged Drain**

As additional waterproofing would be difficult, it was our recommendation to properly repair the grade of the home, clean the drainage, install gutters and consider hardscape next to the home to minimize future moisture intrusion. This, of course, in addition to remediation of the wet areas.

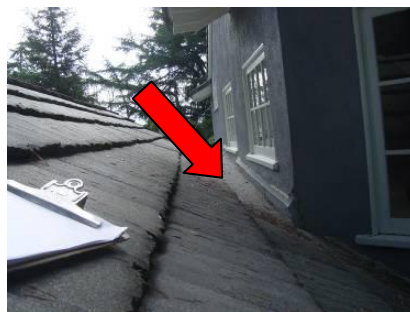
It turned out the suggested roof repair by local roofing contractor would not have solved the problem as the true issue was poor roof design of the flashing detail as you can see in image (D). In heavy rains, water from the upper roof cascaded onto the lower steep-pitched roof, where it was directed against the building and under the poorly designed counter flashing on the wall, eventually finding its way into the living room ceiling.

**(D) Arrow showing point of water entry at flashing**

Our recommendation was to install a new wide cricket flashing, taller counter flashing, and gutters on the upper roof to redirect the bulk of the water.

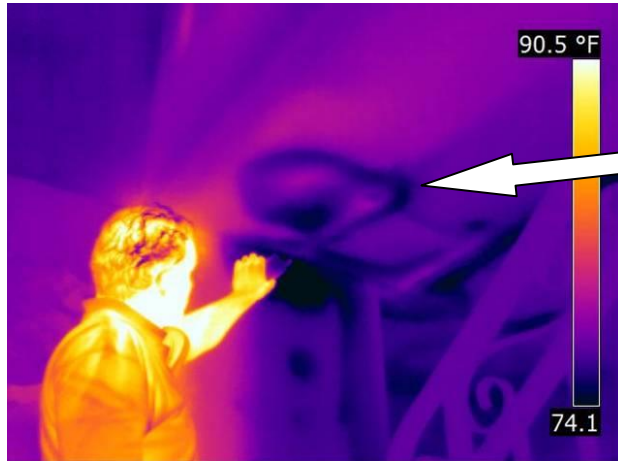
**Thermal**

Upon arrival we did our normal routine and documented conditions and took moisture readings but when we turned on our infrared camera, we saw the true problem. There was no visible moisture at the ceiling but we quickly confirmed the wet area with our thermal camera. This led us back to the tub but we decided to confirm our suspicions with a quick water test of the tub upstairs. We tested the tub with hot water and within minutes, we were able to see water coming down the return wall.

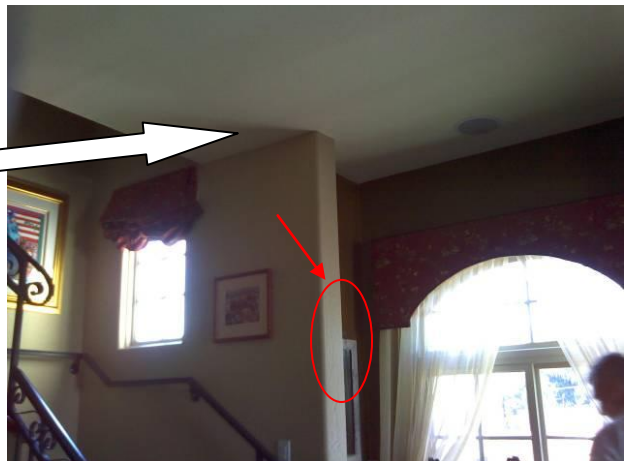
**Visual (arrow shows where only visible stain was noted)**

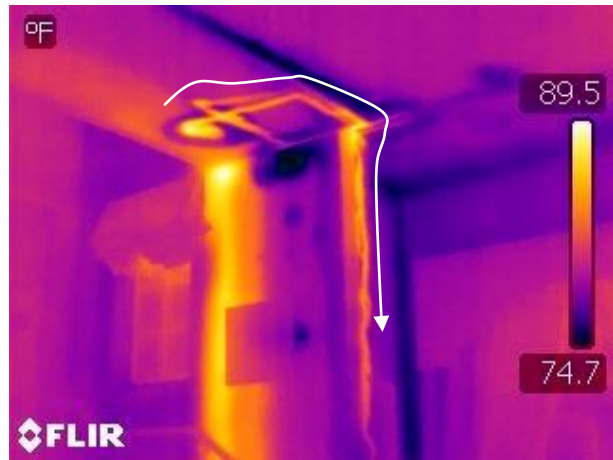
We followed the moisture path and saw how that wall leads right back to where the tub drain is...voilà! case solved.

**Water testing showing water travel**

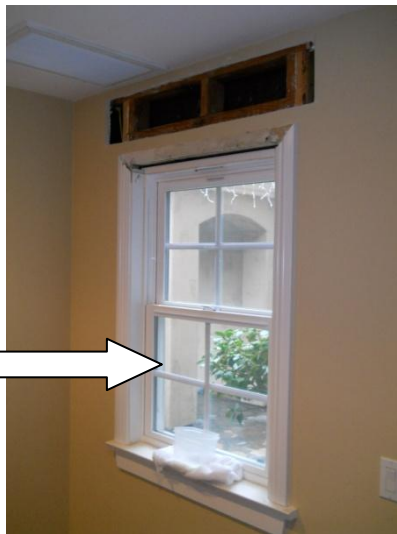
**Interior View. Owner opened up portions of wall to find leak.**

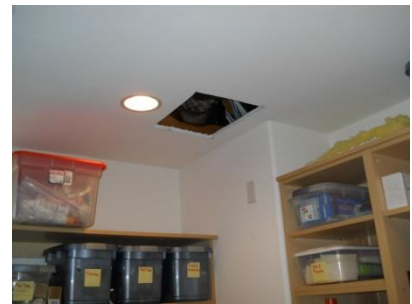
**2nd story above bedroom closet suspected and owner cut holes in ceiling looking for source.**

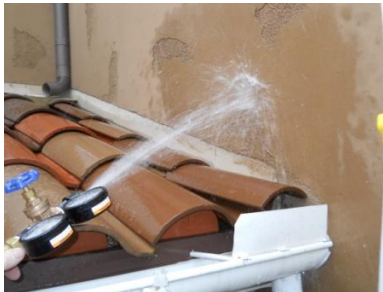
**Water testing suspected area**

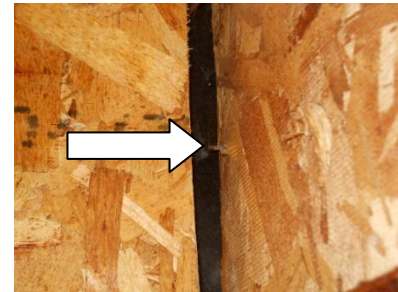
**Visual showing nail penetration**

Water testing of the residence at the lower suspected area and having opened up the ceiling allowed us to confirm our suspicions. It appeared that the contractor had penetrated areas of building paper which were allowing moisture to come into the residence. Although they had come at previous times to repair, as mentioned earlier in this paper, it is only a matter of how much water had to saturate the stucco before it would appear and in this case...5 minutes of water did the trick.

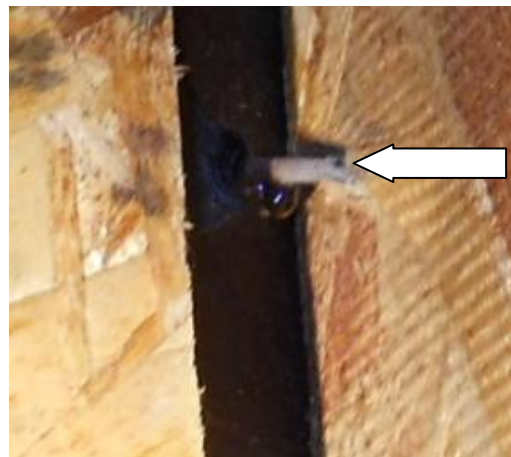
**Close up of nail with drip**
