Thermographic Inspection of Building and Roof Water Intrusion in the State of Florida

James Brady
Level III Certified Infrared Thermographer
Brady Infrared Inspections, Inc.
935 Pine Castle Court
Stuart, FL 34996
Ph: 772-288-9884

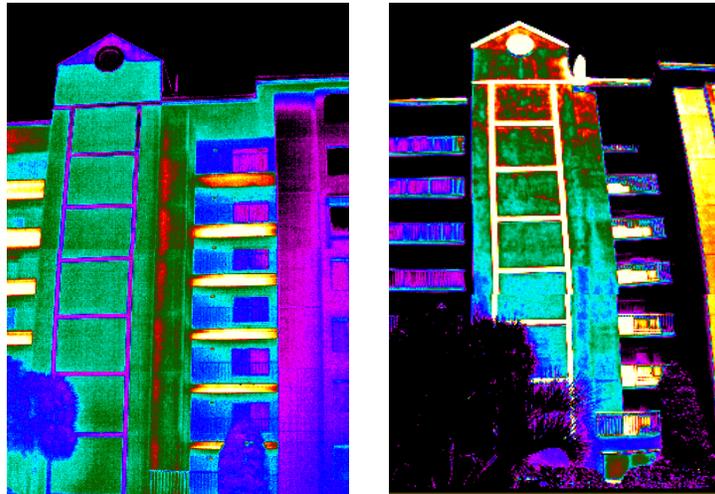
Figure 3. Infrared image on left shows thermal pattern on building's stairwell tower wall during an evening scan under cooling conditions. A thermal anomaly can be seen along the inside corner of the stairtower and trash chute.

Infrared image on right shows thermal pattern on building's stairwell tower wall during an afternoon scan under warming conditions. A mottled thermal anomaly can be seen on the front face of the stairwell tower, possibly showing areas of delaminating stucco.

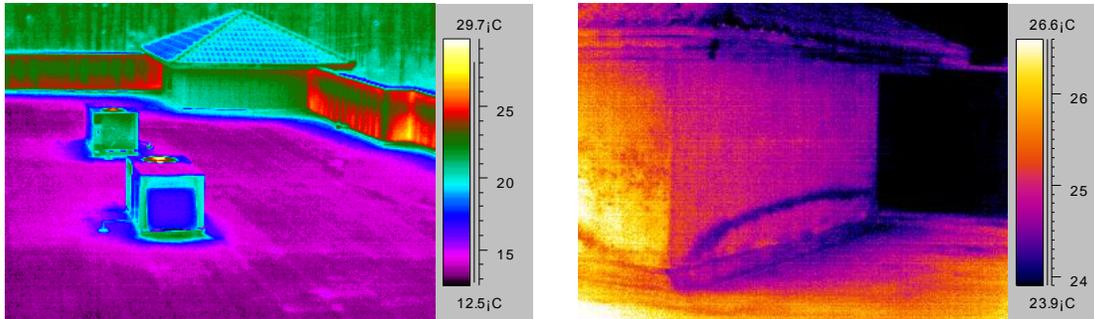
Figure 4. Infrared image on left shows penthouse wall void of any thermal anomalies during dry period and the same wall, on the right, one day after a rain event showing a radial thermal pattern of moisture

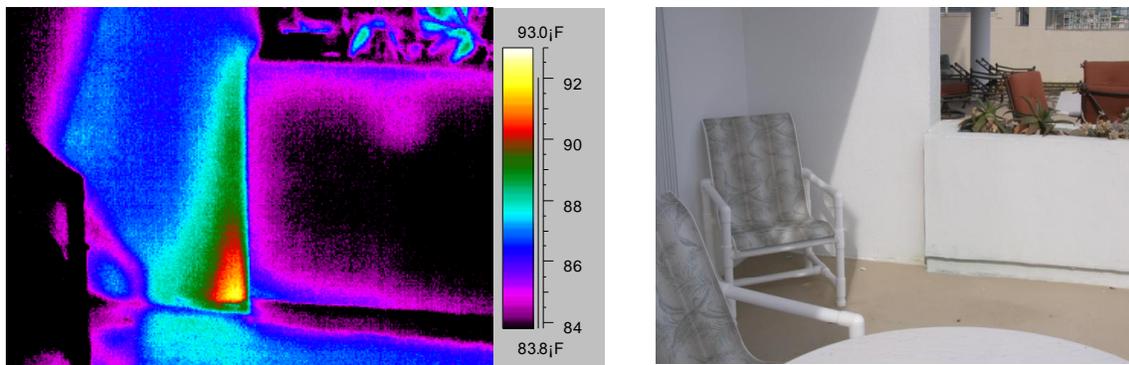
Figure 5. Infrared image shows thermal anomaly of trapped moisture in wall during an early morning scan. Area of anomaly tested positive for moisture using moisture meter

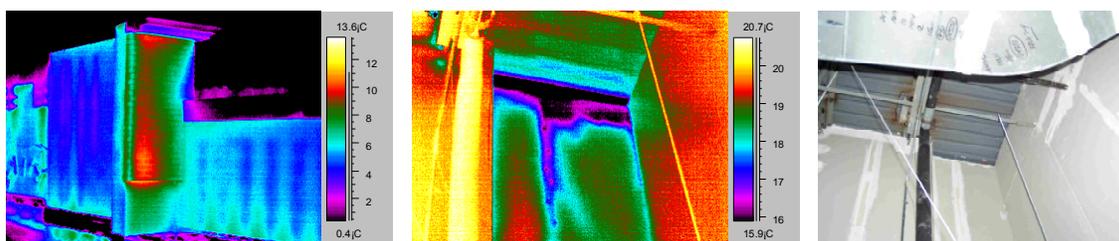
Figure 6. The left infrared image shows a thermal anomaly on the side of brick column. Inspection above the tile ceiling shows a cold anomaly of tracing water directly below the brick column

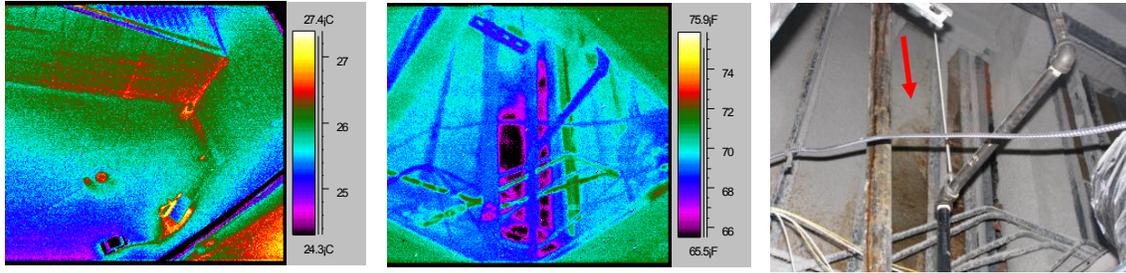
Figure 7. The left infrared image shows a thermal image of a roof taken from a higher roof showing a warm anomaly on the side of a metal panel wall. Conducting a thermal and visual inspection of the interior side of the wall (middle and right photos), above the drop ceiling, confirmed that the thermal anomaly did, in fact, represent moisture

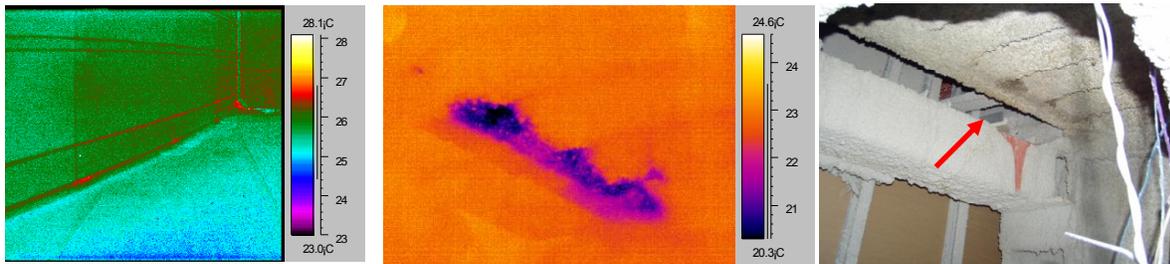
Figure 8. The left infrared image shows a thermal image taken along the same metal panel wall tie-in with the roof in Figure 7. Small, yet strong thermal anomalies were detected, yet no moisture was found in the roof during destructive testing next to the anomalies. Conducting a thermal and visual inspection of the interior side of the wall (middle and right photos), above the drop ceiling, confirmed that the thermal anomaly did, in fact, represent moisture (dark area at arrow in visual photo) that was migrating along the edge of the metal roof deck

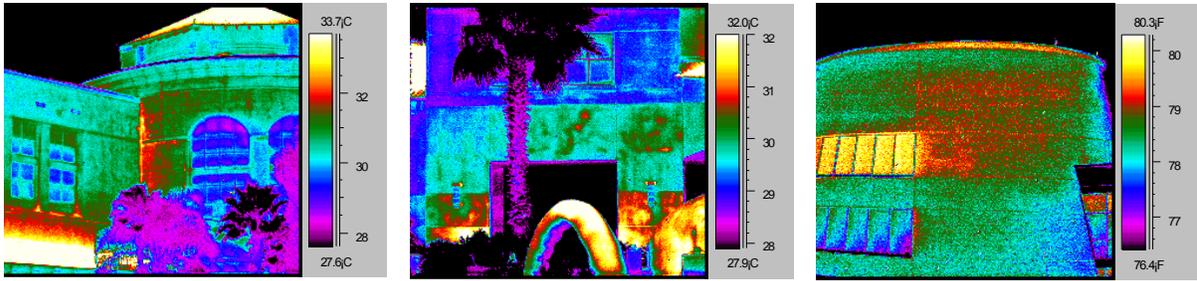
Figure 11. Examples of trapped moisture within EIFS wall panels. Areas of moisture are represented as orange patterns on wall

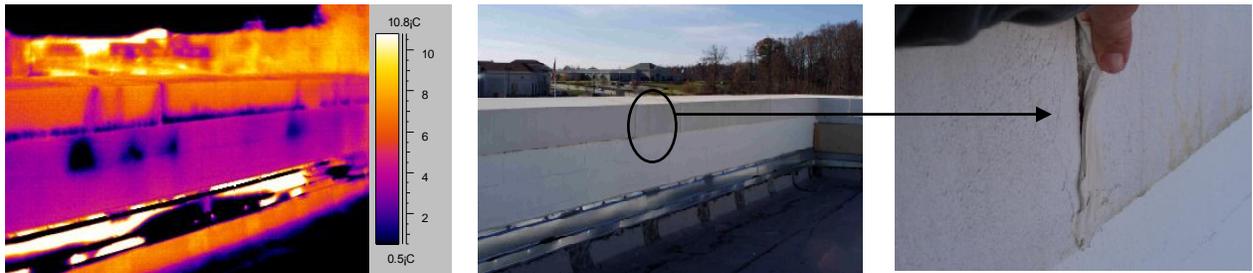
The images below show an example of water migration through open caulk joints on a foam sill fastened atop a concrete block parapet wall.

Figure 12. Infrared image shows migrating and trapped moisture. Middle image is control picture showing location of one of several areas where caulk joint is open as shown in right image

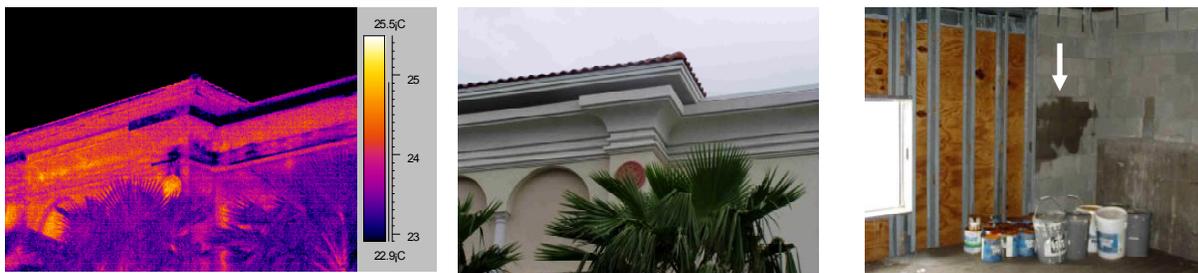
The images below show an example of water migration through a mechanically fastened foam coping detail. Water originally entered into the foam material because of a poor quality finish coating.

Figure 13. Infrared image shows trapped moisture in foam coping detail as dark areas at arrow. Middle image is control picture showing foam detail and right image shows water migrating into block wall at arrow. Images captured within 6 hours of a rain event during a warming cycle

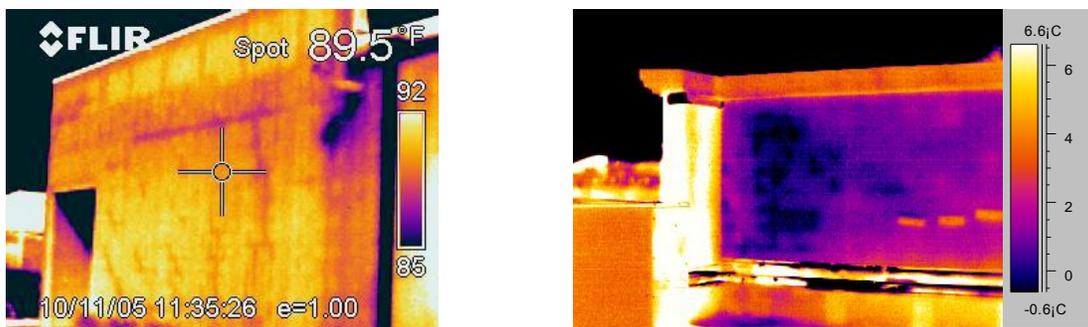
Figure 14. Moisture infiltration on concrete block walls with elastomeric coating. Image on left shows a hairline crack in the wall where water is entering the wall. Image on right shows a coat system that is breaking down, allowing moisture to be absorbed through the block face

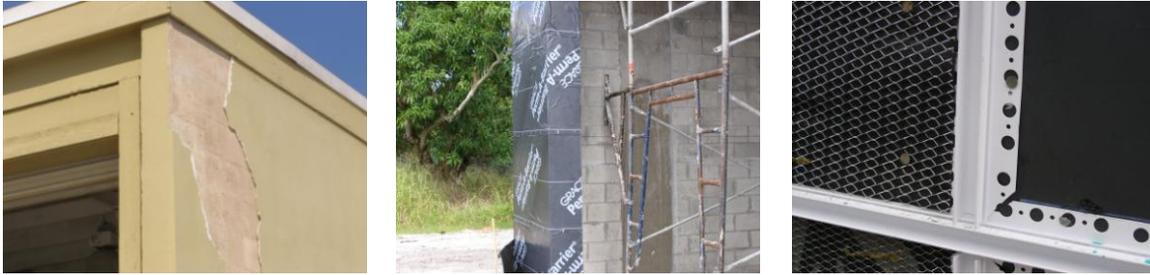
Figure 15. Image on left shows direct applied stucco over CMU that is de-bonding. Middle image shows vapor barrier directly applied to CMU prior to metal lath and stucco finish. Image on right shows mechanically fastened metal lath and control joint bands applied over moisture barrier and CMU

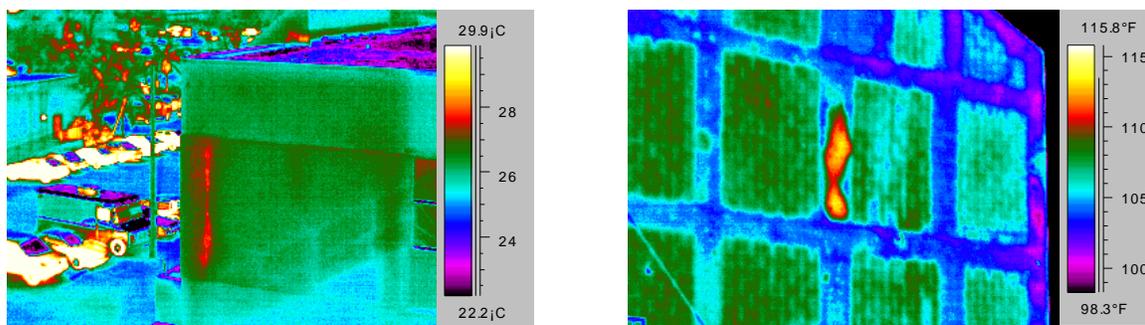
Figure 16. Image on left shows a vertical crack in stucco warming much quicker than the surrounding wall during an early morning sun. Faint thermal halos on the side of the crack are areas of de-bonded stucco. Image on right shows an area of de-bonded stucco (orange area)

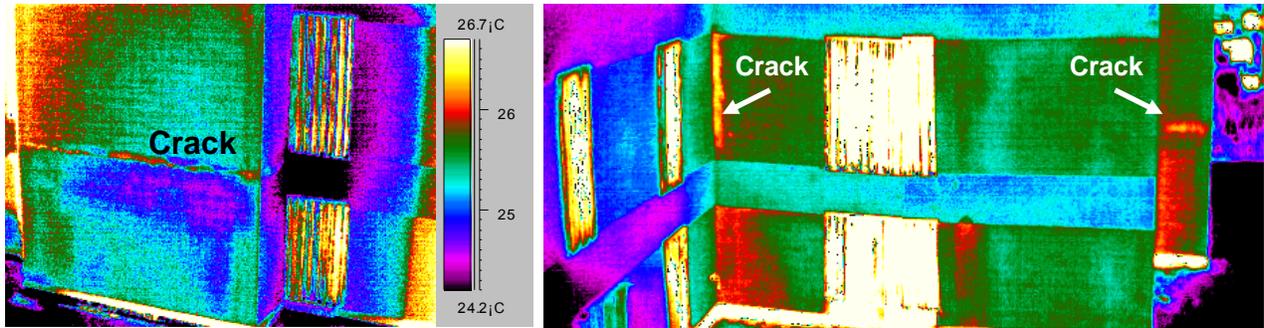
Figure 17. Image on left was taken during an early morning sun and shows a horizontal crack in stucco with possible trapped moisture seated in the wall (blue/purple area). Right image shows a vertical and horizontal wall crack up high with possible trapped moisture and stucco de-bonding (orange areas). Areas of stucco de-bonding were tapped with a hammer to confirm their condition

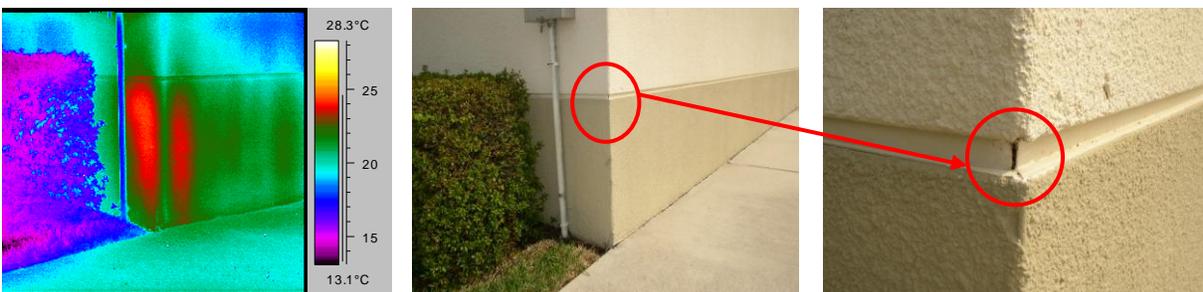
Figure 18. Image on left shows trapped moisture in a stucco wall system below a control joint. The right image shows an opening in the joint at a corner seam that is allowing water to enter the wall

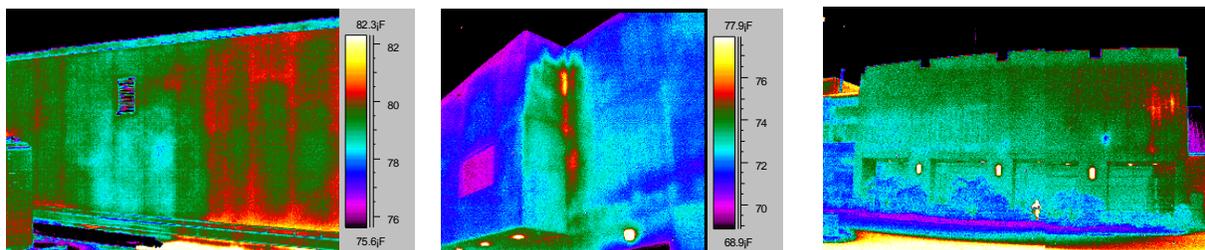
Figure 20. Infrared image showing examples of deficiencies (orange areas in images) in stucco finish coats applied over framed construction

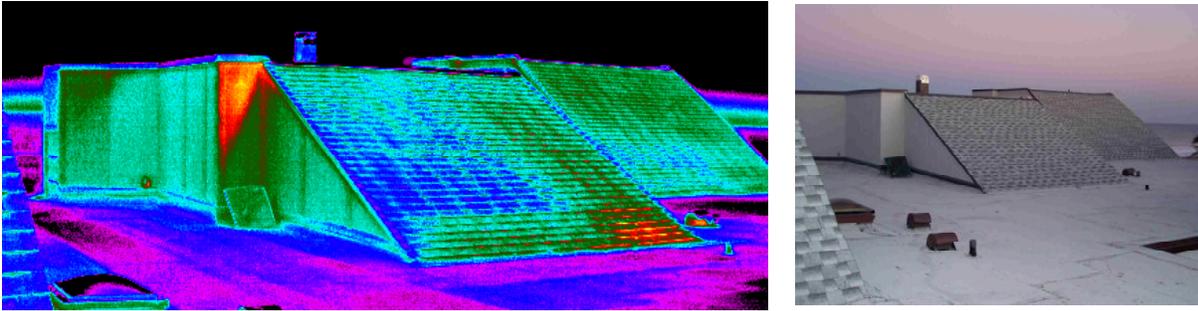
Figure 21. Infrared image showing trapped moisture (orange areas) in wood siding and sloped wood sheathing on a shingle roof system

Following the submittal of our report, the deficiencies cited above along with several others were verified by the contractor and corrected. It was found that the contractor was not aware of the water damaged wall siding and had failed to replace rotted and water soaked roof decking prior to installing new roofing material.

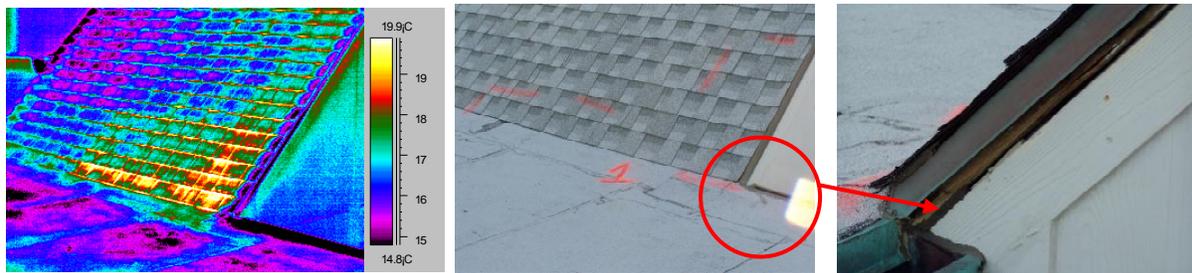
Figure 22. Infrared image showing trapped moisture (orange areas in images) beneath a shingle roof system. Edge metal flashing was not installed correctly and allowed for moisture to enter the wood deck

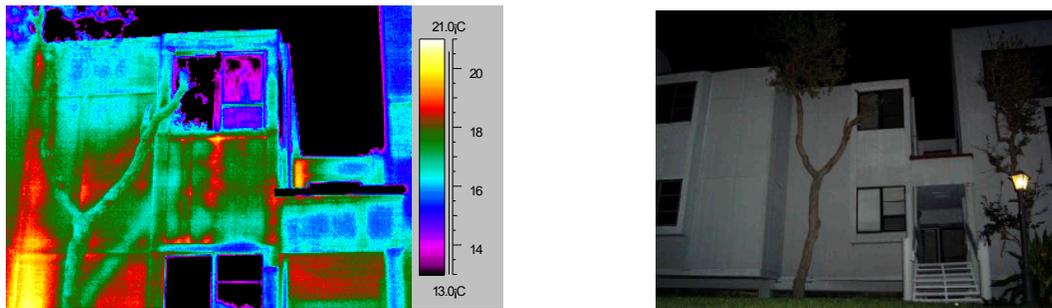
Figure 23. Infrared image showing trapped moisture (orange areas in images) in wood siding of a condo unit

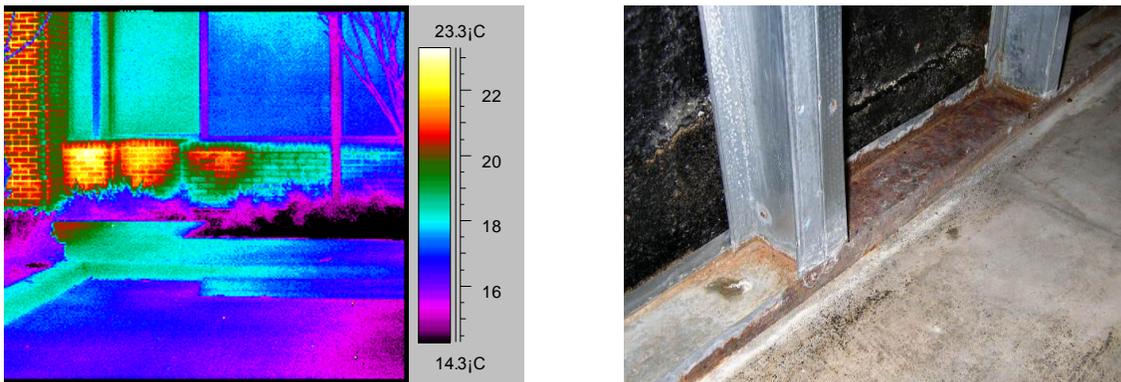
Figure 24. Infrared image on left showing trapped moisture (orange areas in images) in brick. Image on right shows back side of brick with water retardant coating and rusted metal studs from seeping water

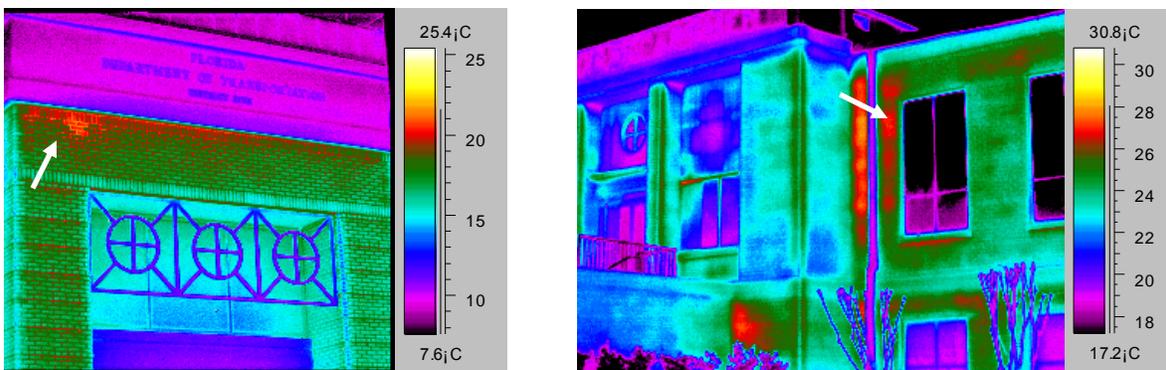
Figure 25. Infrared images showing trapped moisture (orange areas in images) in brick

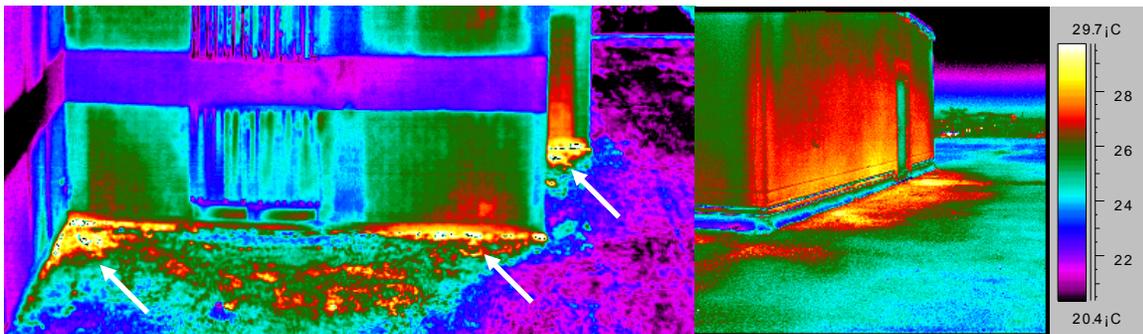
Figure 26. Infrared images showing trapped moisture (orange areas in images) in roof system. Areas on walls tested positive for both moisture and stucco de-bonding and were directly correlated to extensive wall cracks

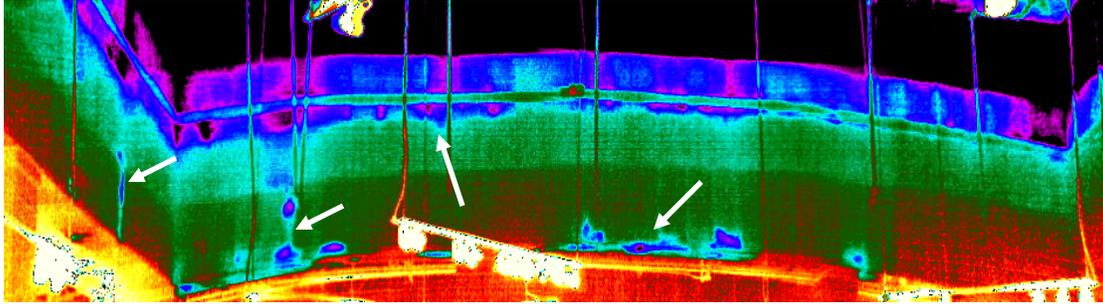
Figure 27. Tracing water trails (black/blue/purple colors) on an atrium wall during a rain storm. An inspection on the outside of the atrium showed that the windows (shown in black at top of image) were leaking

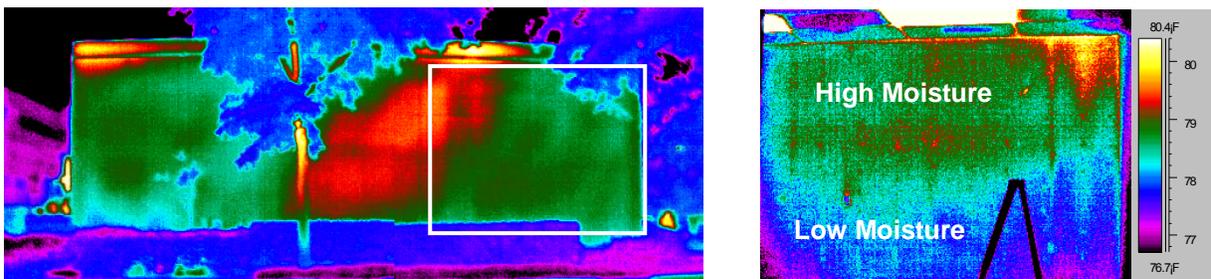
Figure 28. Infrared image on left shows an exterior wall with a thermal anomaly that tested dry for moisture at a depth of 1.5 inches into the wall surface. White box on image shows approximate location of interior wall as shown at right. The image on right shows the interior side of the wall that tested positive for moisture in the upper section of the wall

Upon submitting the results to the client, he told me that several years ago the exterior wall had numerous hairline cracks that allowed enough moisture into the building so that the interior drywall had to be replaced because of mold damage. The cracks on the wall were repaired and repainted and the problem was thought to have been corrected. It was apparent from our scan that although the exterior side of the wall was void of moisture, moisture was still present within the wall system and mold growth behind the wall was very likely.

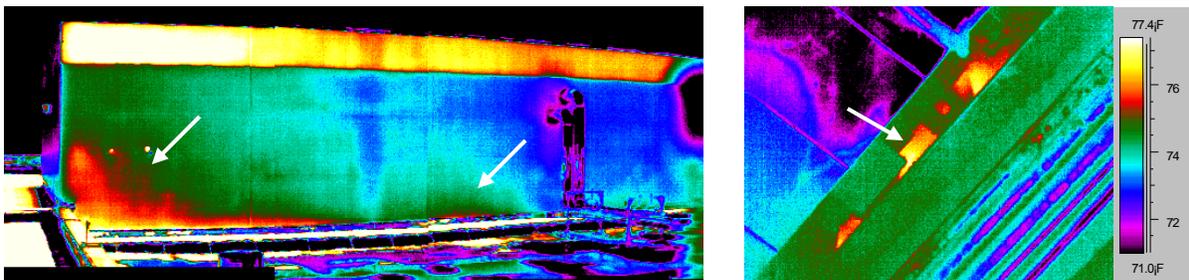
My next step was to check the exterior side of the ceiling area where it met the roof. A thermal anomaly was discovered in a section of the roof flashing along the operating room wall. I also found warm air being drawn into the room along the roof deck inside the drop ceiling. The client followed-up our work with another contractor who used smoke to trace the airflow into the operating room. His results were very close to our initial findings; warm humid air was entering the room via the flashing detail along the roof system.

Figure 29. Infrared image on left shows an exterior wall with a thermal anomaly (orange area) that tested positive for moisture. This wall flashing ties into the upper ceiling area of the operating room. Right image shows the interior side of the roof deck showing warm humid air being drawn into the open ceiling space

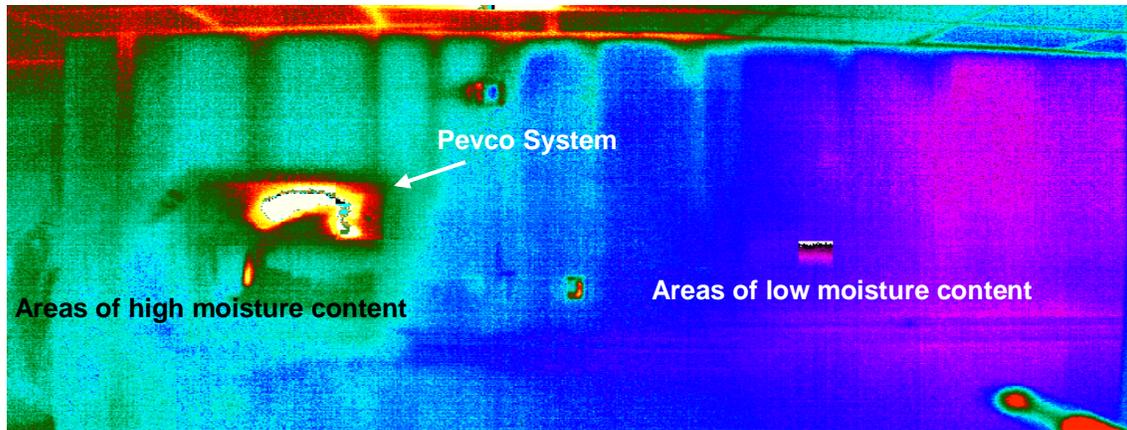
While on the same job, we were asked to see if the interior walls of the operating room had suffered moisture damage because of the looming humid conditions. The results of this inspection showed that one of the main walls had a faint thermal pattern that tested positive for moisture. The anomaly started on the side of the wall closest to the wall that connected to the outside and gradually faded into a normal thermal pattern that tested dry with a moisture meter. It was evident that the warm humid air had migrated behind the walls and was now migrating into the drywall.

Figure 30. Infrared image showing faint thermal pattern of moisture in wall. The wall temperature difference from high to low moisture areas was less than 1.5 F degrees
