A Phased Approach for Large Building Infrared Inspections: A Case Study

James Brady
Level III Certified Infrared Thermographer
Brady Infrared Inspections, Inc.
935 Pine Castle Court
Stuart, FL 34996
Tel: 772-288-9884

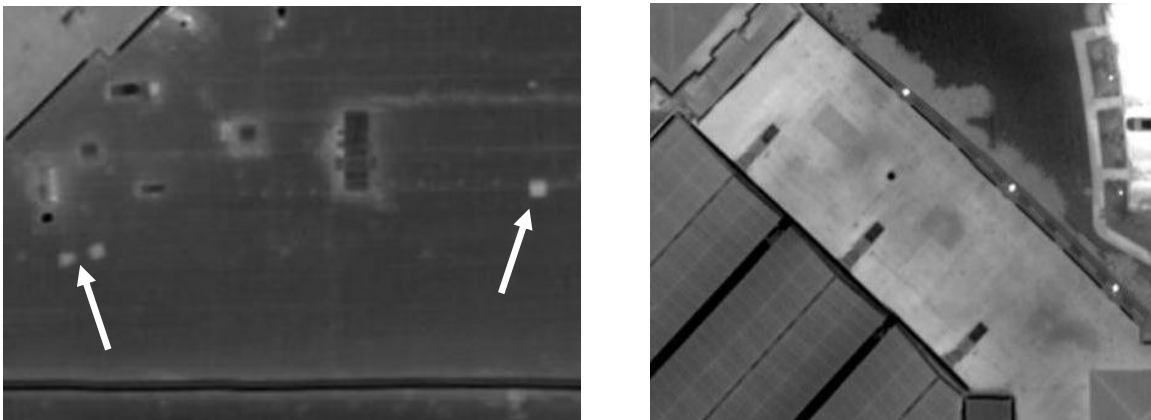
The results of the aerial infrared imaging on the South Roofs showed thermal anomalies that were generally defined as rectangular and square areas typical of wet board insulation (Figure 1). A total of forty-six anomalies were identified and marked on the AutoCAD map.

Figure 1: Aerial infrared image on left showing thermal patterns observed on board insulated roof (white arrows are typical anomalies observed).

Figure 2: Aerial infrared image on right showing thermal patterns observed on a typical lightweight concrete roof.

The aerial infrared imaging on the North Roofs showed an entirely different picture, characterized by a washed-out, mottled thermal pattern (Figure 2). It was suspected but not known with certainty that the lightweight concrete in the roof design was responsible for the thermal patterns we were seeing. After consulting with AITSCAN, only a few areas were marked as “Possible Wet Areas”, however, there was suspicion that large sections of roof could be holding moisture.

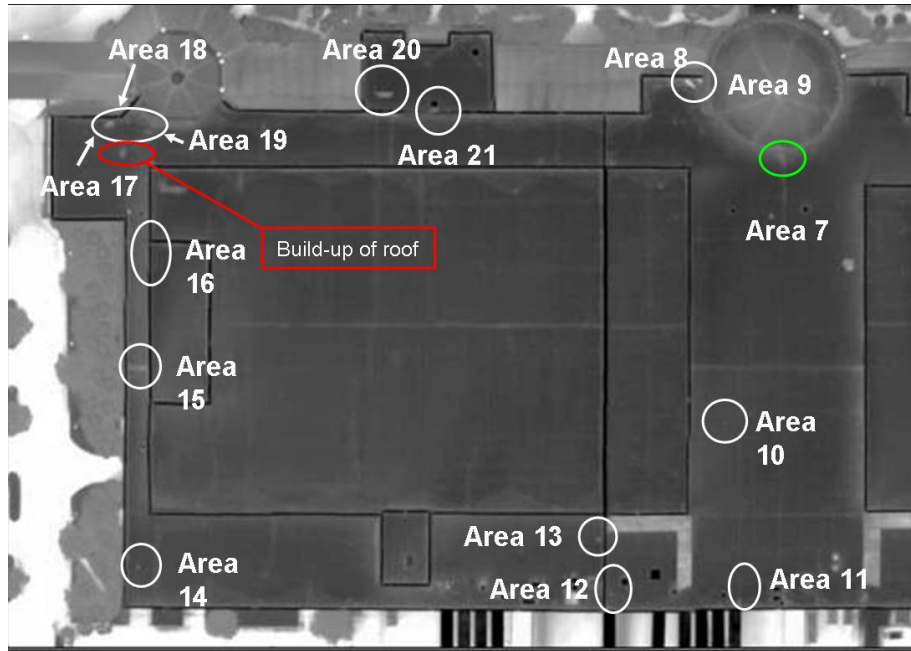
Of the total 46 thermal anomalies identified on the North Roofs through the aerial infrared scan, nine turned out to be something other than wet insulation, and three new anomalies were added (Figure 3). Using aerial infrared imagery to locate and verify aerial thermal anomalies was straightforward and highly efficient. So much so that over 350,000 square feet of roof area was scanned in a single evening by one thermographer. Using the aerial infrared images as a guide, areas of identified anomalies were evaluated both thermally and visually.

Figure 3: Aerial infrared image showing a select number of anomalies classified as verified areas (white circles), false positive areas (red circle), and added areas (green circle) after being inspected by a walk-on survey with a hand-held infrared camera.

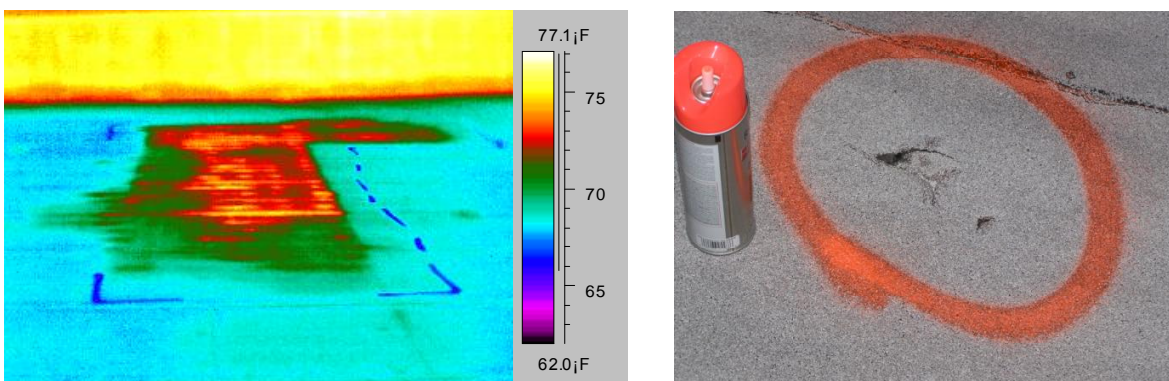
Thermal anomalies indicative of wet board insulation were labeled on the roof and photographed for the report. In general, they showed rectangular to somewhat rectangular thermal patterns on the roof surface (Figure 4a). Moisture verification testing was not conducted on any of the anomalies found; however, in several places punctures and other signs of damage were documented within the boundary of an anomaly (Figure 4).

Figure 4: Typical thermal pattern observed on North Roofs showing rectangular board shaped anomaly. Punctured roof surface observed within boundary of thermal anomaly in Figure 4a.

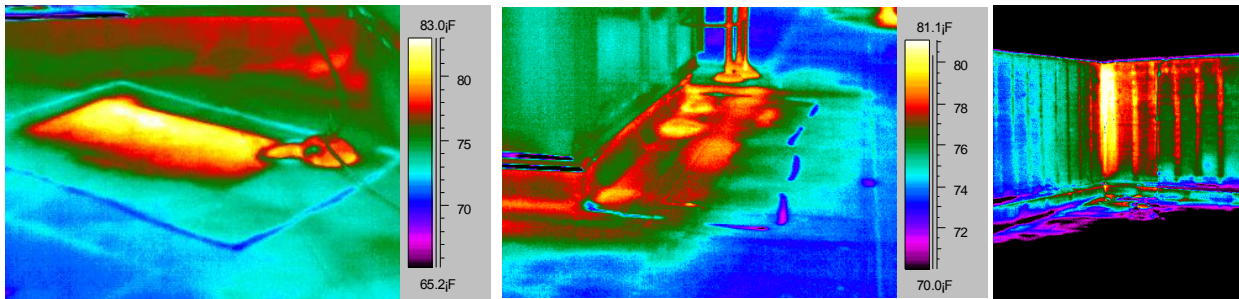
Other occurrences of verified anomalies showed up around pitch pan flashings, AC units and parapet wall related issues. A few of these examples are shown in Figure 5 below.

Figure 5: Left infrared image shows anomaly derived from defective pitch pan seal; middle image shows trapped moisture along AC curb; right image shows possible trapped moisture in parapet wall that is entering flat roof.

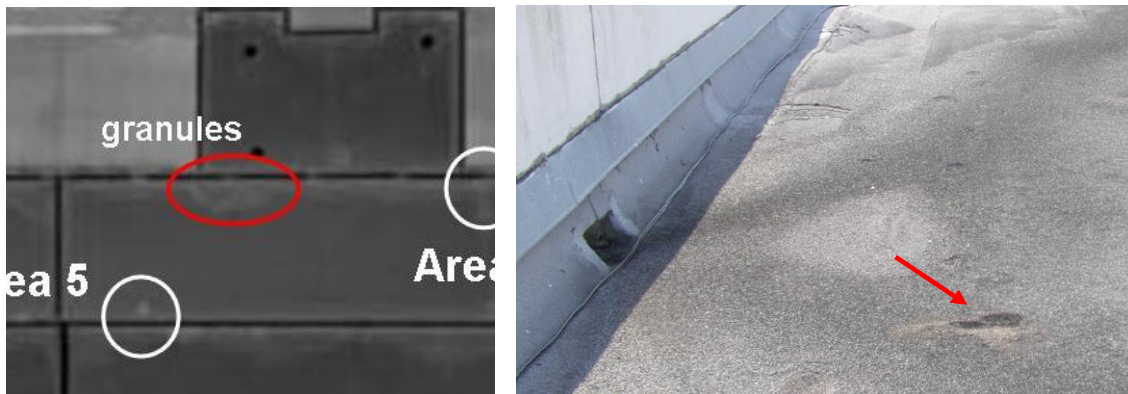
Anomalies that were caused by factors other than trapped moisture were separated out and marked as false positive areas. These included, 1) accumulated piles of roof granules as shown in Figure 6; 2) built-up sections of roof material; 3) small roof penetrations (Figure 6); and 4) unexplained anomaly; where nothing obvious was observed with the handheld infrared camera.

Figure 6: Area of accumulated roof granules (red circle on infrared image) that produced a thermal anomaly observed on the aerial infrared imaging. Arrow in right Figure shows footprint in granule pile

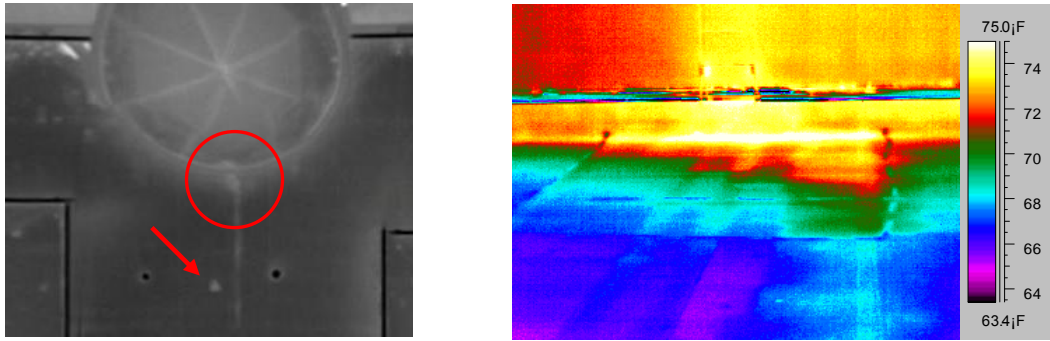
Three new anomalies were documented during the walk-on survey. These areas did not produce a strong enough thermal pattern to be readily observed on the aerial imagery (Figure 7), or were overshadowed by artificial heat sources on the roof (one roof had several stream vents and pipes).

Figure 7: Thermal anomaly previously not identified on aerial imagery marked on roof following walk-on survey. Red arrow shows a roof penetration that was initially labeled as an anomaly on the aerial infrared survey.

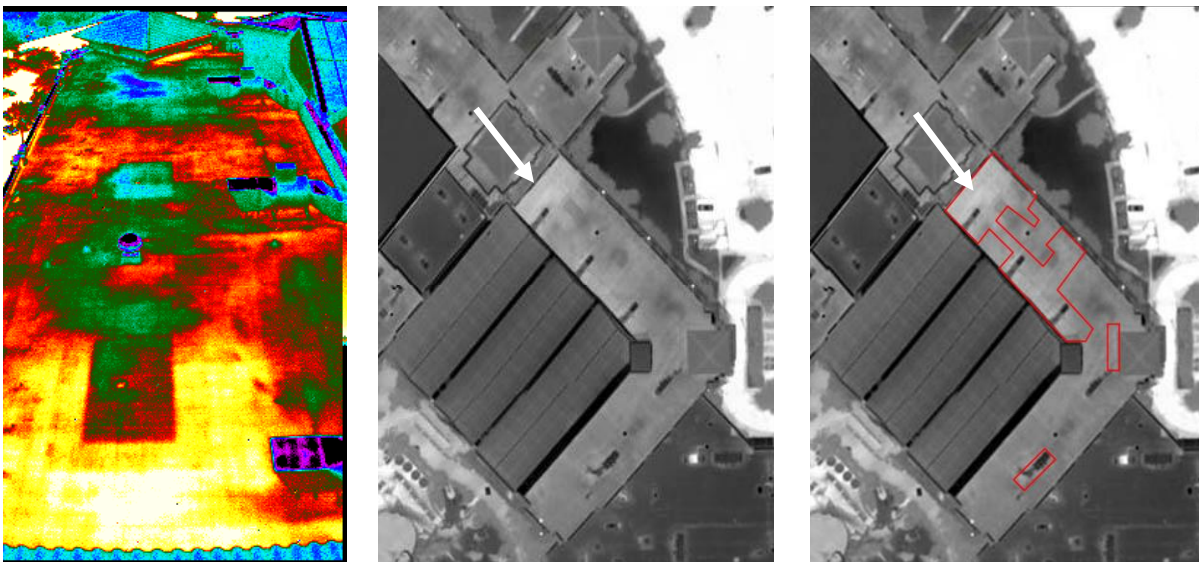
The walk-on survey images showed good correlation with the aerial imagery; a large portion of the roofs had elevated thermal signatures that displayed a mottled pattern. Having the ability to colorize the walk-on imaging helped define the thermal patterns. However, good correlation existed between the aerial and walk-on survey as shown in Figures 8 & 9 below.

Figure 8: Left image – color infrared walk-on roof image; Middle image – unmarked aerial black & white image (white arrow shows look direction of color infrared image); Right image – aerial black & white with anomalies marked on map (red areas).

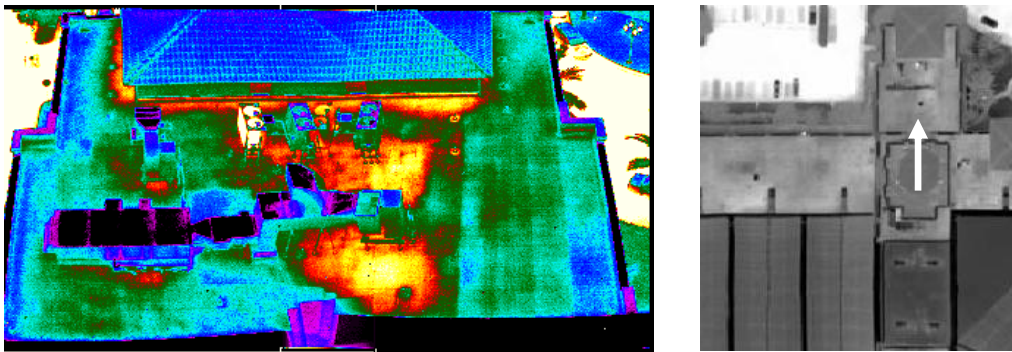
Figure 9: Left image – color infrared walk-on roof image; Right image – aerial black & white infrared image (white arrow shows look direction of color infrared walk-on image).

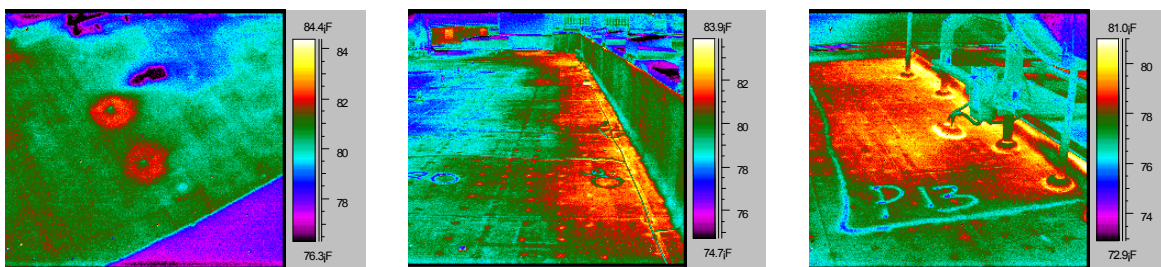
A majority of anomalies were correlated with HVAC equipment stands, lightning ground wire attachment points, window washing anchors, plumbing stacks and vents, and along wall/roof joins (Figure 10). Some anomalies occurred within the roofing field and may represent remnant moisture left behind during installation.

Figure 10: Left image – two circular anomalies around window washing anchors; Middle image – anomalies along a parapet wall; Right image – anomaly around AC stand flashing pans.

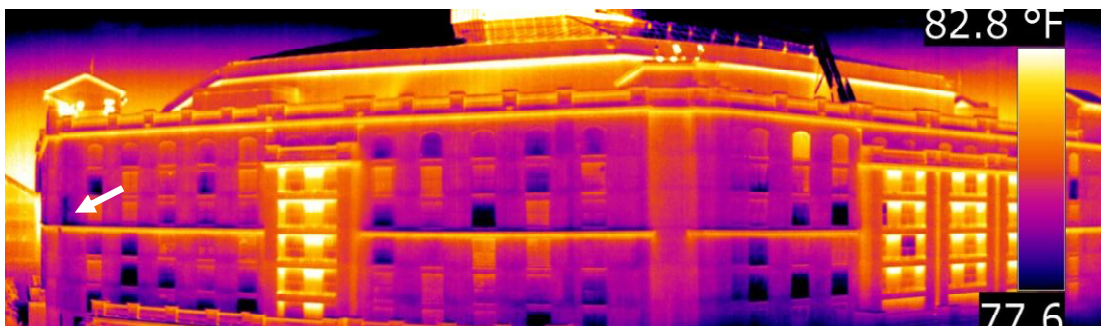
It was decided to baseline image wall sections regardless if thermal anomalies were obvious or not. This was accomplished by capturing multiple shots and later stitching them together to produce a composite image as shown in Figure 11. Once post-processed, the thermograms were reviewed and anomalies indentified. This proved especially helpful to compare thermograms of identical wall sections taken at different times. It also proved useful to indentify anomalies that were not apparent during the actual scan. Figure 11 shows a cold anomaly on the wall that was initially missed in the field but was then followed up with close-up imaging as shown in Figure 12.

Figure 11: Composite infrared image made up of 6 separate infrared images. White arrow shows a cold anomaly that was initially missed during the field inspection.

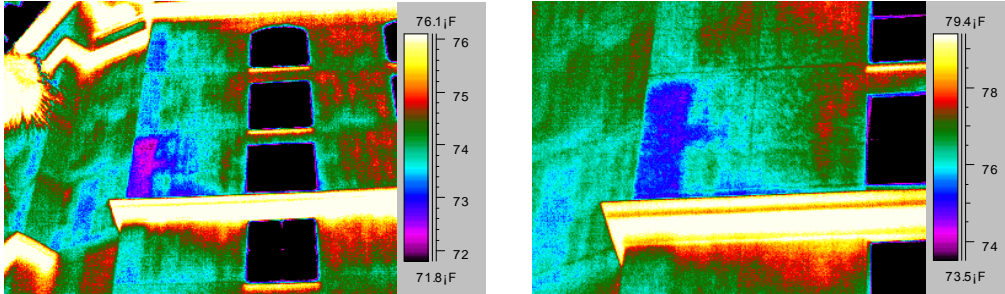
Figure 12: Close-up thermograms of cold anomaly shown in Figure 11.

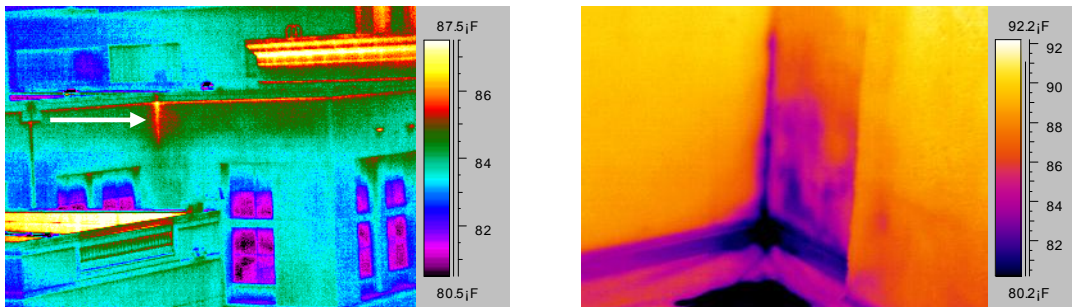
Anomalies were both cold and warm depending upon the time of day a thermogram was captured and the nature of water occurrence in the walls. Deep-seated trapped moisture in the EFIS showed up as warm anomalies when imaged under cooling conditions and cold spots when walls were warming Figure 13.

Figure 13: Right infrared images shows a linear hot spot along a caulk joint just below the parapet wall; Left image shows a close-up shot of a cold anomaly in the corner of wall just above the stucco-stop wall / roof flashing.

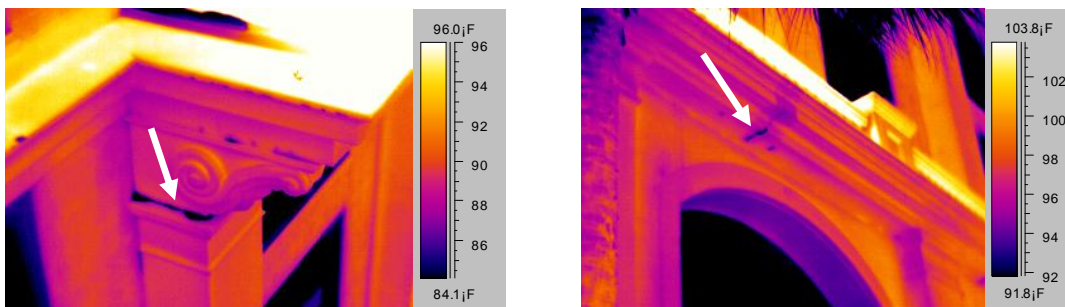
Following rain events, thermal anomalies showed up as cold spots along and between failing and weak caulk joints. Examples of these anomalies are shown in Figure 14.

Figure 14: Cold anomalies of trapped water exploiting weak and degraded caulk seams.

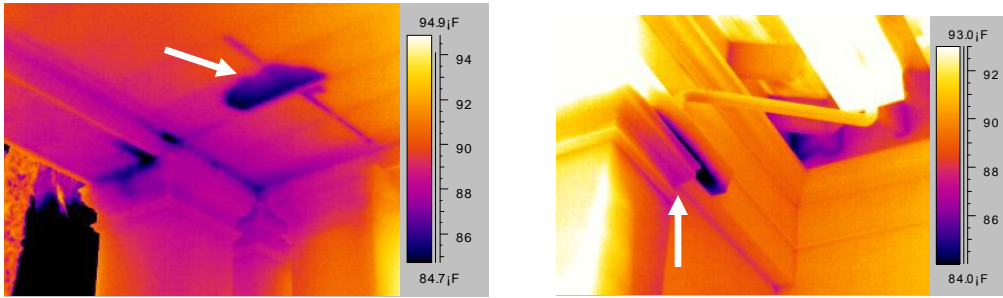
Finally, leaky roof drains and gutter systems produced cold anomalies following rain events are shown in Figure 15.

Figure 15: Cold anomalies from leaking roof drain and gutter system.

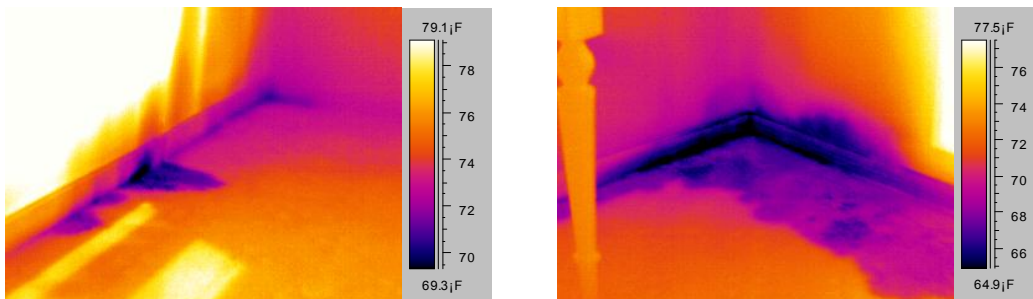
Thermal anomalies observed were always cold spots that appeared along baseboards and spilled out into the carpet (Figure 16). In one room, we were afforded the ability to access the balcony and discovered a thermal anomaly on the roof leading the exterior wall of the room, suggesting that a roof leak was causing the interior leak (Figure 17).

Figure 16: Cold anomalies along baseboards and carpet.

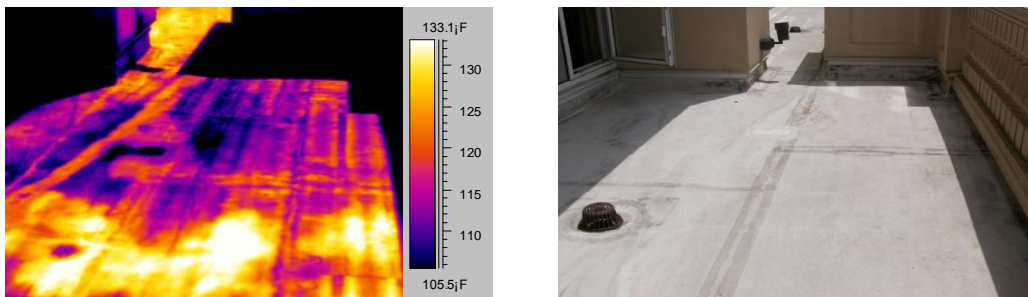
Figure 17: A cold thermal anomaly on a balcony roof captured in the middle of the morning as the roof was warming. The visual photograph shows the location of the hotel room's exterior wall and window - the location of the interior leak.
