Diagnosis and Repair of Failing In-floor Electric Radiant Heating Lines

Lee Durston BS, CBST
Forensic Building Scientist
BCRA
2106 Pacific Avenue, Suite 300
Tacoma, WA 98402
Ph: 253-627-4367

Abstract

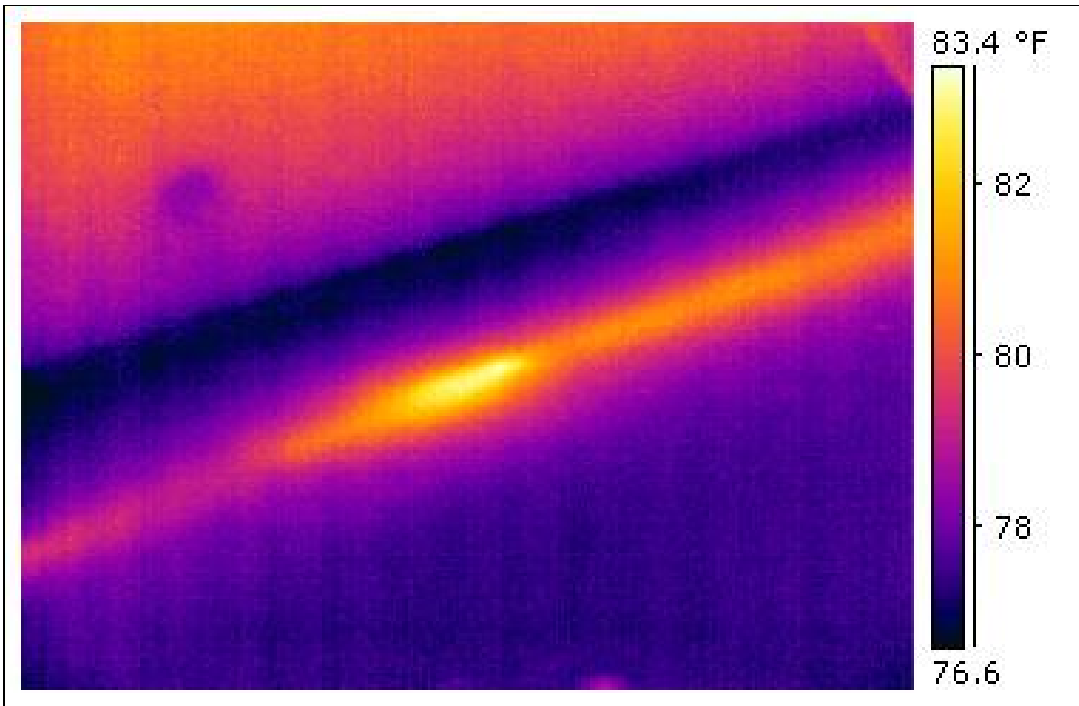
Thermal anomaly representing arc fault

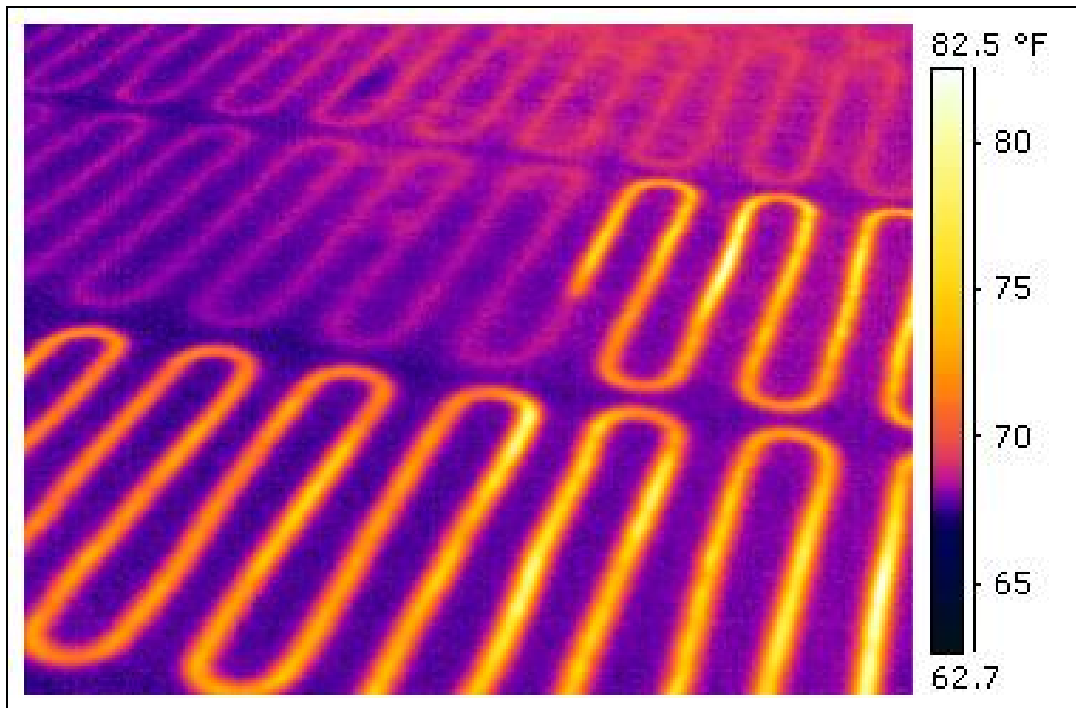
Thermal anomaly representing arc fault. Note the remainder of the line operating at half power

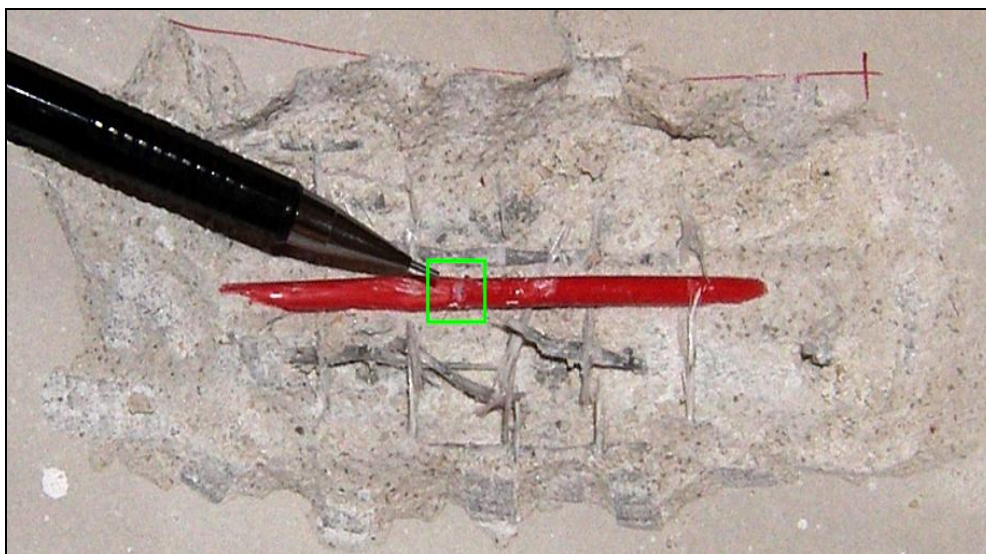
Excavation and investigation of wire

Once you have identified the fault, carefully mark the area on the floor and turn the power off at the breaker panel. Let the floor cool and repeat the exercise confirming the location of the fault. Upon confirmation, excavate the subfloor material for visual inspection of the wire. You will be looking for a level of damage that corresponds with the prior testing results. Be careful not to damage the wire further with excavation tactics. Once the wire is uncovered there may be only a small cut in the insulation or there may be a large burned area. Further exploration into the internal wire components will reveal the exact mode of failure. Once this area is clearly defined, have the electrician clean up the wires involved and provide in-line splices where needed. Once this is complete, all wires can be closed up with wiring shrink wrap. Many manufactures provide all the materials needed in a “splice kit”, usually sold for joining mats or extension wires.

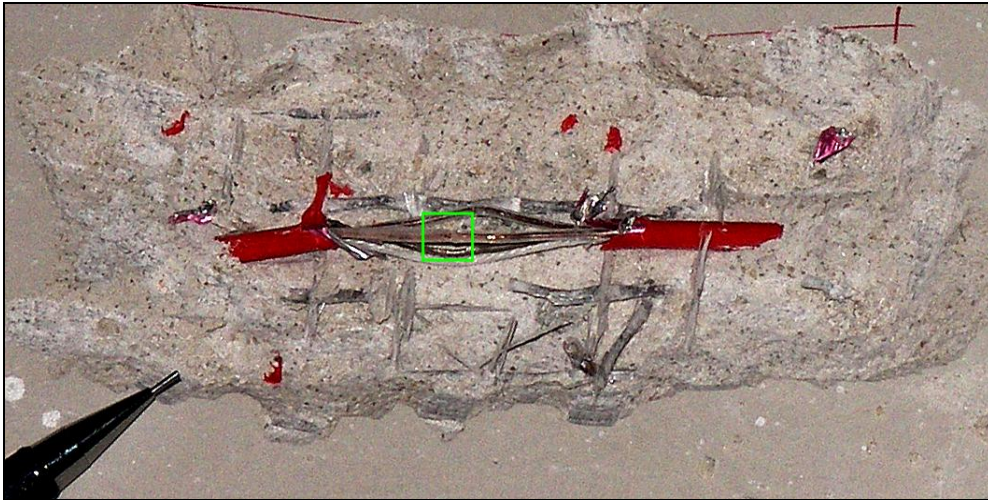
Diagnosis of problematic wire

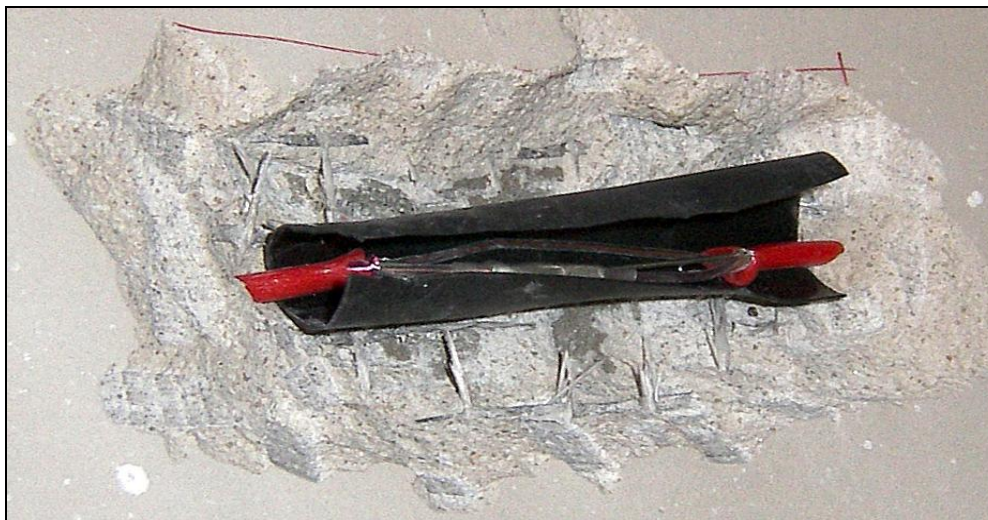
Repaired wire ready for shrink wrap

The radiant lines should be retested once the repair is complete. This retest should happen without the thermostat in place and then with it in place. Once verification of the fully operational system is completed, the subfloor should be repaired.

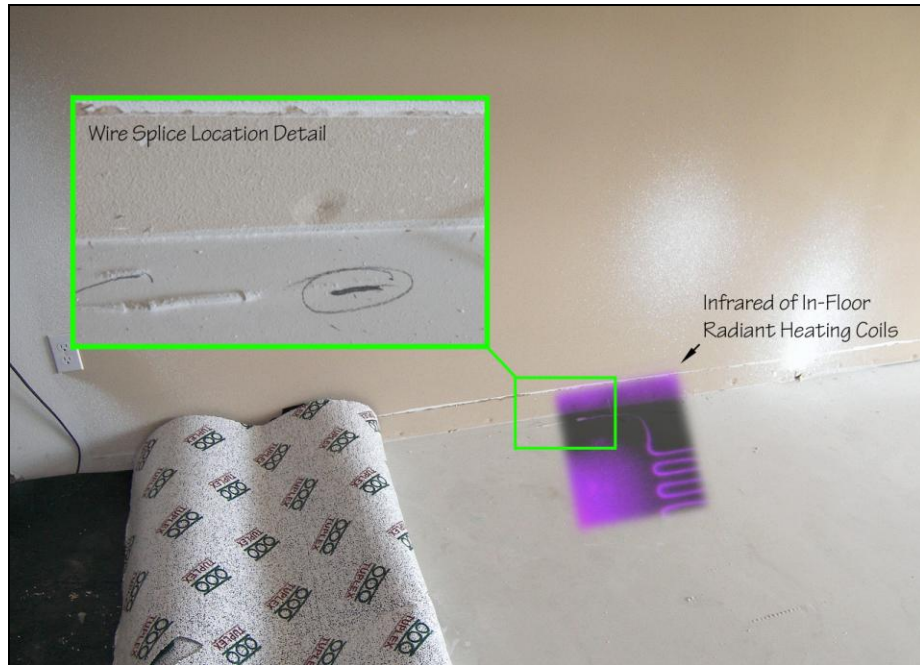
Identified thermal anomaly

Although the mat as a whole seemed to be performing properly, infrared analysis revealed the factory splice joining the lead to the mat radiated greater amounts of heat than the subsequent coils. At the request of the site superintendent, the wire splice was chipped out of the concrete for visual inspection and clearer infrared analysis. The uncovered section of wire showed deformation in the same location as the highest heat radiation, thus demonstrating that the splice was the location of the thermal anomaly.

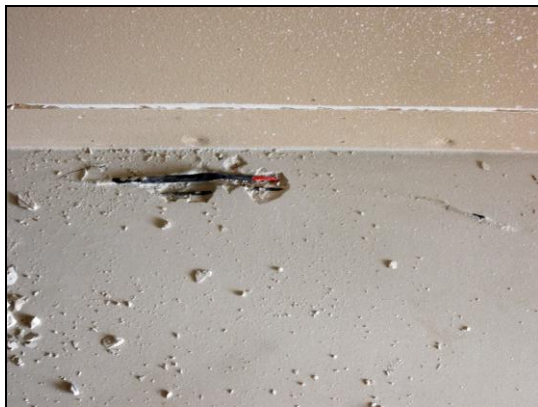
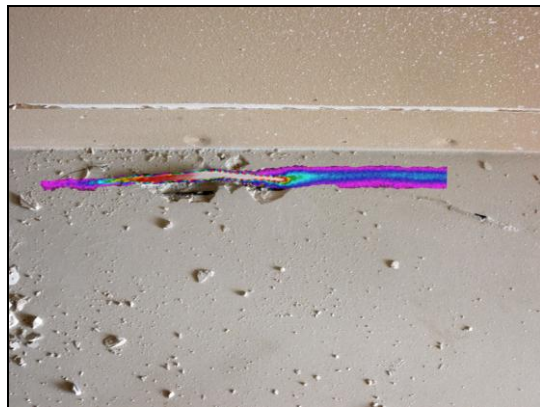
Excavated wire

With infrared overlay

Infrared analysis indicated that mat #4 was installed properly and the coils were functioning as intended, but that the factory-made wire splice to the power lead, which occurs just before the radiant coils, radiated an unusual amount of heat. In electrical applications, unusually high radiance is a sign of fault or shorting and should be inspected for proper insulation and connection. It is BCRA's opinion that the apparent fault of mat #4 is in the wire splice, rather than the radiant heat coils.

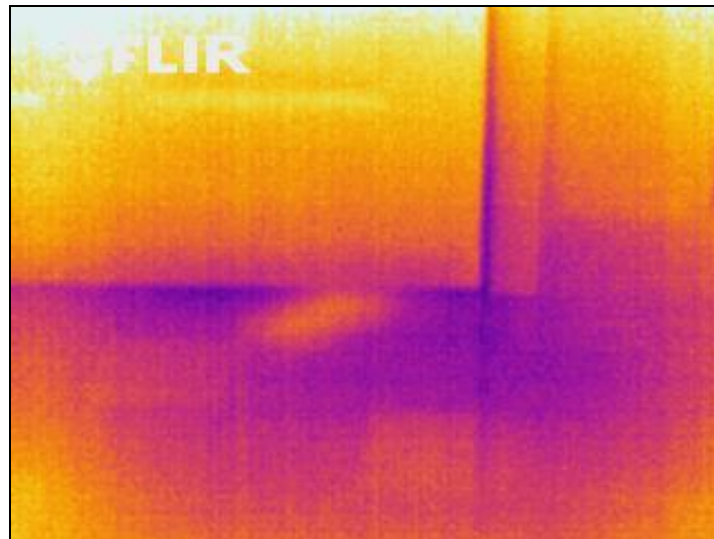
Thermal anomaly in area of bathroom entry door

Excavation and repair of this line was completed without BCRA present and the floor is now functioning properly.

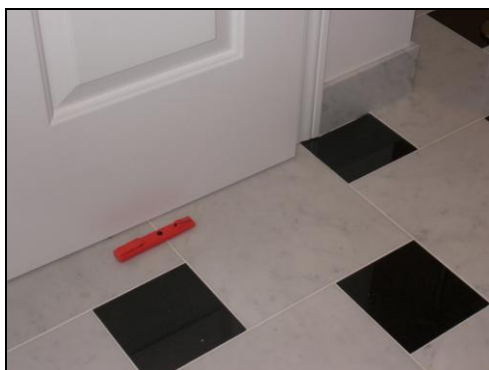
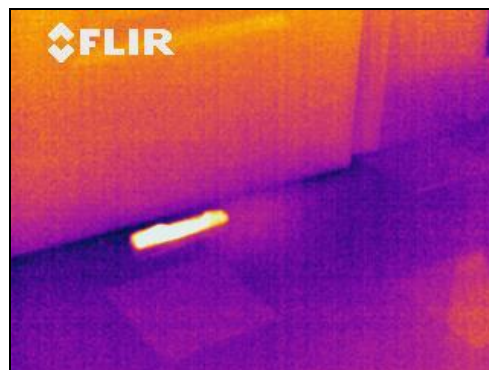
Visible light photograph

Infrared thermogram

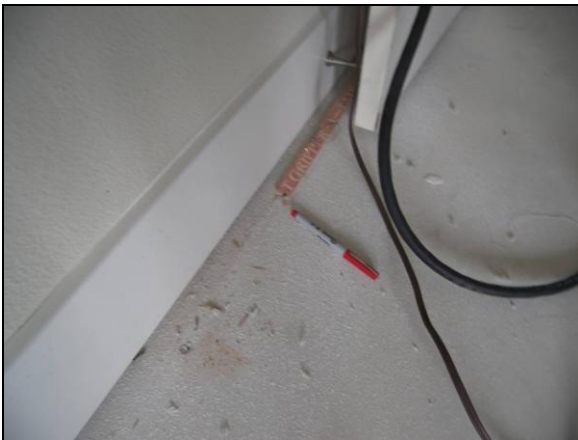
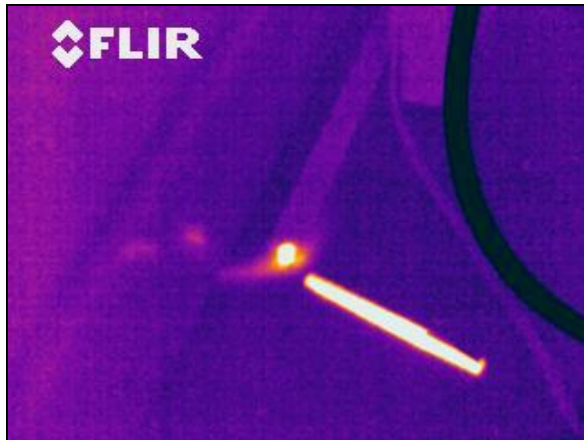
Unit 305: Arc failure in bedroom

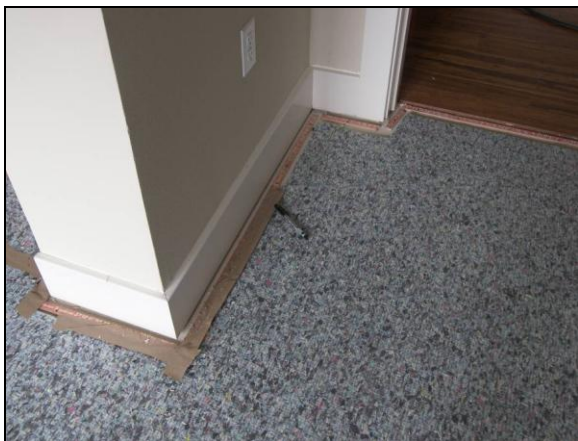
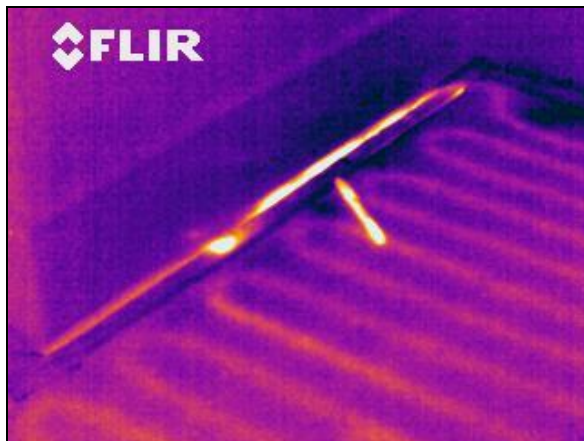
Unit 101: Arc failure in bedroom

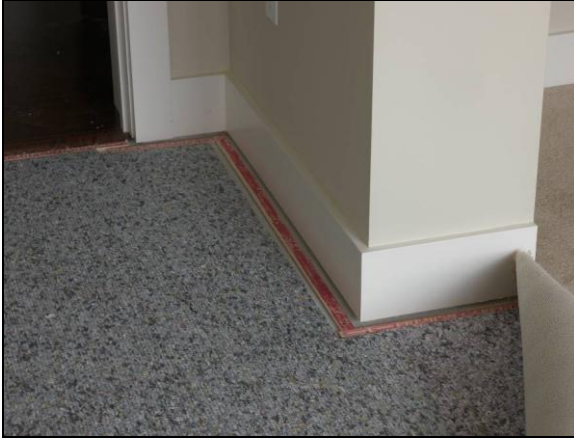
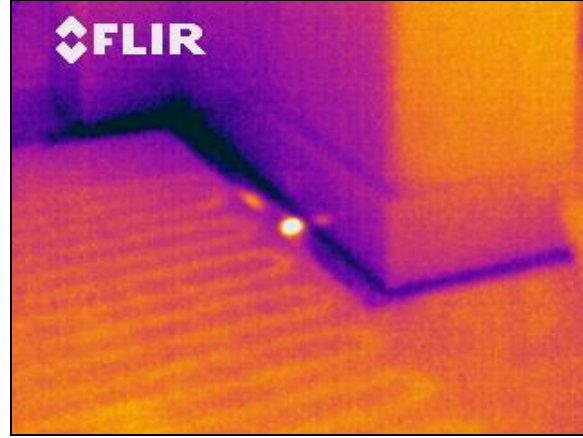
Unit 105: Arc failure in bedroom

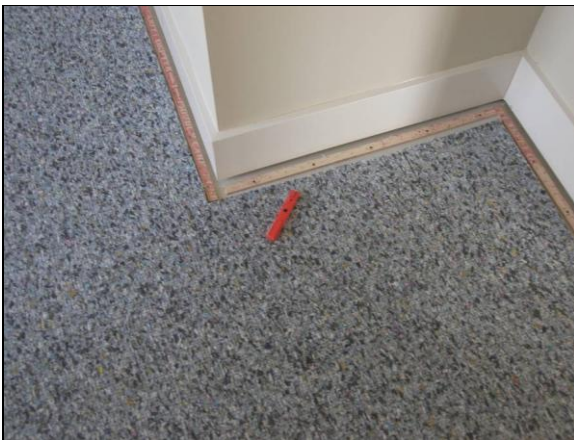
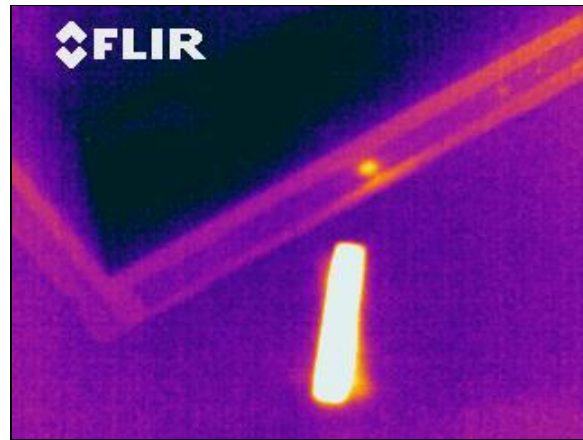
Unit 106: Arc failure in bedroom
