# Applying Infrared Imaging Techniques to Marine Surveying

John (Jack) N. Allinson, II BS  
SAMS® Accredited Marine Surveyor AMS®  
Level 1 Certified Infrared Thermographer  
J.N. Allinson Associates, Inc.  
222 University Blvd. North #2  
Jacksonville, FL 32211  
Ph: 904-721-2177  
www.allinson.com

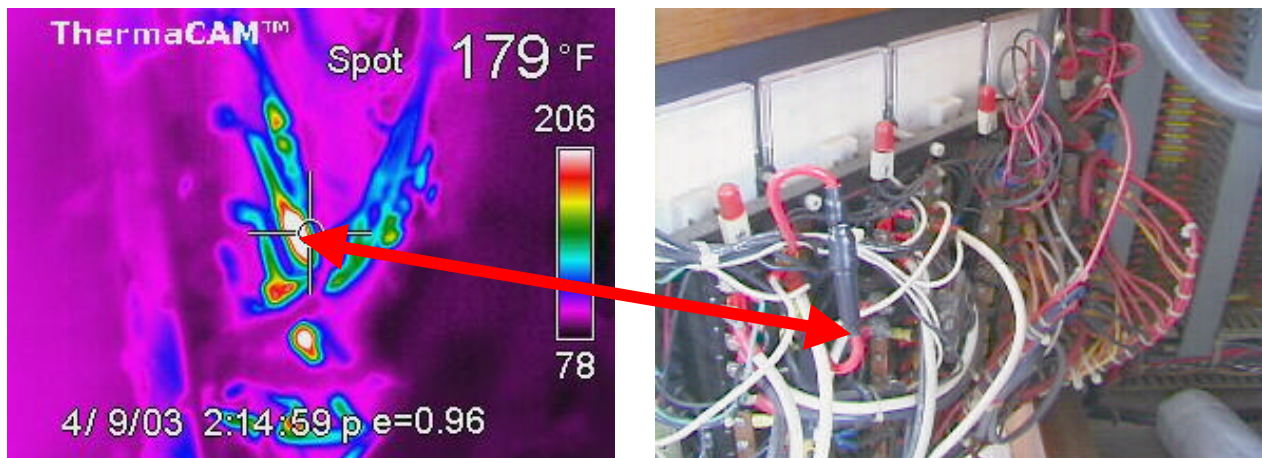
This is the back of an electric distribution panel in a 40-foot boat. Visual inspection shows that the wires are intact, wire insulation and terminals were free of burn or scorch marks. Infrared view shows that one of the wires in the bundle of wires is much hotter than the others. The heat and resistance in this wire caused its magnetic circuit breaker to trip intermittently.

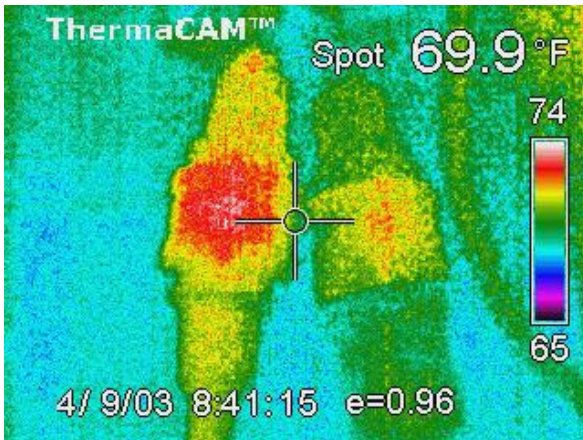
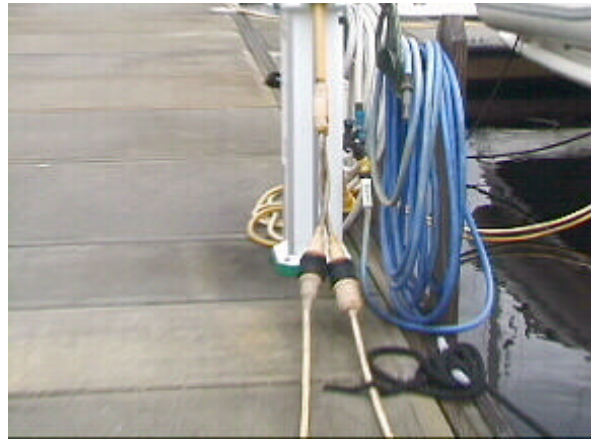
This is a power pedestal on a dock that supplies electric power (shore power) to a boat. A single 50 amp 220vAC shore power cord (light yellow) splits into two 30 amp 110vAC feeds. This item is known as a “Y adapter” and is commonly used for boats that have two 30 amp 120vAC inlets. There is electrical resistance building up on the left leg of the “Y adapter” and it should be scheduled to be replaced.

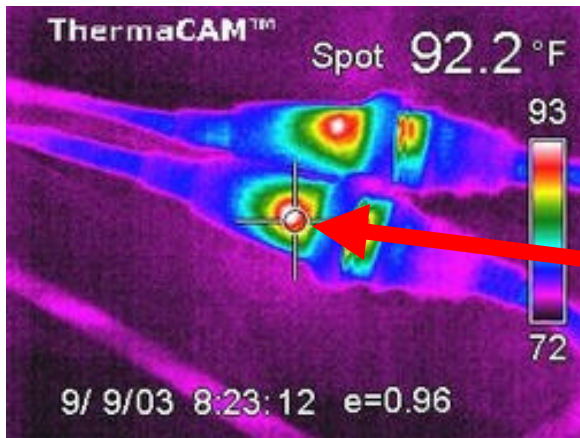
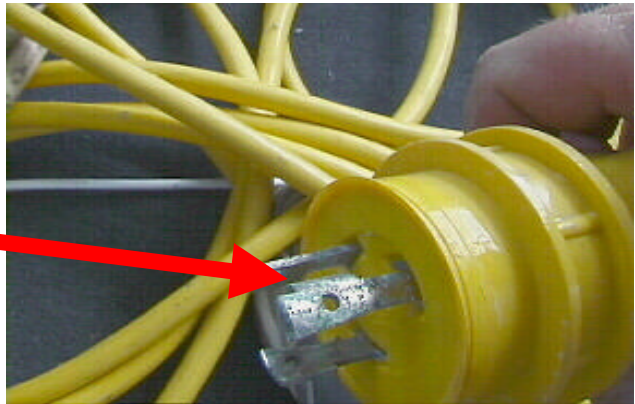
Two assembled two 30 amp 110vAC feeds. Infrared shows warm spots. Checking plug confirms surface corrosion (red arrow) on the pins. Infrared image reinforces to owner why the pins need to be free of corrosion.

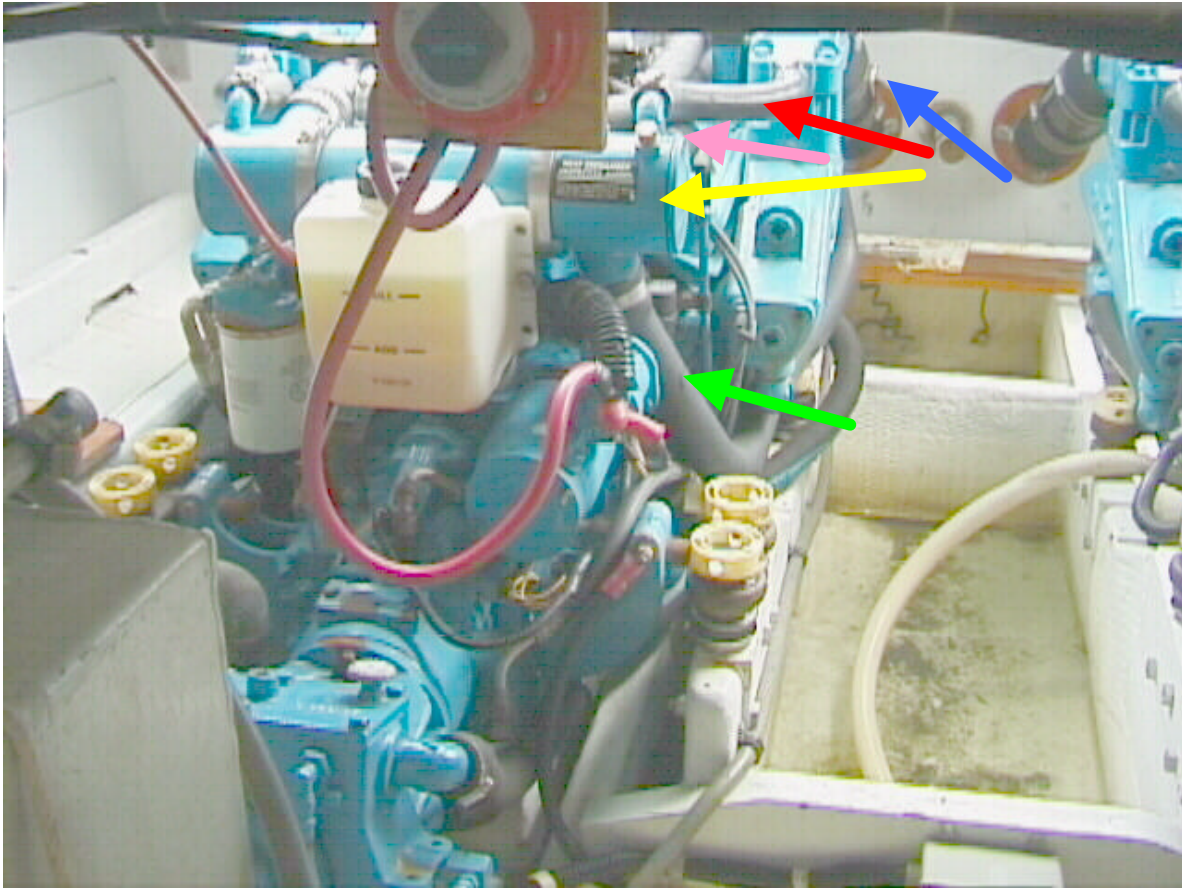
**Figure 2.** Anterior view from inside the engine compartment of a gasoline powered engine's cooling system. Green arrow points to raw water intake hose. Yellow arrow points to heat exchanger. Pink arrow points to a sacrificial "pencil zinc" fitting in raw water. The pencil zinc is a maintenance item and is periodically inspected and replaced when it becomes wasted. Raw water feeds to exhaust manifold (red arrow) where it mixes and is ejected as a wet exhaust (blue arrow).

**Cause of overheating:** Blockage in the raw water coming from the heat exchanger. A loose pencil zinc worked itself free and lodged in the heat exchanger (pink arrow, figure 2), thus preventing the correct amount of water from mixing with engine exhaust gases, which caused the exhaust hose to start to fail.

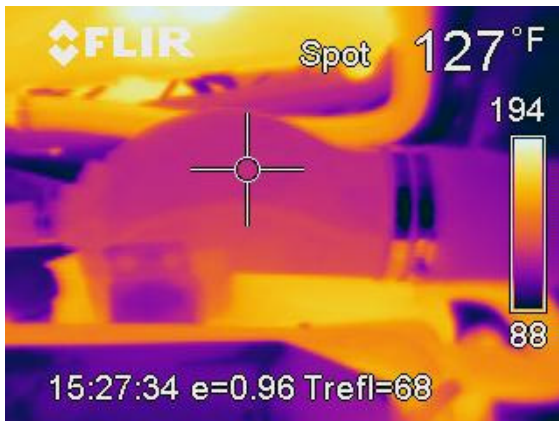
**Figure 3.** Uniform temperature pattern on wet exhaust riser. Everything appears to be normal.

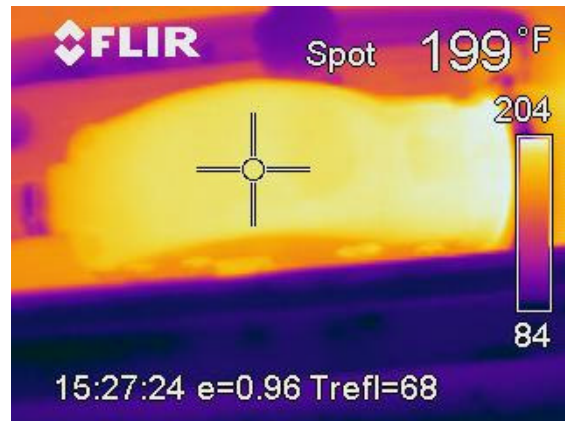
**Figure 4.** Non-uniform as well as elevated temperature pattern on wet exhaust riser. Something is not right!

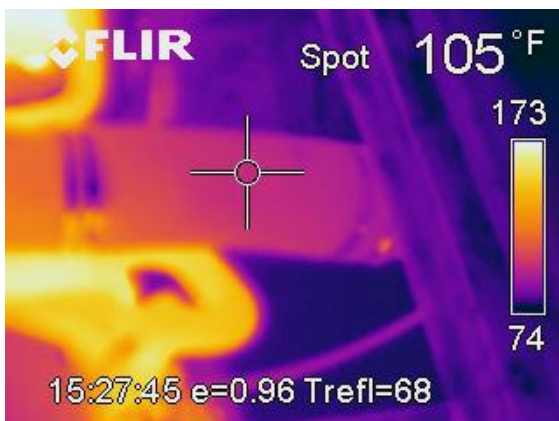
**Figure 5.** Uniform temperature on wet exhaust rubber hose. Everything appears to be normal.

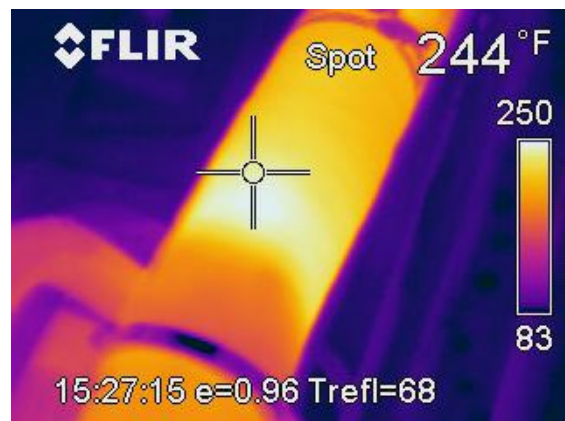
**Figure 6.** Non-uniform overheated wet exhaust rubber hose. Something is not right! Engine was shut down and the exhaust hose was removed for inspection. Interior wall of rubber hose was found to be charred and separated.

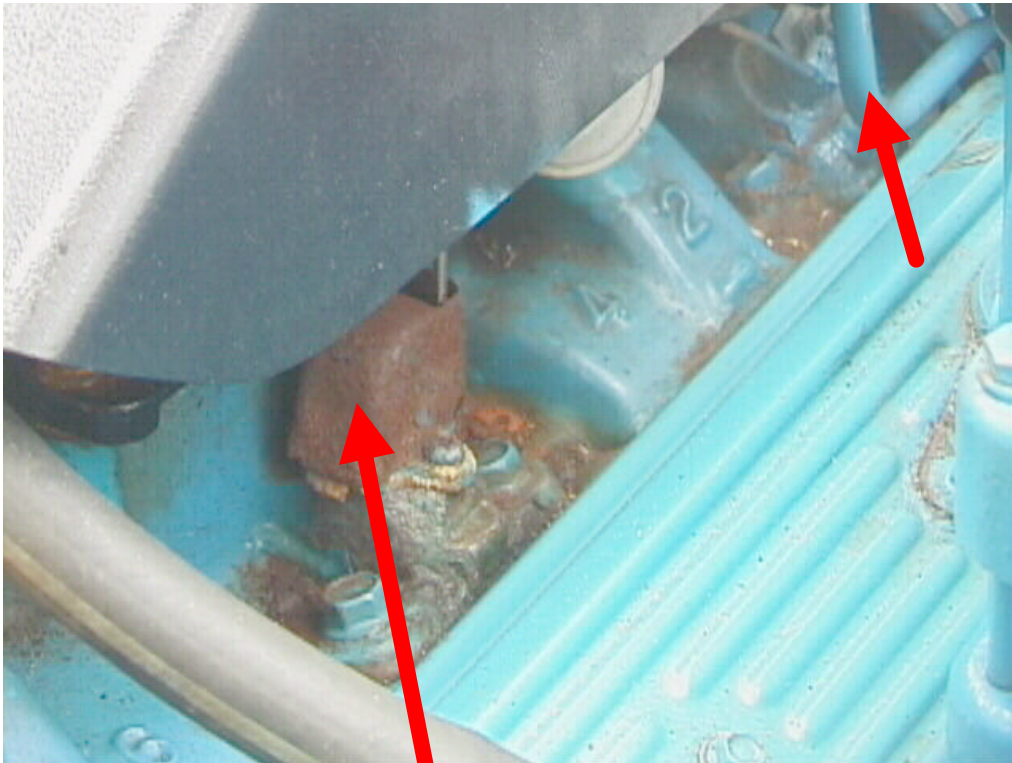
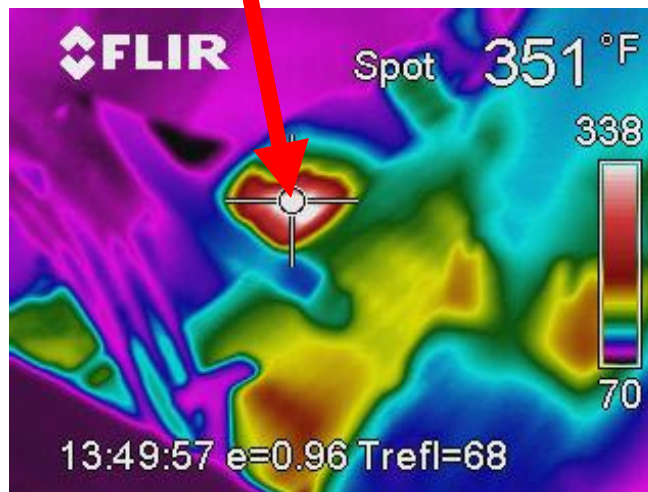
Red arrow in photograph above points to the “cook stove” that visually appeared as a simple rusted part mounted on the engine block. Why is this part rusty and the paint discolored? **Answer:** The “cook stove” is part of a mechanical choke assembly for the carburetor installed on this engine. The assembly reacts to the temperature of exhaust gases that pass by it.

The thermal image illustrates why this part is commonly called a “cook stove” by some mechanics. The measured temperature reinforces that sections of fuel supply lines should not come in contact with the engine surface.

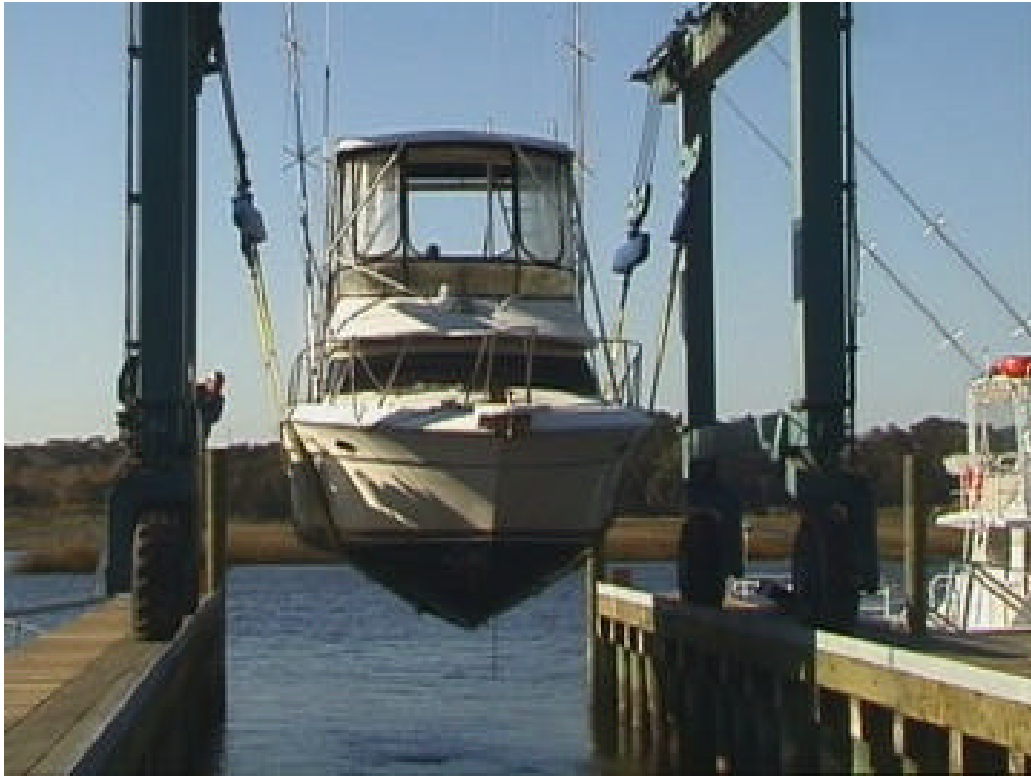
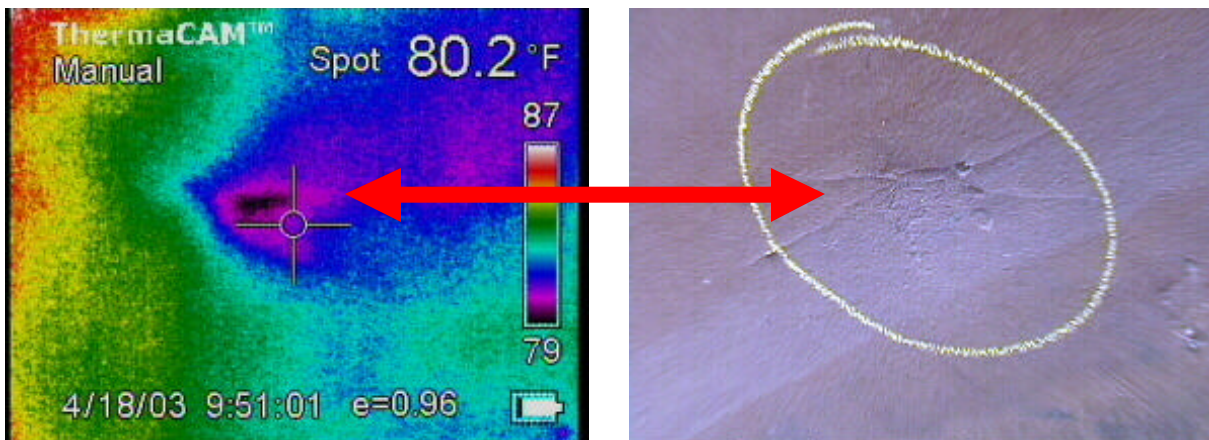
The area circled in yellow shows an unusual indentation in the hull of a boat constructed with FRP. Area visually appears to be dry. Infrared image shows cooler temperature, revealing moisture intrusion in this portion of the hull.

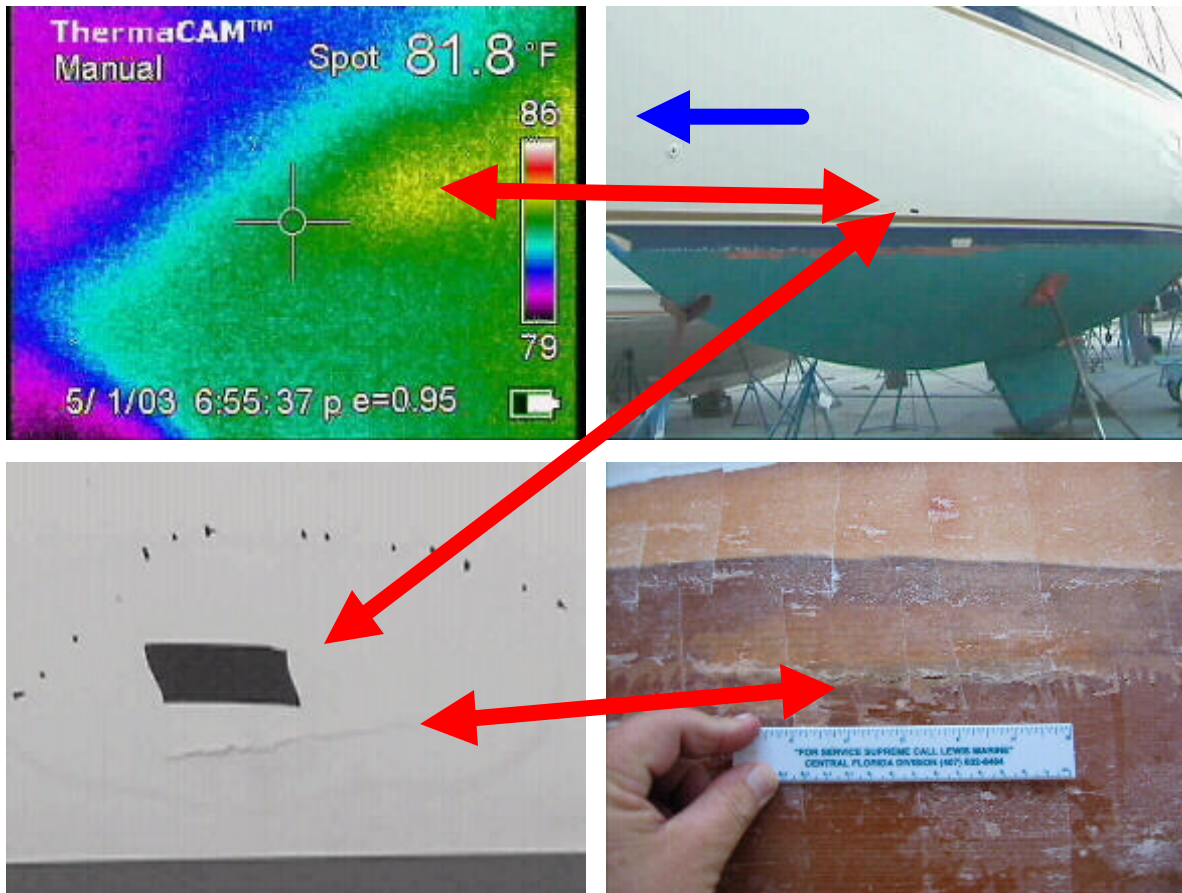
This is the side of a sailboat constructed with a FRP composite of balsa wood and fiberglass laminate. The sailboat sustained impact damage on the bow (blue arrow). An R thermal scan of the hull sides showed an anomaly, and there was a faint visual sign of delamination. The infrared image shows warmer temperatures, revealing the extent and pattern of delamination in the FRP.
