# Trestles Anyone? A Thermographic Nightmare

Jon L. Grossman  
Hi-Tech Inspection Services, Inc.  
7520 NW 54<sup>th</sup> Street  
Miami, FL 33166  
Phone: 305-639-1820  
Fax: 305-639-1928  
www.hi-techinspections.com

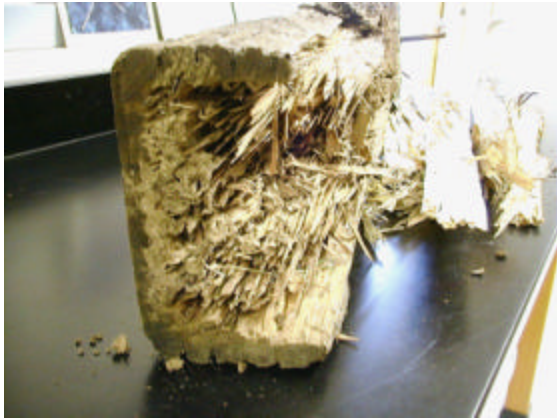
The image on the left is a creosoted railroad tie that has been infested by Formosan termites. The tie had been hollowed out, but the exterior appeared normal. Note the wheat-like structure of the remaining wood. The tie has no structural strength.

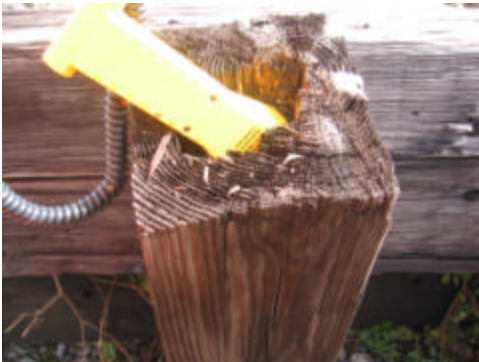
**"A" – Back wall – Wing wall:** Results from the inspection team at the west end were almost immediate. Evidence of live termite infestation was located in the back wall and the wing wall on the south side of the tracks by utilizing the Termatrac<sup>®</sup>, IR and visual inspection.

The digital picture at left shows a bracing column maintaining a wing wall on the south side of the tracks. The decayed area had been opened up after the Termatrac<sup>®</sup> had noted some insect pest activity. The exposed area revealed not only termite galleries but also live termites.

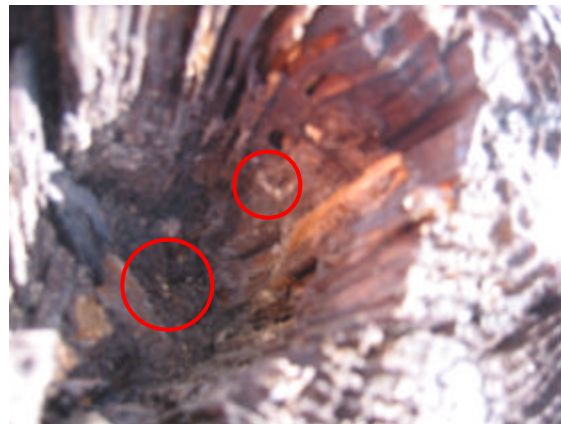
The digital photo at right clearly shows the presence of termites within the wood structure. (See red circles for actual termites.) The consulting entomologist made a positive identification of the species as being that of the Formosan termite. Further inspection of the wing wall and end wall brought forth the conclusion that there was, in all probability, at least one termite colony within close proximity.

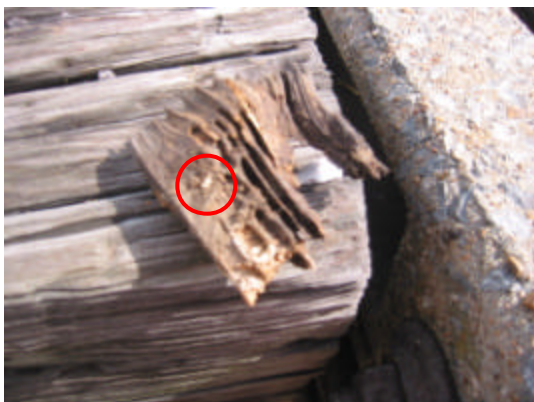
The digital photo at left shows a section of the support bracing from the wing wall that evidences severe damage from termites. Further inspection of the north side wing wall and the back wall revealed evidence of termite infestation and damage, but in a cursory examination did not show live termites in the specific areas inspected at that time. The end wall and wing wall sections may have/be providing an entry point into the stringer sections, thus providing a foraging route for the termites. (See live termite in red circle.)

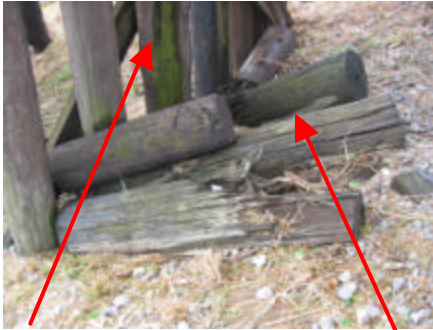
Piling 3 of Bent 2

**“A” – Bent 1:** In Bent 1, sections of old pilings that had been removed from the structure were found adjacent to the pilings of Bent 2. These old sections were found to contain live termites. The old sections of pilings were acting as a food source for one or more of the termite colonies.

After the IR-100 revealed some anomalies in the pilings, live termites were located by use of the Termatrac<sup>®</sup> and by visual inspection in the old sections of pilings that had been left beneath Bent 1. It was not known if the termites had an entry point from the ground directly beneath the discarded sections, or whether they had an entry point up through the piling’s point of contact with the ground.

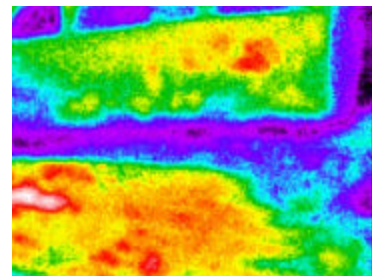
The IR image at left is a grayscale infrared image of the old piling sections. The image at right is a HC infrared image of the same section. High moisture sections are in red due to direct sun exposure.

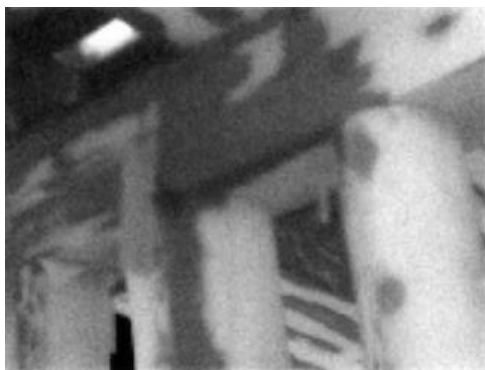
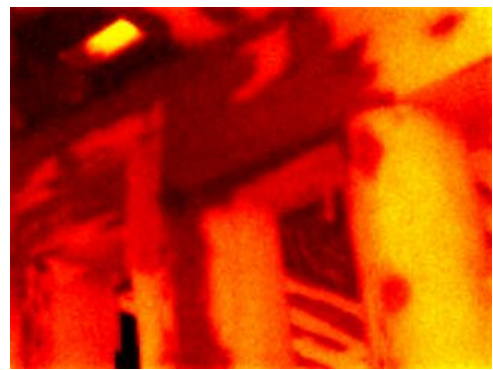
**“A” – Bent 2:** Bent 2, Piling 3 and its cap, which can be seen from the below thermal image, showed signs of high moisture content that are conducive to the presence of termites.

The IR image in grayscale at left and HM scale at right show the areas of high moisture content on the cap area of Bent 2.

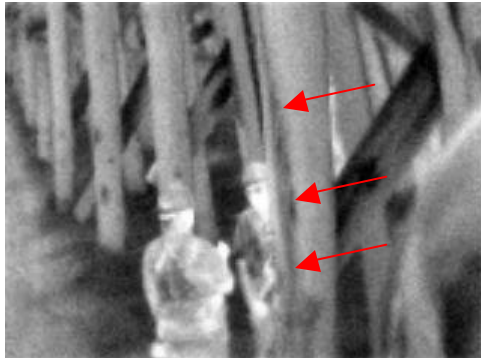
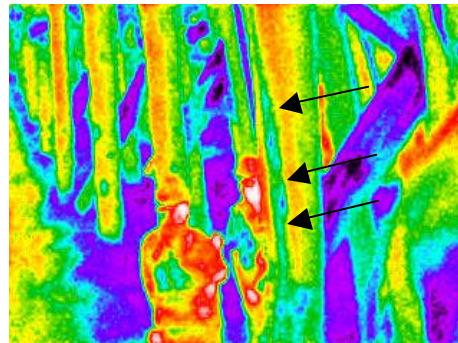
**“A” – Bent 3:** In Bent 3, Piling 1, which can be seen in the below photo(s), mechanical and visual inspections revealed active mud tubes with live termites, as well as other physical damage and evidence.

The longer distance IR images above clearly show the residual moisture in Piling 1. (See red arrows.) Mechanical and visual investigation revealed evidence of mud tubes and live termites, as well as other physical damage.

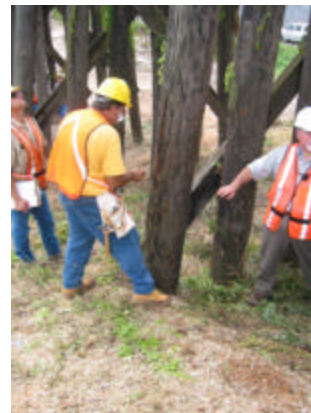
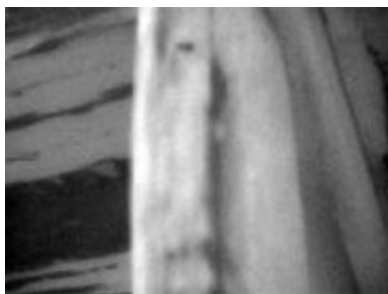
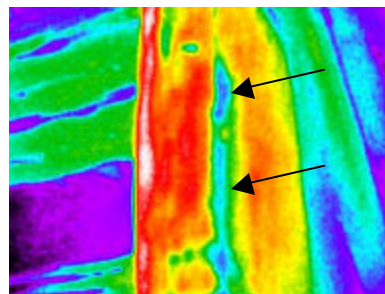
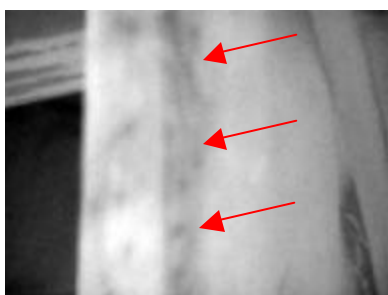
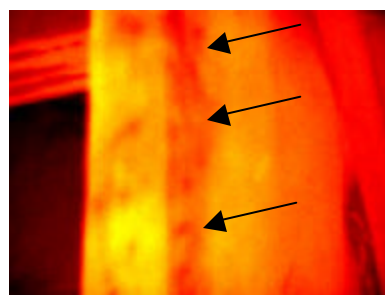
The IR gray scale images below and on the left and the HC image (upper right) and HM image (lower right) clearly show the residual moisture under the surface of the piling where evidence of mud tubes was mechanically located.

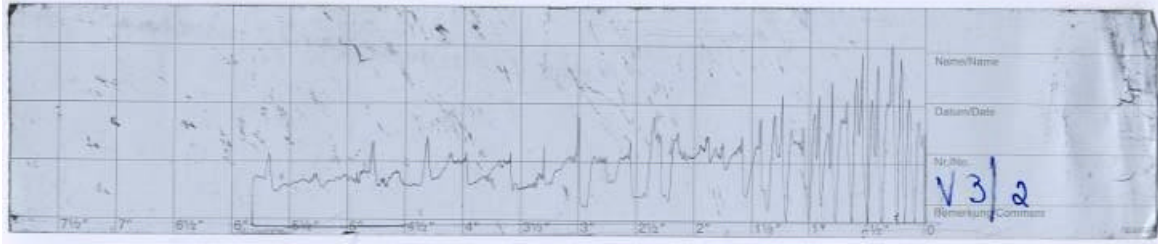
The resistograph image, above, of Bent 3, Piling 2 shows a typical grain pattern of wood in the piling. There was no evidence at the point of drilling that there was any damage to the interior of the piling.

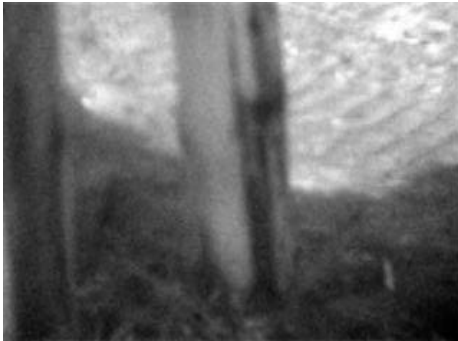
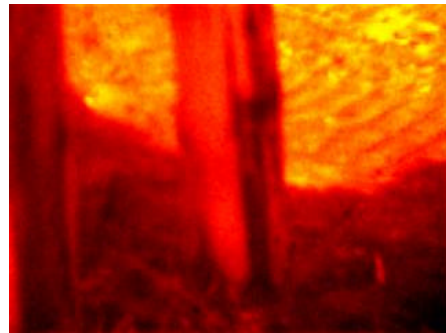
**“A” – Bent 4:** In Bent 4, Piling 6 mud tubes were located leading upward. Activity was not confirmed; however, excessive moisture was indicated with a moisture meter but not confirmed by use of the IR camera in Stringers 6 & 7. Note: Notations of excessive moisture were not confirmed by use of a moisture meter due to rain conditions at the site. Excessive moisture was indicated by use of the IR camera comparing like or similar structures to determine if those structures contained excessive moisture.

Grayscale and HM scale images indicate moisture revealing mud tubes.

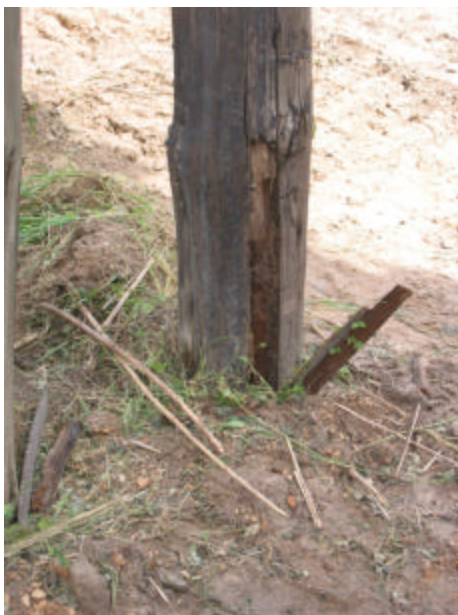
Manual and visual inspection of the piling revealed evidence of mud tubes and physical damage.

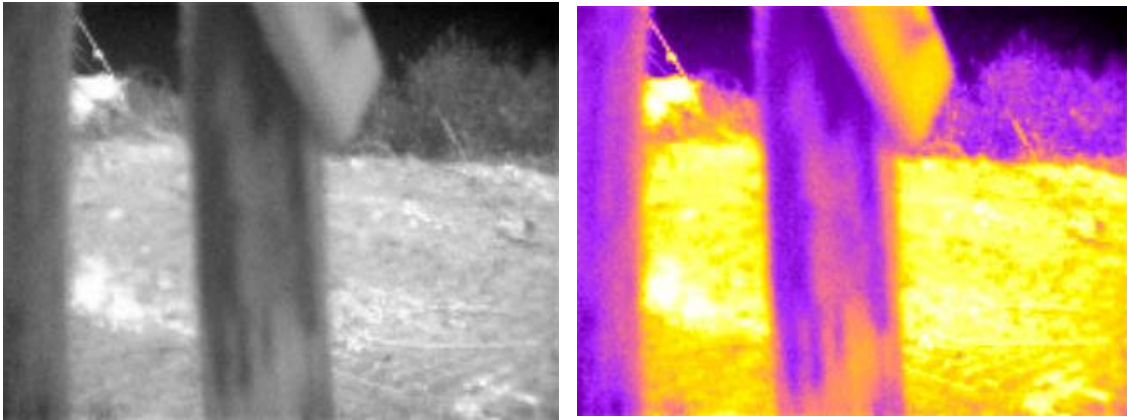
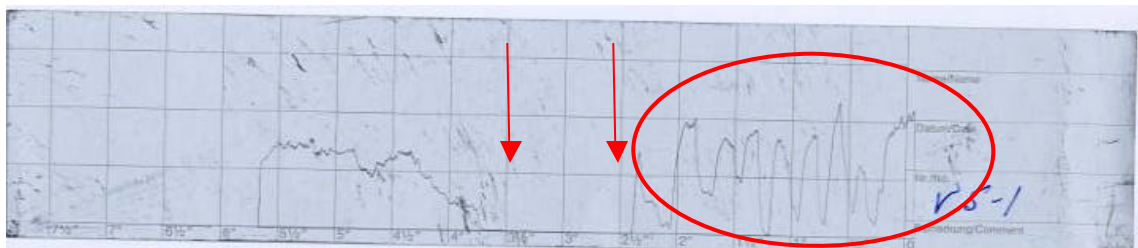
The resistograph image, above, of Bent 5, Piling 1 shows a typical grain pattern of wood in the area marked within the red oval. In addition, the graphic shows a void area of approx 1.5” in the area marked between the red arrows.

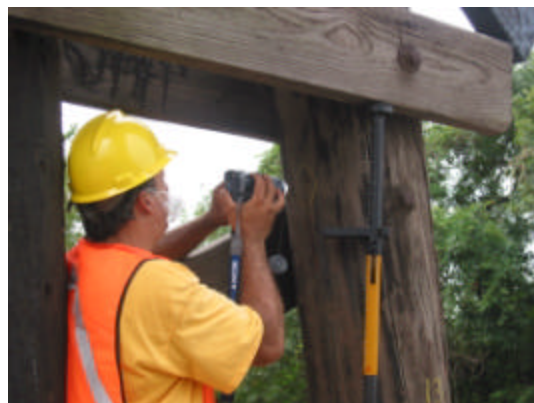
Evidence of live termite activity is being recorded in the upper section of a Piling 1.

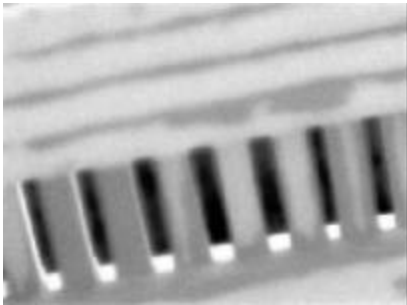
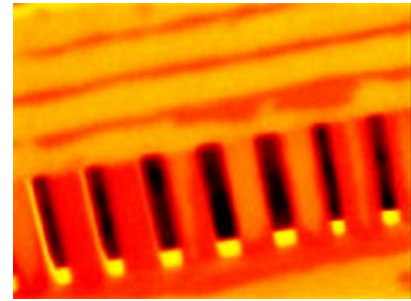
**“A” – Bent 6:** In Bent 6, Stringers 2, 3, 4 & 6, patterns typical of excessive moisture were noted with the IR camera, but not confirmed.

The grayscale image at left and the HM image at right show evidence of excessive moisture in Stringers 2, 3 & 4.

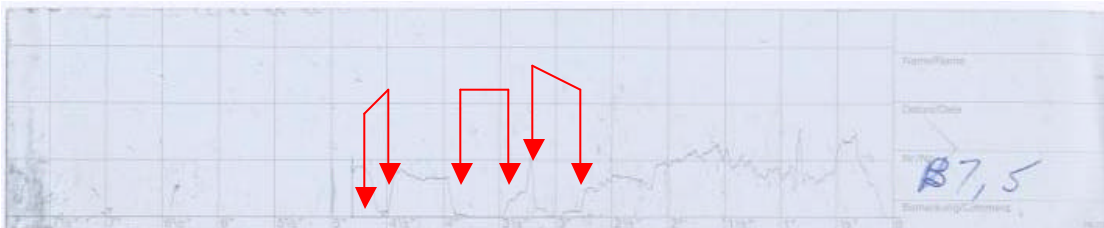
**“A” – Bent 7:** In Bent 7, Piling 1 showed live termite activity and Piling 5 showed evidence of previous termite activity. Acoustic means detected live active termites in Stringers 1, 2, 3 & 4. Use of IR had indicated excessive moisture in Stringers 2, 3 & 6.

The resistograph image, above, of Bent 7, Piling 5 shows the presence of wood in the initial 3 inches of the drill site. From that point forward, there are several areas marked (between the red arrows) evidencing small voids. The last void on the left between 4.5” and 4.75” is very typical of a termite gallery where the softer wood had been removed between the hard ring area.

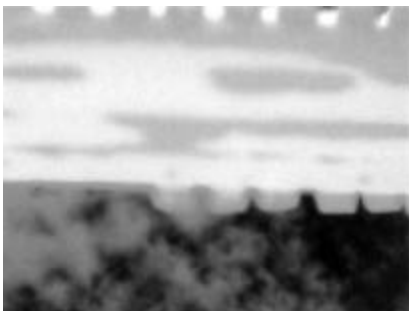
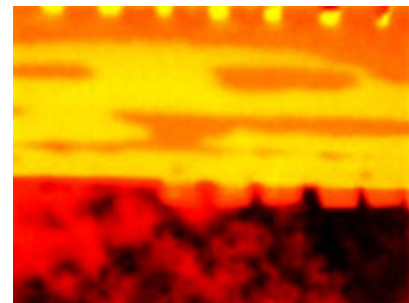
**“A” – Bent 8:** Piling 1 showed evidence of termite damage, but no active termites were located. Acoustic means indicated that Stringers 1, 2, 3 & 4, as well as Stringers 5, 6, 7, & 8, contained live termites.

The grayscale image at left and the HM image at right show evidence of excessive moisture in Stringers 5, 6, 7, & 8.

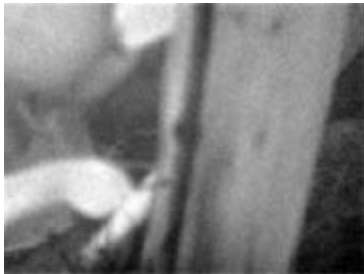
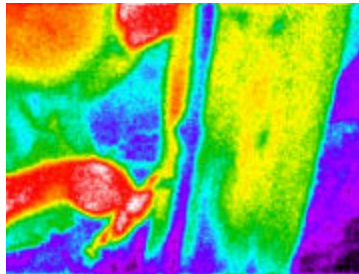
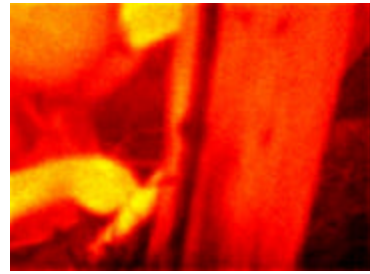
The grayscale image on the left, the HC image in the middle and the HM image on the right all show evidence of high moisture levels where carpenter ant and termite mud tubes were found after a mechanical inspection.

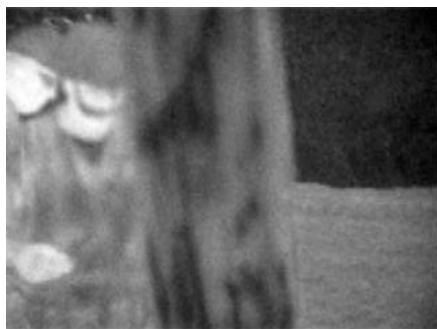
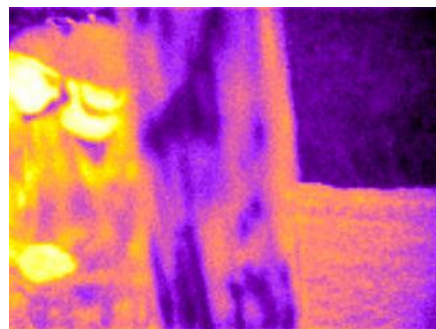
“A” – **Bent 11:** Piling 1 showed the presence of mud tubes and Acoustic means indicated that Stringers 1, 2, 3 & 4, as well as Stringers 5, 6, 7 & 8, contained live termite activity. Mechanical and visual inspections indicated evidence of damage to the Stringers.

The grayscale image (left) and the B image (right) show evidence of pockets of excessive moisture.

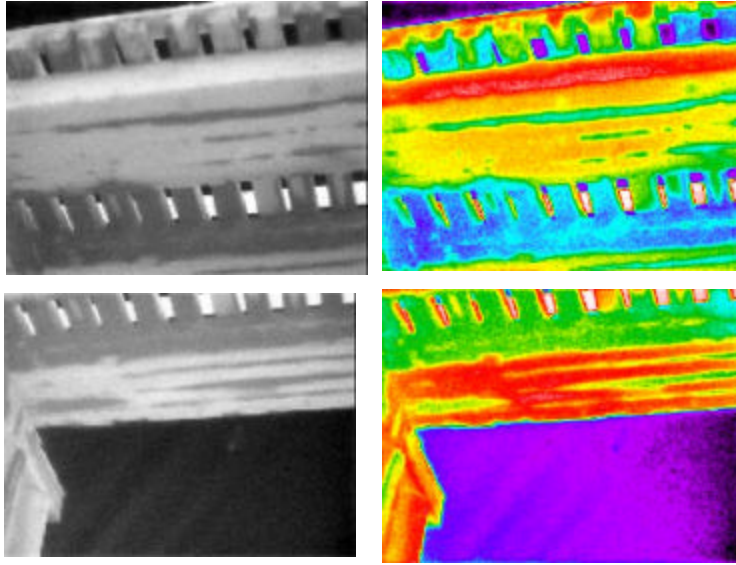
The IR images above show evidence of excessive moisture in Stringers 1 thru 4 on the top two images, and Stringers 5 thru 8 on the bottom two images.

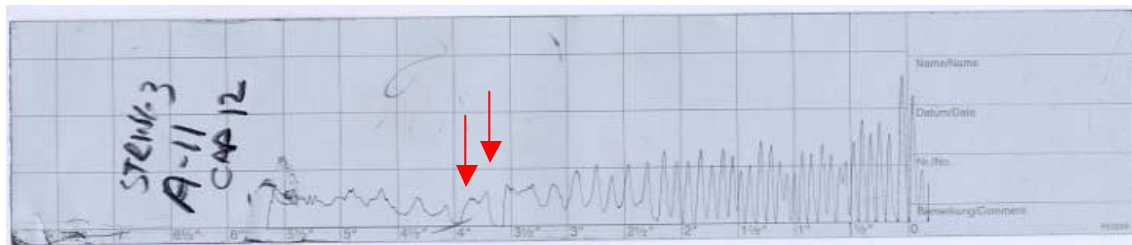
The Resistograph image of Bent 11, Stringer 3, shows evidence of 2 small voids shown between the 3-1/2" and 4" marks. The red arrows indicate their location.

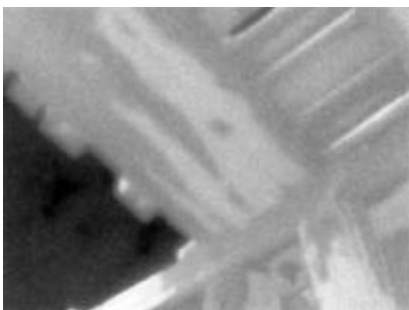
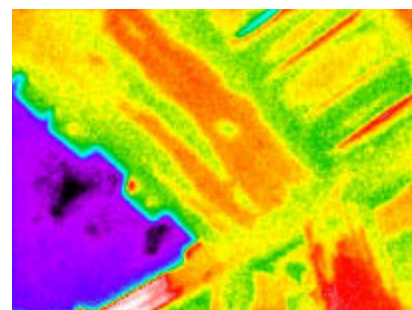
The IR grayscale image (left) and HC image (right) indicate high moisture levels in Stringers 5 thru 8.

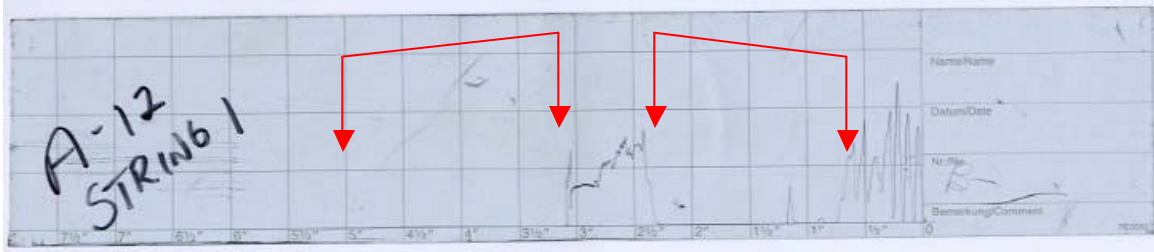
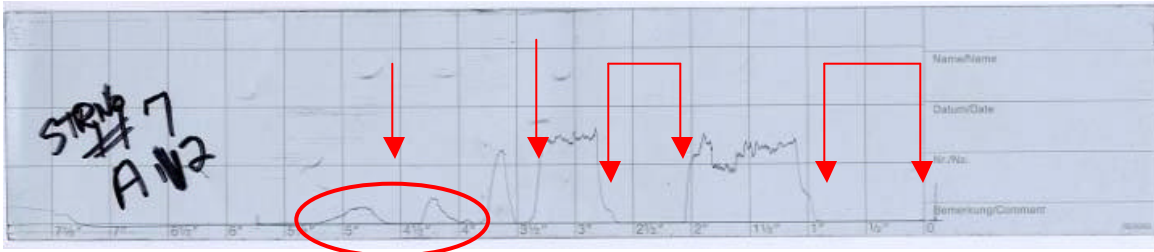
The Resistograph image above, of Bent 12, Stringer 1 evidences areas of voids at the drill site. The areas between the arrows indicate the location of the void areas. The image, below, of Stringer 7 also shows 4 areas of voids (red arrows) and an area of softness (red oval) or low resistance which may indicate decay.

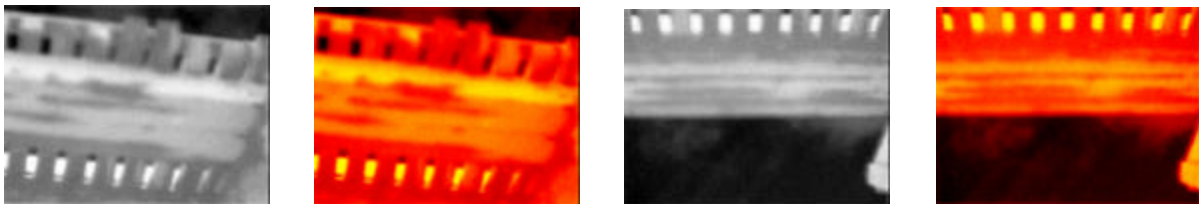
“A” – **Bent 14:** Acoustic means indicated that Pilings 1, 2, 3, 4, 5, & 6 and Stringers 1, 2, 3 & 4, as well as Stringers 5, 6, 7 & 8, contained live termites. IR scan indicated Stringers 1, 2, & 3 and 6, 7 & 8 contained excessive moisture.

The IR images above show evidence of excessive moisture in Stringers 1 thru 4 on the left two images and Stringers 5 thru 8 on the right two images.

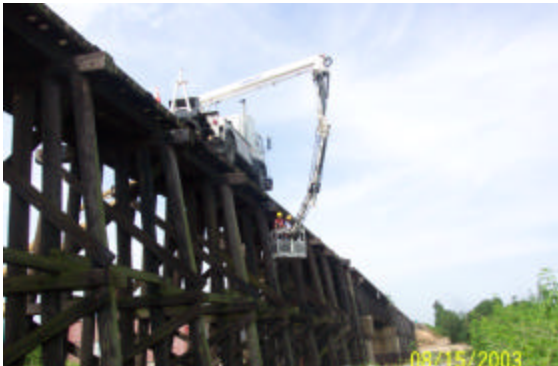
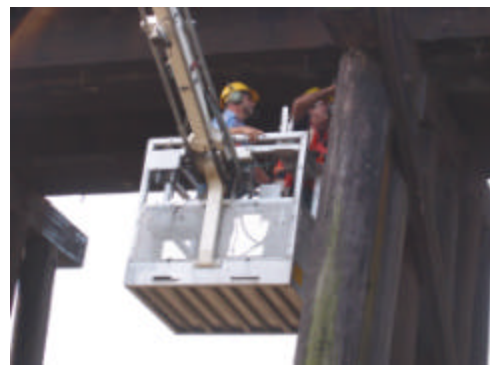
“C” – **Bent 7:** IR scans indicated excessive moisture in Pilings 1, 2 & 4. Acoustic means indicated live termite activity in Pilings 1, 2, 3, 4 & 5 and visual inspection located mud tubes and evidence of live termite activity in Pilings 1, 2, 3, 4 & 5. Acoustic means indicated that Piling 4 recorded 1,606 hits in 30 seconds, indicating a major access route. Additionally, 3 ties were noted with evidence of live termite activity.

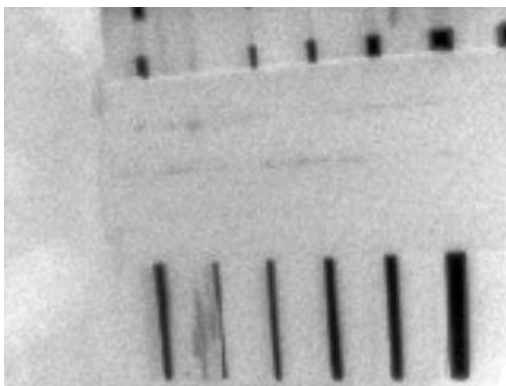
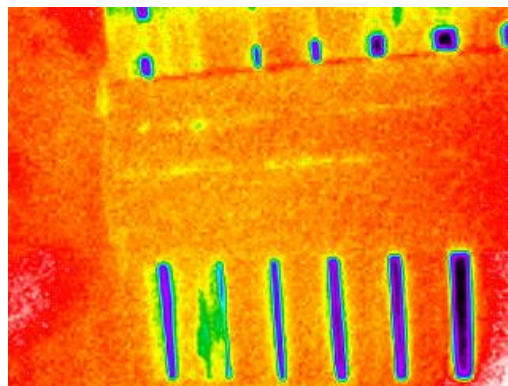
“C” – **Bent 17:** Piling 2 demonstrated carpenter ants and Piling 4 demonstrated mud tubes. IR imagery indicated high moisture levels and live termites were located in the Cap in the center / top section. Additional live termites were located in one Tie.

IR imagery indicated high moisture content in the cap area and indicated a damaged area in one tie.

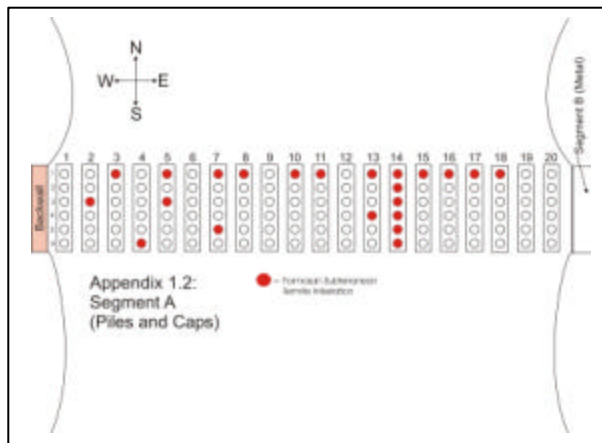
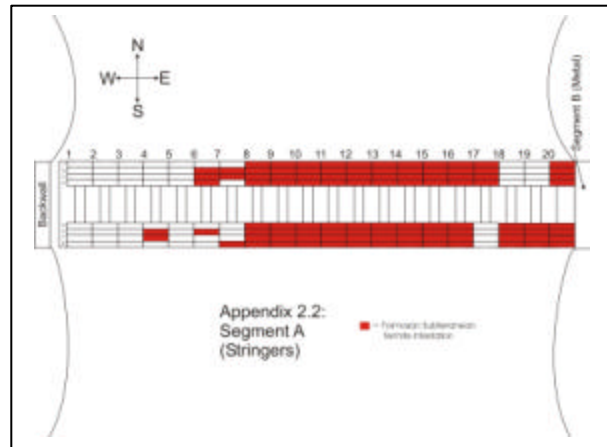
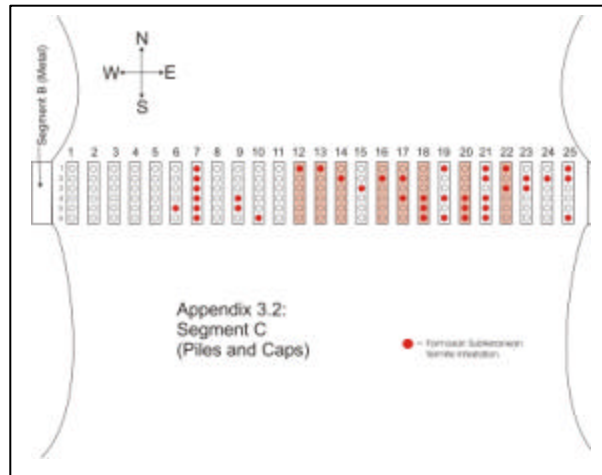
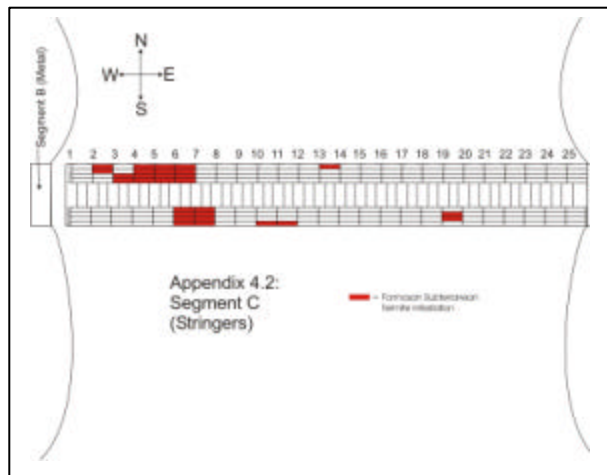
The following graphics represent the extent of the problem areas found by the brief survey:

As a result of the survey, the wooden trestle bridge was replaced within 90 days by a concrete bridge at a cost of over \$3 million. Makes one think about the estimated other 2,000 plus wooden trestle railroad bridges in the US and what catastrophe might be lurking in the making from our world of insect pests.
