Saving Green or Going Green? Incorporating Infrared into Building Energy Audits

Peter Hopkins, Vice President
Level III Certified Infrared Thermographer

United Infrared, Inc.
PO Box 1403
Bonsall, CA 92003

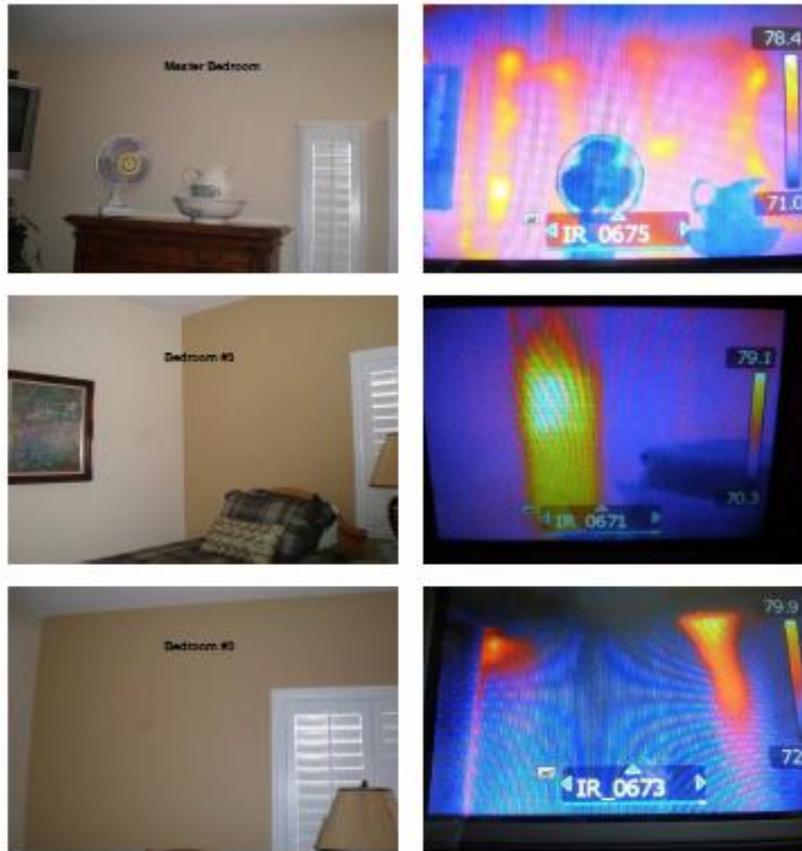
Example of a poorly conducted survey and an inadequate report taken from an unnamed report. These images represent the entire thermographic section of a report taken during a home inspection.

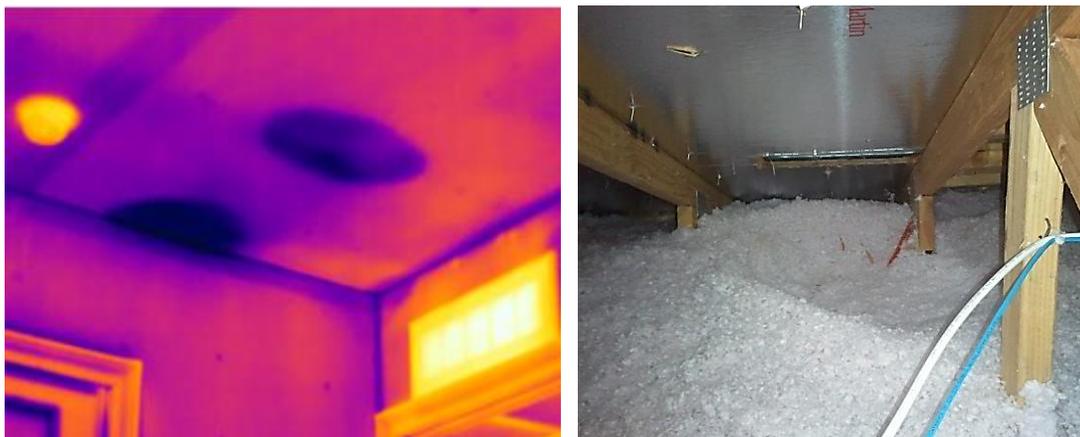
Leak or missing insulation? The image on the left is a leak; however, I have seen similar anomalies with missing loose-fill insulation that occurs in attics when wind is blowing through roof vents which creates a vortex spiral in the insulation.

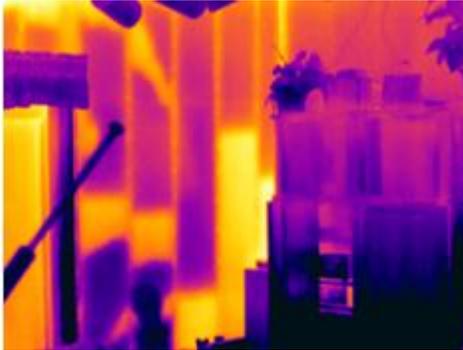
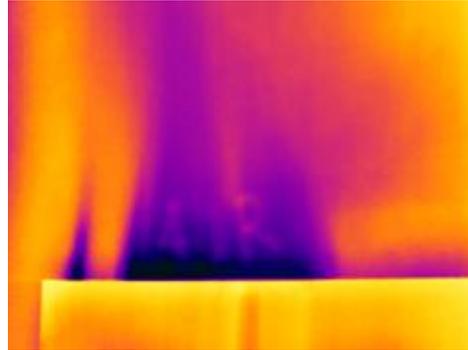
Conductive and radiant heat transfer occurring due to missing insulation. Convective heat loss can be seen with an infrared camera and a pressure differential.

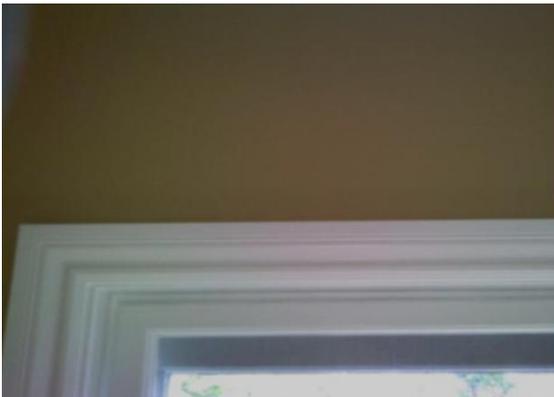
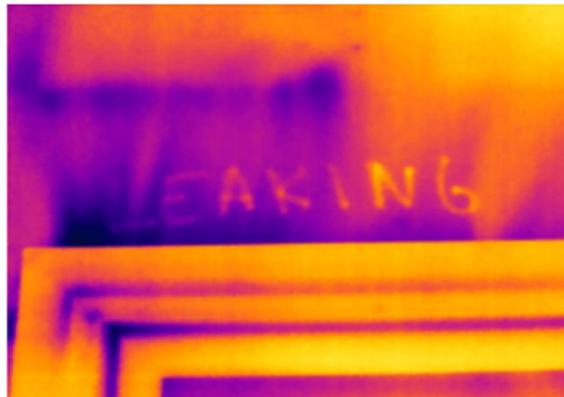
Air leakage at a window found during a blower door test.

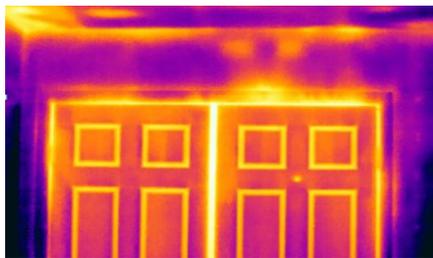
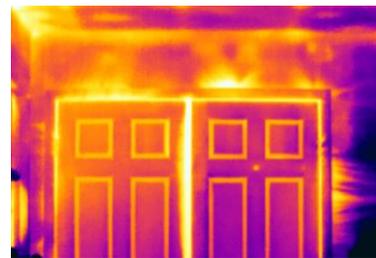
Test showing before and after blower door. Notice areas easily seen with infrared technology when a blower door is utilized.

Infrared alone is a qualitative measurement, whereas incorporating IR with a blower door will allow you to quantify the air leakage. Some current standards like ASTM C1060 and the RESNET standard discuss proper inspection techniques along with processes for utilizing infrared in conjunction with an infrared camera. There are some guidelines on minimum resolution for conducting a survey, but a general guideline is the better the temperature differential, the better the image will show anomalies.

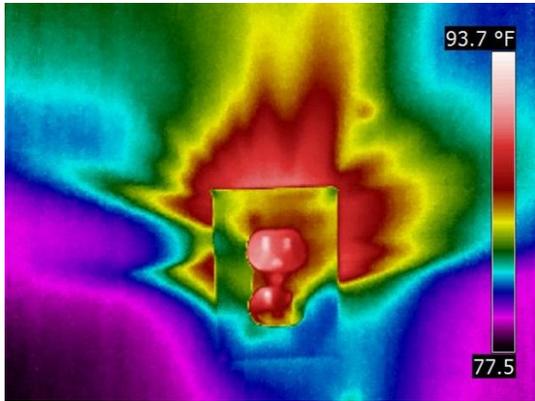
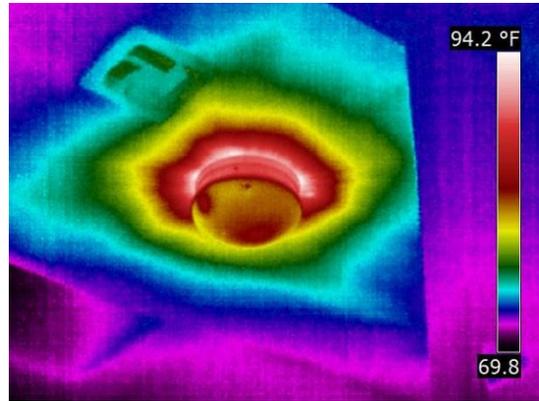
Most would think an Energy Star home would be perfect, based on the marketing hype. As you can see in the examples above, what was acceptable was excessive air leakage.

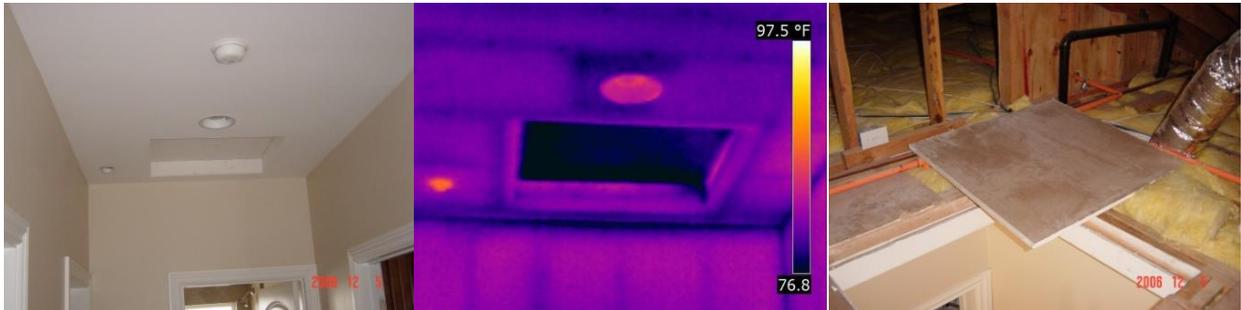
One of the most common defects in a home is missing insulation at the attic access cover. Standards require that the insulation be mechanically fastened to the cover. As you can see in this imagery, it was clearly never there.

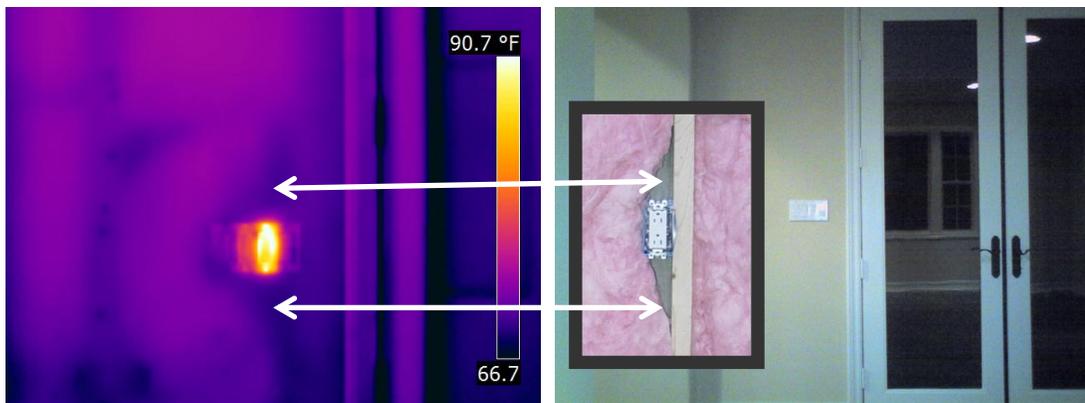
One of the amazing things about IR thermography is how easy it brings to light where heat is moving. Standards require insulation to be cut around electrical boxes, with proper placement behind the box. The infrared image on the left clearly shows how the insulation is not installed correctly behind the box, creating a void allowing heat loss. The inset image on the right is an example of how this would look like when the wall is opened.

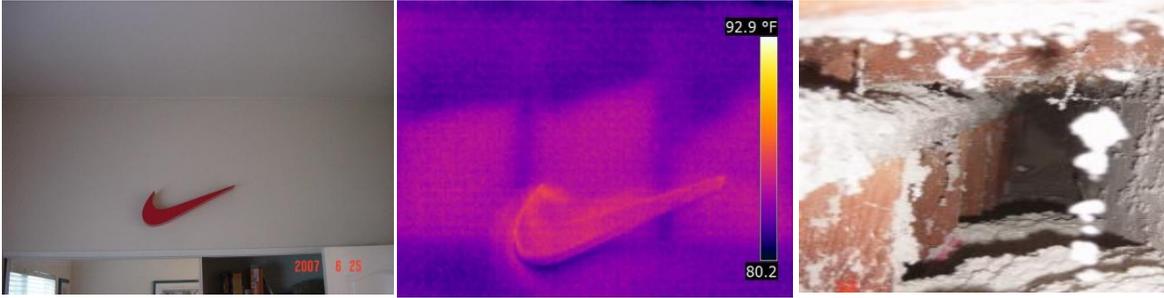
Homes prior to mid-1970 were not required to have insulation. A very big industry arose at that time with retrofit insulation companies offering to reinsulate houses. Since they were insulating cavities deep in the walls, the question became, how do you verify a proper job? I have the answer, but at this point I am sure you already know what it is. Notice the attic photo confirming missing insulation.

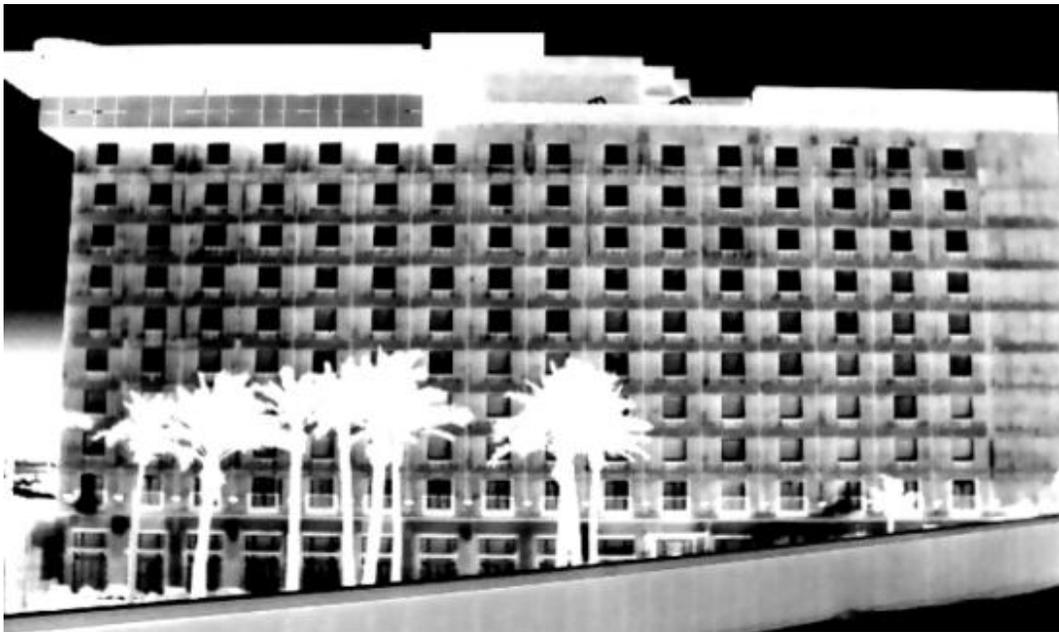
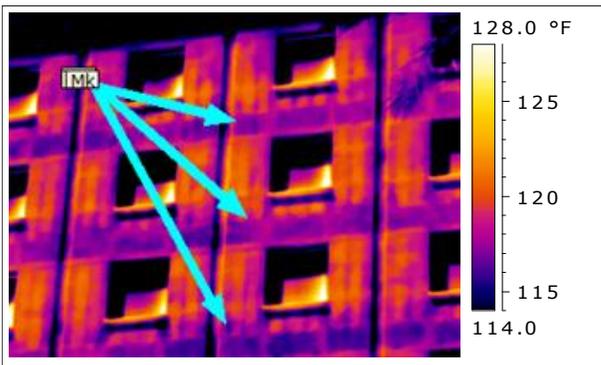
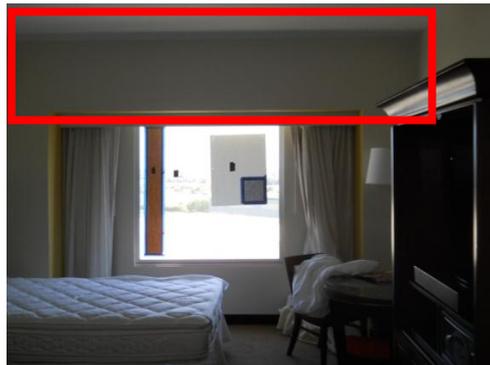
Thermogram shows thermal loss occurring between floors. The photograph above shows area where wall was furred out and likely not insulated as should. Current standards require insulation on all six sides, with no gaps or voids between weather barrier and air barrier (top, bottom, left, right, front and back).
