The Importance of Spatial Resolution in Infrared Thermography Temperature Measurement – Three Brief Case Studies

Robert P. Madding, Gary L. Orlove, and Bernard R. Lyon, Authors
Ed Kochanek, Presenter
Infrared Training Center, FLIR Systems, Inc.
25 Esquire Road
North Billerica, MA 01862
Ph: 978-901-8675
www.flirthermography.com

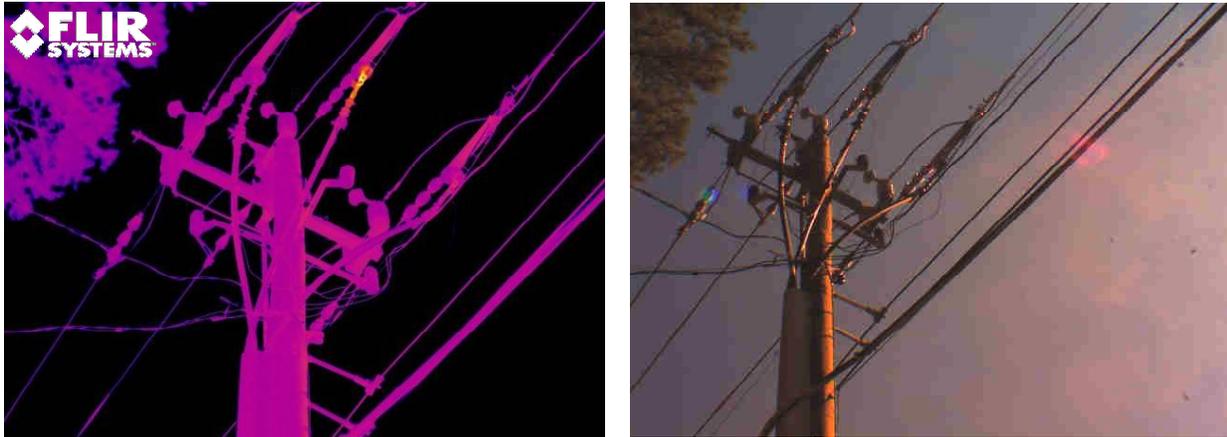
Figure 1 shows an IR and visual image pair of a problematic mechanical disconnect on a 23kV distribution system. These connections are between an underground feed and the overhead lines. All the IR images for this case were taken with the cameras in their standard configuration with no additional optics at a range of 36 feet.

Figure 1. High resolution IR image and visual counterpart of a set of 23kV distribution switches. The center phase shows a significant temperature rise. Distance to target is 36 feet.

We thermally tuned the level and contrast of each image for maximum “viewability” of the problem, so the temperature scales are close, but not exactly the same. In all cases the thermal anomaly can be seen, but it is much clearer in the high resolution image, to the extent one can see the bolt patterns on the connection. However, if this were the extent of the difference, one could justifiably argue using a lower resolution IR camera, hence lower cost would suffice. But what do the temperature measurements show? Table 1 gives the measurement summary.

It is very interesting to see the high resolution IR camera gives twice the delta-T (ΔT) temperature rise as the low resolution IR camera and 25% more than the medium resolution camera. For this study, we used an emissivity of 0.95 for all cameras; probably not exact, but this emissivity will give a temperature reading lower than the actual reading. The differences will only increase as the emissivity is lowered. So, we are considering the best case scenario for measurement comparisons among these cameras.

We estimated the load at 50% based on our utility contact's experience. The temperature rises calculated for 100% load¹ are given in the column labeled " ΔT Load corr". For one set of severity criteria used by the Electric Power Research Institute (EPRI), the load corrected temperature rises are in the critical category (135 F° rise or higher) for the high and medium resolution cameras and almost critical for the low resolution camera.

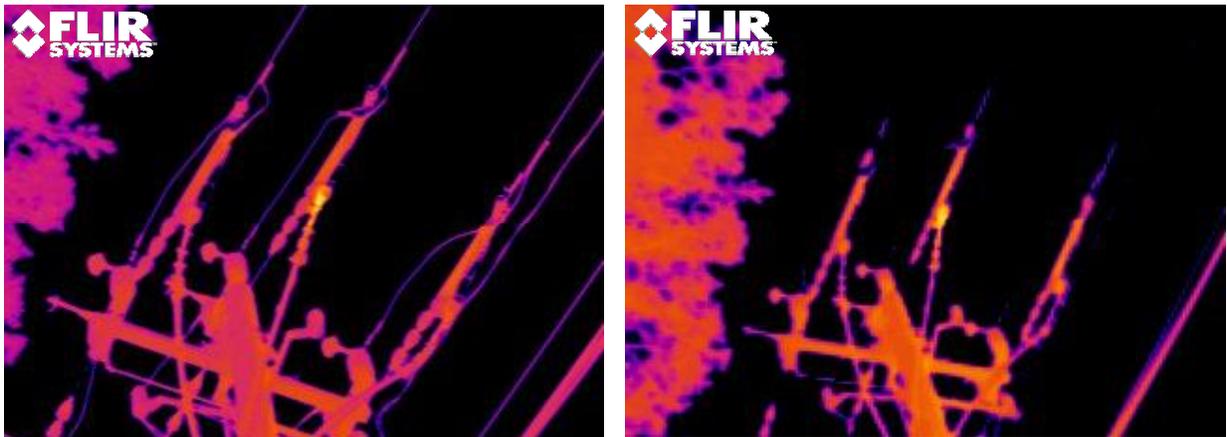
Figure 2 shows the medium (left) and low resolution IR images of the same set of switches.

Figure 2. Medium (left) and low resolution images of the same setup as in Figure 1.

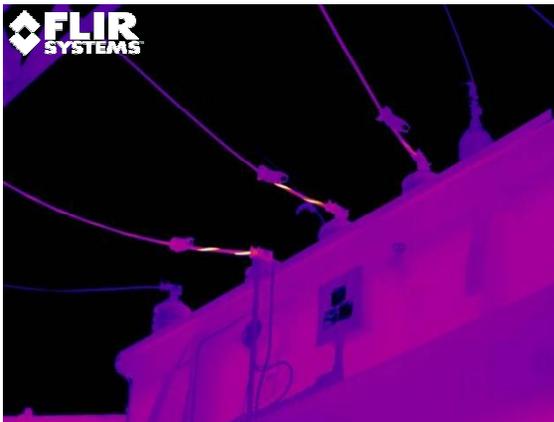
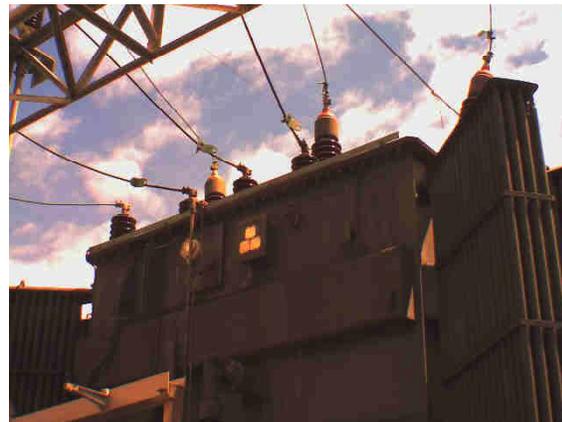
Figure 3 shows an IR image and visual image pair of a 115kV to 23kV substation transformer low side with definite problems on two of the phases. The jumpers from the bushings to the feed are stranded cables where some of the strands have broken over time or are not well connected. This causes overloading of the remaining good conductors resulting in significant heating. This is often termed "barber poling" for obvious reasons.

Figure 3. High resolution thermal image of a 115kV to 23kV substation transformer low side. Significant thermal anomaly on left and center phase jumpers due to some strands broken or poorly connected. IR image effect is often termed “barber poling”.

Measured load on this transformer was 40% of maximum. Range was 33 feet. Cable diameter is nominal 3/4". This was taken in early June when the weather was cool and electrical demand in the area was low. Figure 4 gives the medium (left) and low resolution IR camera images of the same scene.

But what about the temperature readings? Table 2 gives a comparison of maximum temperature readings for the left-most phase with barber poling. For this study, the results are even more dramatic than for the pole switch. Here, the ΔT measured with the high resolution camera is over 2.3 times that of the low resolution camera. And the problem severity according to the EPRI criteria is critical at 40% load for the medium and high resolution measurements!

The load corrected temperature rises are of great concern. We deemed the problem so significant we sent a report immediately to the utility that owns the substation transformer. Because, when air conditioning season hits, there is a very high probability of failure of this system, with load temperature rises at full load estimated as approaching 900°F.

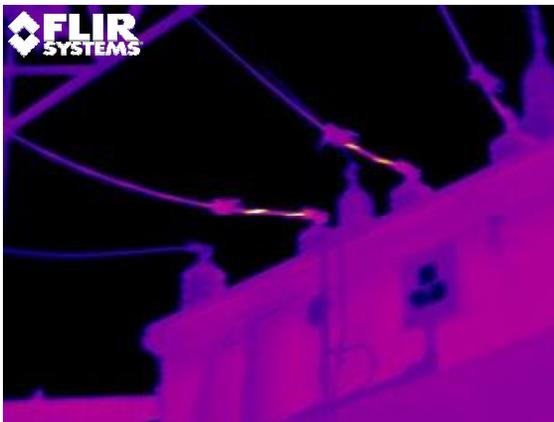
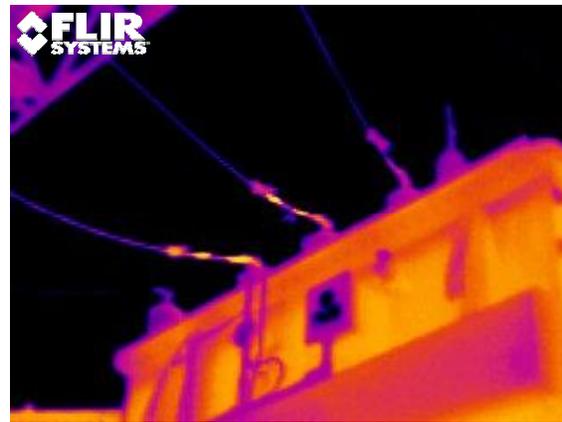
Figure 4. Medium (left) and low resolution images of the same setup as in Figure 3.

Again, the thermal anomalies were picked up by all the infrared cameras, so these problems would not have been missed.

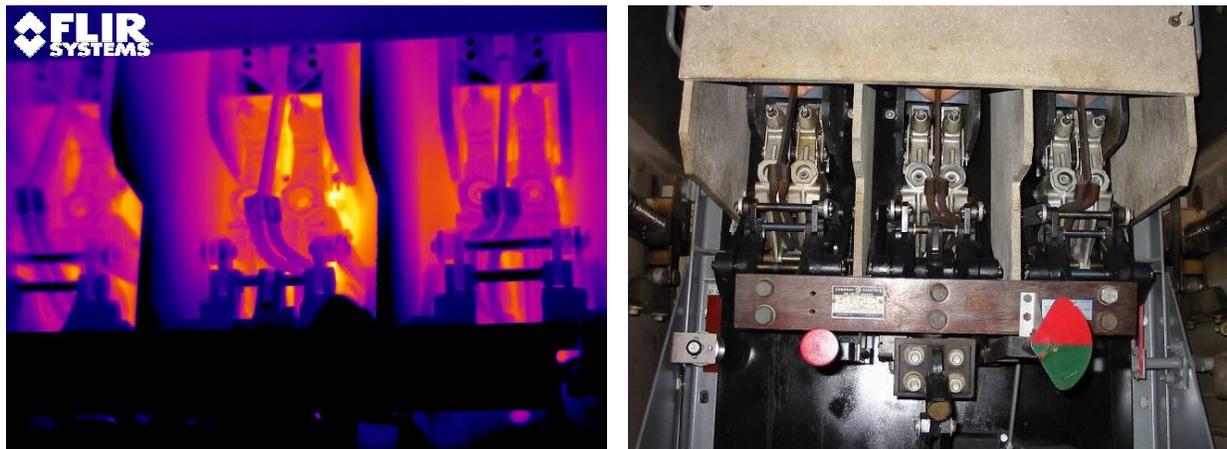
Figure 5 shows the high resolution IR and visual image pair of a 480 volt generator tie-in breaker at a paper mill. This breaker had a 3,000 amp load at the time of measurement, estimated at 75% of full load.

Figure 5. High resolution IR image and visual photo of 480 volt generator tie-in breaker.

We estimated the distance at 4 feet, though the problem was somewhat in the rear of the switchgear and could not readily be identified. It was definitely a problem with temperature rises somewhat lower than the above examples, but still significant. If the tie-in breaker fails, the paper mill production shuts down until it is repaired.

Table 3 gives the temperature data for this case study. Here, the differences among the cameras are less significant than in previous examples due to the closeness of the range and size of the target.

There is enough difference so the load corrected high resolution ΔT is right at the EPRI critical level, where the low resolution ΔT is still in the middle of the serious category. Having said that, the EPRI severity criteria are used here just as an example for comparison purposes. The Infrared Training Center does not advocate any specific set of severity criteria as there needs to be a lot more research done. Much of what is published is based on experience and a desire to have something to go on. There are many sets of severity criteria published and they are all different. See the paper by Giesecke for additional comments and insight on severity criteria.

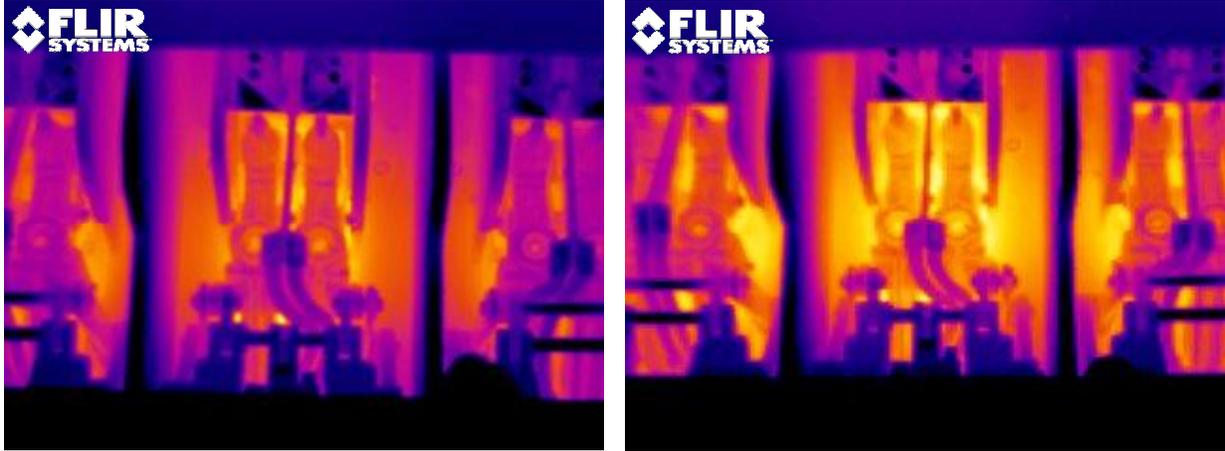
Figure 6. Medium resolution (left) and low resolution IR images of 480 volt generator tie-in breaker.
