Getting to the “Core” of Your Generator Stator Problems

Sonny James, Level III Certified Infrared Thermographer
Owner, Senior Instructor / Managing Director

Abstract

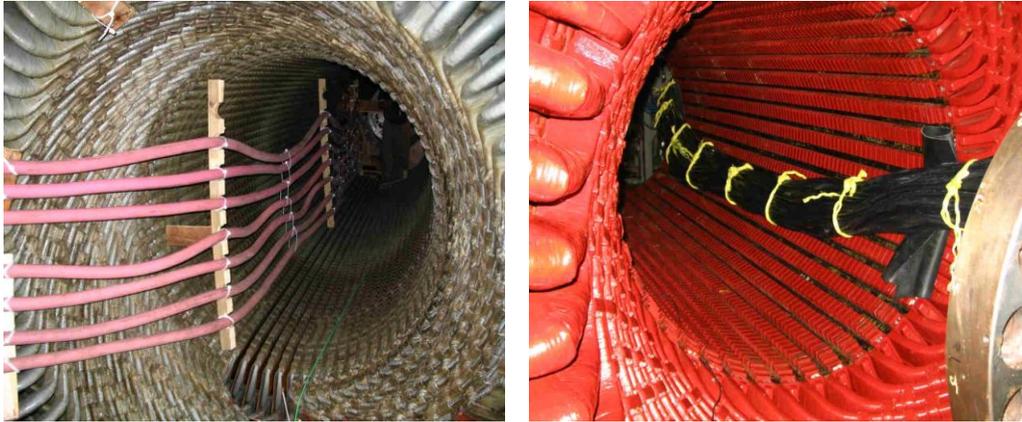
The Loop test involves exciting or fluxing the stator core to, or near to, the full rated flux of the generator by means of several turns of a high voltage insulated winding through the bore and around the outside of the stator. This induced flux produces fault currents similar to when the generator is in operation. If shorts are present, this will result in localized heating. This localized heating can then be seen with a thermal camera, pinpointing the exact location to be repaired.

Images showing Loop Test setup through the stator cores

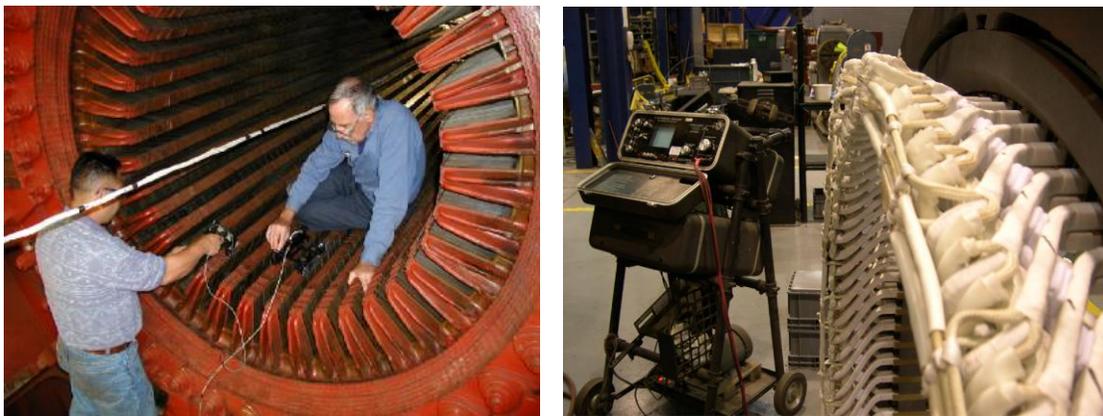
Electromagnetic Core Imperfection Detection (ELCID) test was developed as a way to readily test machines where a high power source was not available or deemed too risky. The ELCID test uses a very low flux level excitation winding that a technician would scan over the laminations. The fault current from shorts are detectable by electromagnetic means and the response is shown on a meter or oscilloscope screen.

Images showing ELCID testing and equipment

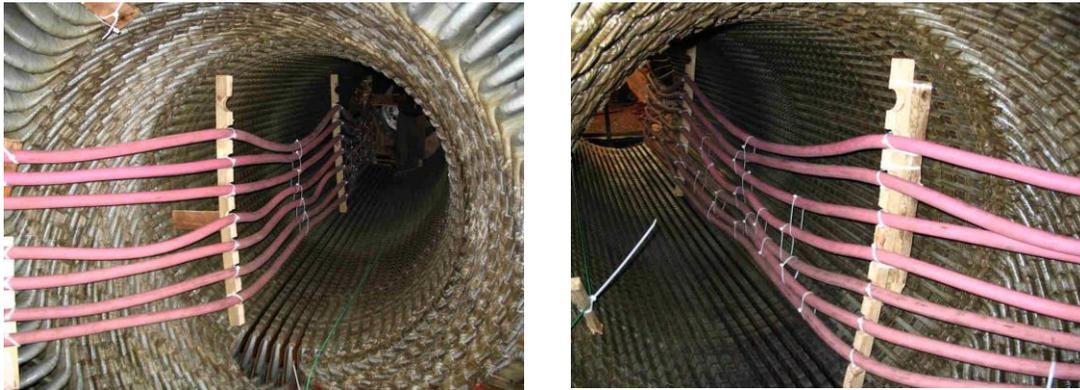
Loop Test with thermography (after ELCID testing and repairs)

Image showing loop test setup from turbine and exciter sides

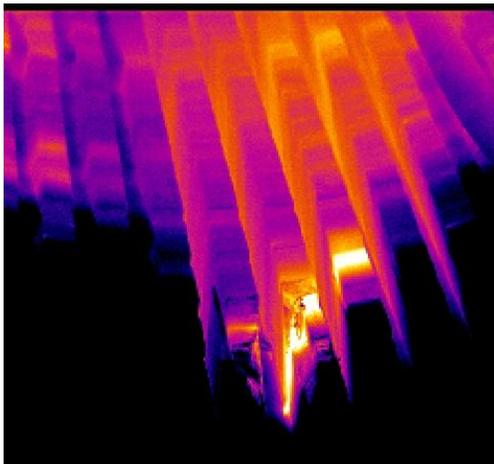
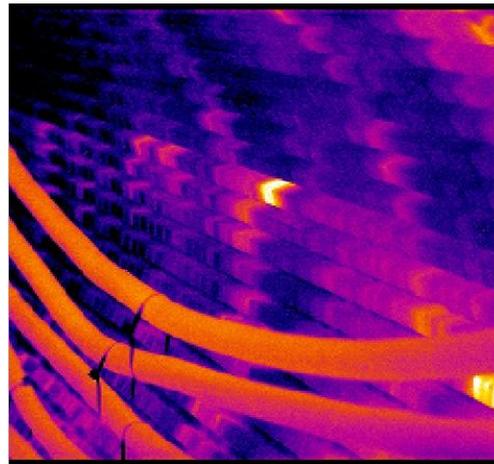
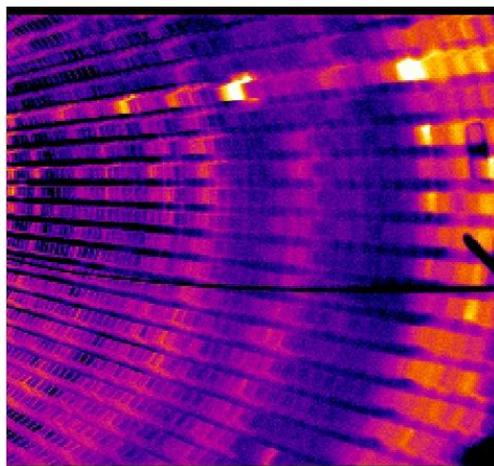
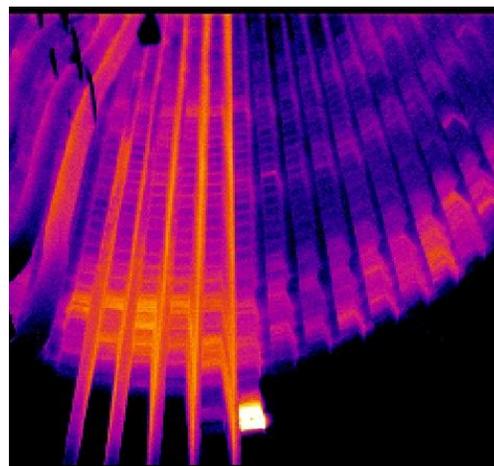
This particular stator had just recently suffered a failure resulting in the burning out of a series of iron packs located on the bottom of the turbine side of the stator.

Prior to the thermographic survey, the damaged section of the core was repaired and tested with ELCID.

Images showing hot spots due to lamination shorts (missed by ELCID test)

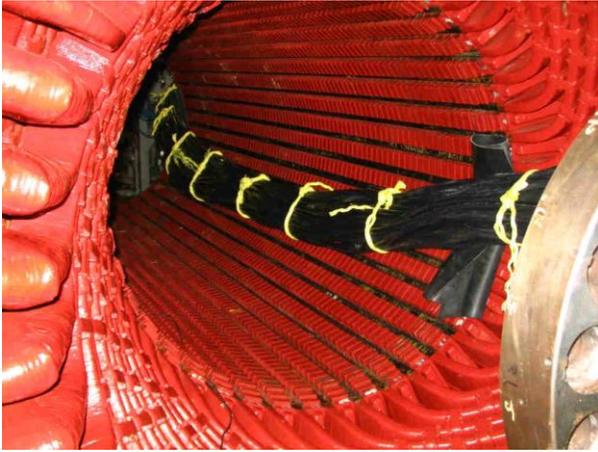
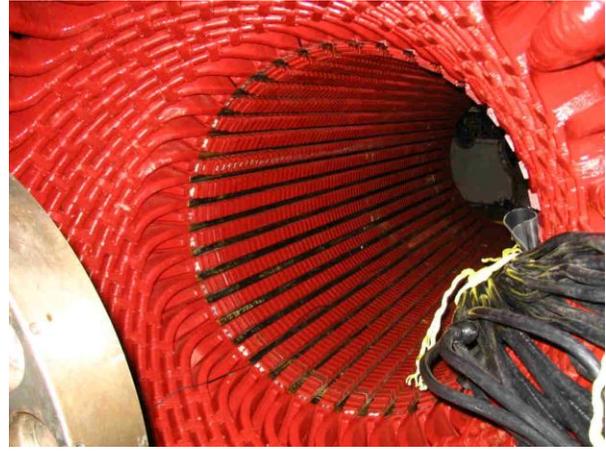
Initial Loop test with thermography (after ELCID testing and repairs)

Image showing loop test setup from turbine and exciter sides

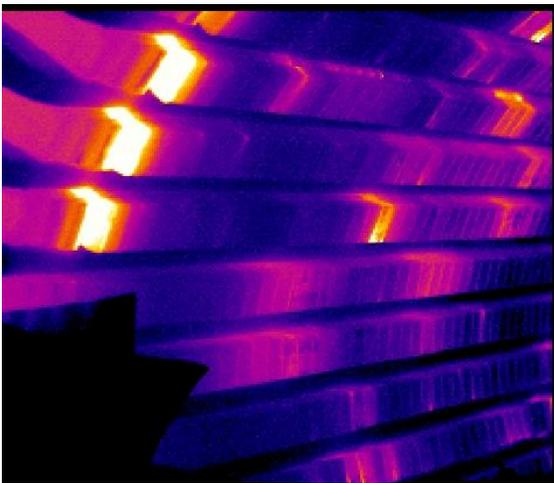
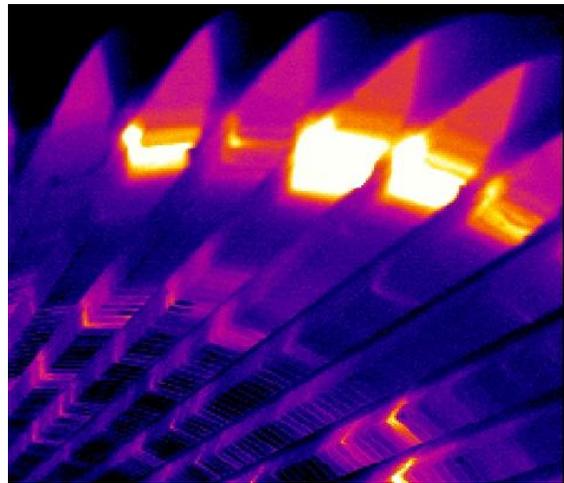
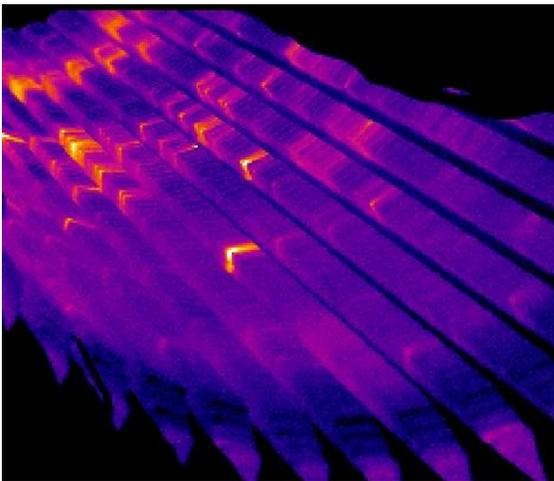
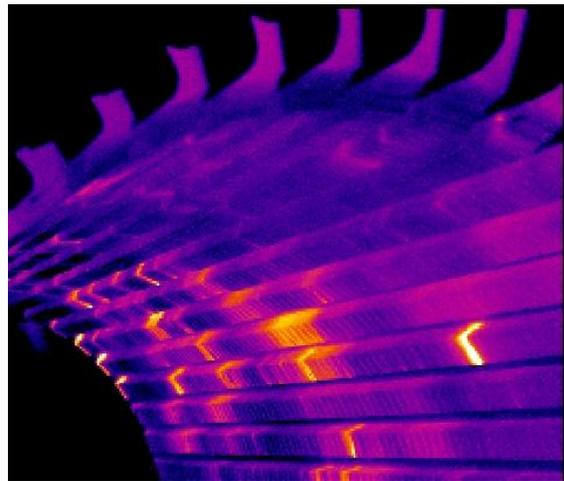
This particular stator had suffered a failure resulting in the burning out of a series of iron packs located throughout the turbine side of the stator.

Prior to the thermographic survey, the damaged sections of the core were repaired and tested with ELCID.

Image showing hot spots due to lamination shorts (missed by ELCID test)

Shorts in laminations were easily repaired by attempting to carefully separate the lamination with the use of a knife or other suitable tool or by grinding out the short area with a pencil grinder while still staying within the acceptable limits.

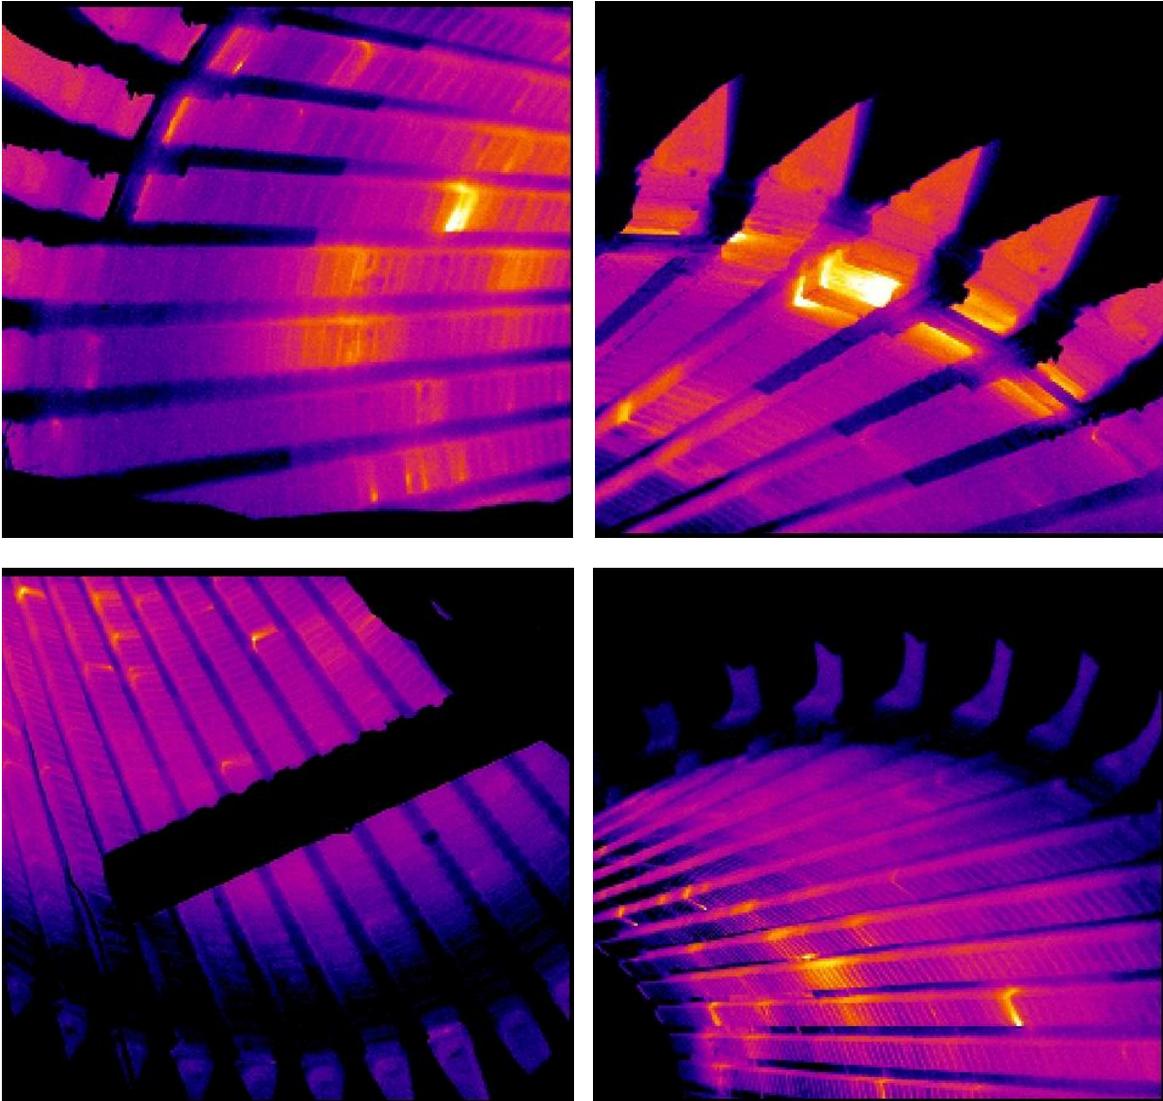
Second Loop test with thermography after repairs

Image showing shorted areas successfully repaired or at acceptable Delta-T
