# **Delta T Alert: Wireless Temperature Monitoring of Electrical Enclosures**

## **Abstract**

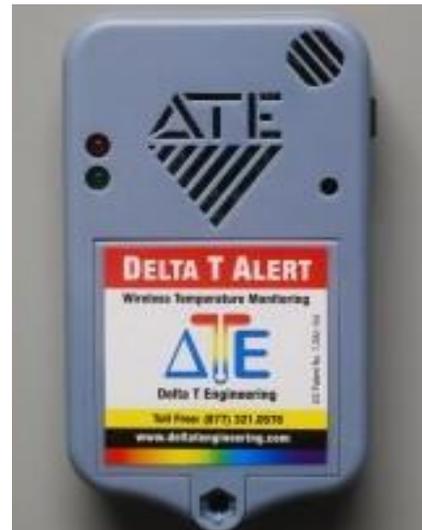
You can avoid a major electrical breakdown - and significant financial loss - with the "Delta T Alert". Developed by Delta T Engineering, LLC, this patented device magnetically attaches to your electrical equipment covers, monitoring the Delta T (temperature differential) between the interior of an electrical enclosure and the ambient temperature of the room that enclosure is in.

You can adjust the Delta T to collect data on a daily basis, at specific time intervals. The information is then transmitted wirelessly to an onsite computer for analysis. Whether your panels are located in a 20° warehouse in Alaska, a 100° switchgear room in NYC or a 65° data center in Tuscaloosa, the Delta T Alert can warn you of excessive temperature rise within your electrical enclosures before more serious problems arise.

Delta T Alert is a self-contained temperature-monitoring sensor that attaches magnetically to electrical enclosure covers. This sensor is designed to work on NEMA 1 enclosures which are constructed for indoor use to provide a degree of protection to personnel against incidental contact with the enclosed equipment and to provide a degree of protection against falling dirt.

Delta T Alert is comprised of two temperature sensors - one to monitor the electrical enclosure's interior temperature and the second to monitor the room's ambient temperature where the enclosure is located. To monitor the enclosure's internal temperature, a 15/32" hole is drilled into the cover of the enclosure after the cover is removed. Delta T is then magnetically attached with the interior sensor protruding into the panel 7/8 of an inch. Both the size of the hole and the length of the interior sensor conform to protection classification NEMA IP20. This classification protects against access to hazardous parts with a finger.

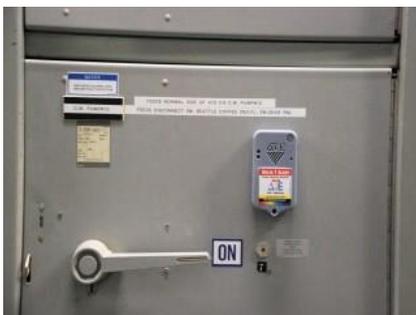
Delta T Engineering, LLC installed Delta T Alert's on all critical enclosure's located within the Main Switchgear Room. The Delta T units were programmed to record temperature rise within the enclosures three times per day. This data was transmitted wirelessly to the Chief Engineer's computer for analysis and

On March 1, 2009, twenty-four Delta T units were installed within the Main Switchgear Room and programmed to send the Delta T data to the Chief Engineer's computer at 9:30 am, 12 noon and at 3:00 pm. All enclosures where the units were installed were operating within the normal temperature range until March 26, 2009. On this date, the Chief Engineer received an "Elevated" alarm on Condenser Water Pump #12 fused disconnect. This alarm was observed within the opening page of the Delta T Alert Software. Please see figure #1.

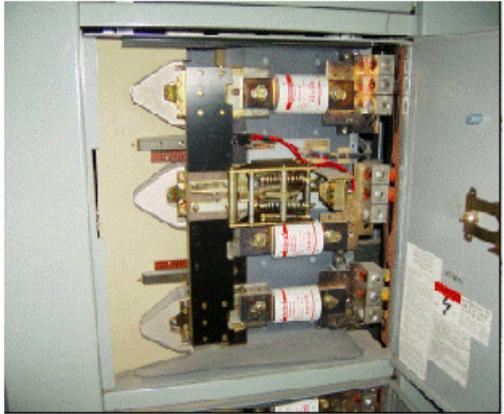
**Identification of Problem** - After the Chief Engineer reviewed the Delta T Alert data, he employed his thermographer to conduct an infrared scan on Condenser Water Pump #12 fused disconnect . Thermography results showed an almost 13 degree temperature rise on phase “A” fuse connection. See Figure #2.

Event #	Date:	Location:	MCC or Panel	Equipment Label:	Priority
1	03/30/09	Main Switchgear Room	MS - A2	CW Pump #12 Fused Disconnect	3
Apparent Temperatures:		Image Date 3/30/2009 Image Time 11:35:55 AM		Reference Photo:	
<p>Problem Temperature: <b>92.4 °F</b></p> <p>Reference Temperature: <b>79.7 °F</b></p> <p>Temperature Rise: <b>12.7 °F</b></p> <p><b>Figure 2</b></p>

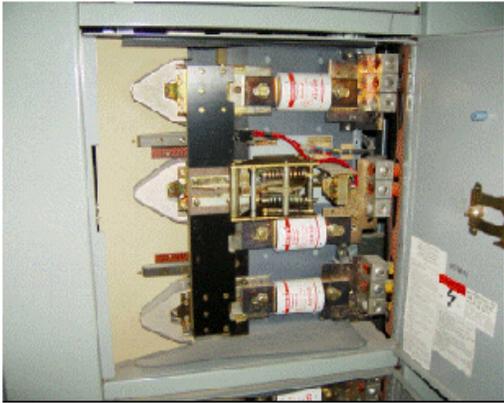
Event #	Date:	Location:	MCC or Panel	Equipment Label:	Priority
1	04/05/09	Main Switchgear Room	MS - A2	CW Pump #12 Fused Disconnect	Repaired
Apparent Temperatures:		Image Date 4/5/2009 Image Time 12:54:16 PM		Reference Photo:	
<p>Problem Temperature: <b>84.2 °F</b></p> <p>Reference Temperature: <b>82.1 °F</b></p> <p>Temperature Rise: <b>2.1 °F</b></p> <p><b>Figure #4</b></p>

The Chief Engineer submitted the Infrared survey findings to his electrician. CW Pump #12 fused disconnect was de-energized and corrective action was performed on phase “A” fuse connection by his electrician. Phase “A” connections were disassembled, contact surfaces were cleaned and re-assembled to the proper torque values. Figure #4 illustrates a thermogram after corrective action was completed. **Both before and after thermograms were recorded during same load conditions.**
