The Importance of Spatial Resolution in Infrared Thermography Temperature Measurement – Three Brief Case Studies

Dr. Robert Madding, Director, Infrared Training Center
Ed Kochanek, Presenter
FLIR Systems, Inc.
25 Esquire Road
North Billerica, MA 01862
Ph: 978-901-8000

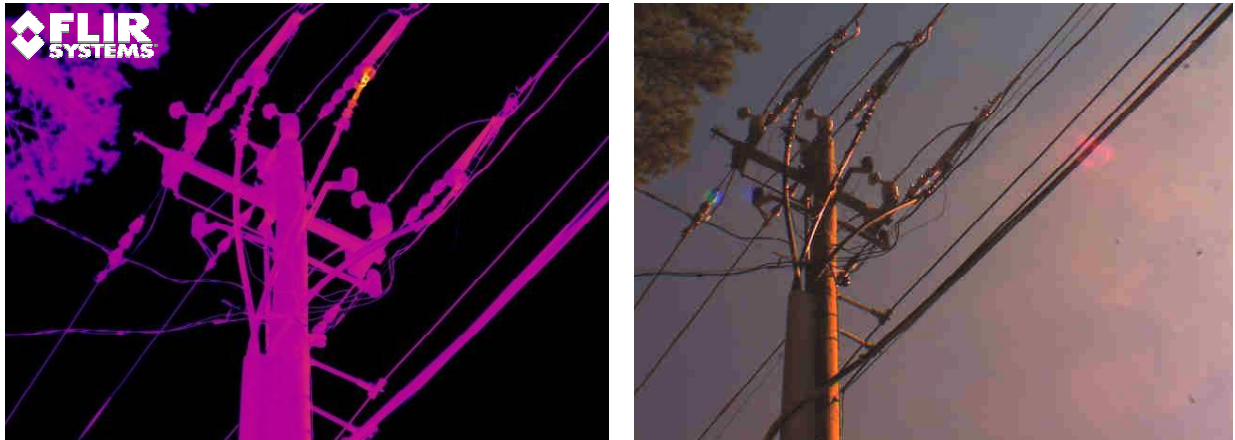
Figure 1 shows an IR and visual image pair of a problematic mechanical disconnect on a 23kV distribution system. These connections are between an underground feed and the overhead lines. All the IR images for this case were taken with the cameras in their standard configuration with no additional optics at a range of 36 feet.

Figure 1. High resolution IR image and visual counterpart of a set of 23kV distribution switches. The center phase shows a significant temperature rise. Distance to target is 36 feet.

We thermally tuned the level and contrast of each image for maximum “viewability” of the problem, so the temperature scales are close, but not exactly the same. In all cases the thermal anomaly can be seen, but it is much clearer in the high resolution image, to the extent one can see the bolt patterns on the connection. However, if this were the extent of the difference, one could justifiably argue using a lower resolution IR camera, hence lower cost would suffice. But what do the temperature measurements show? Table 1 gives the measurement summary.

Switch Disconnect at 12 Yards				
IR Camera	Temperatures			% Load (estimated)
	T	ΔT	ΔT Load corr	
Hi Res	173°F 78°C	91 F° 50 C°	271 F° 150 C°	50
Med Res	155°F 68°C	72 F° 40 C°	216 F° 120 C°	50
Lo Res	125°F 52°C	45 F° 25 C°	133 F° 75 C°	50

It is very interesting to see the high resolution IR camera gives twice the delta-T (ΔT) temperature rise as the low resolution IR camera and 25% more than the medium resolution camera. For this study, we used an emissivity of 0.95 for all cameras; probably not exact, but this emissivity will give a temperature reading lower than the actual reading. The differences will only increase as the emissivity is lowered. So, we are considering the best case scenario for measurement comparisons among these cameras.

We estimated the load at 50% based on our utility contact's experience. The temperature rises calculated for 100% load¹ are given in the column labeled " ΔT Load corr". For one set of severity criteria used by the Electric Power Research Institute (EPRI), the load corrected temperature rises are in the critical category (135 F° rise or higher) for the high and medium resolution cameras and almost critical for the low resolution camera.

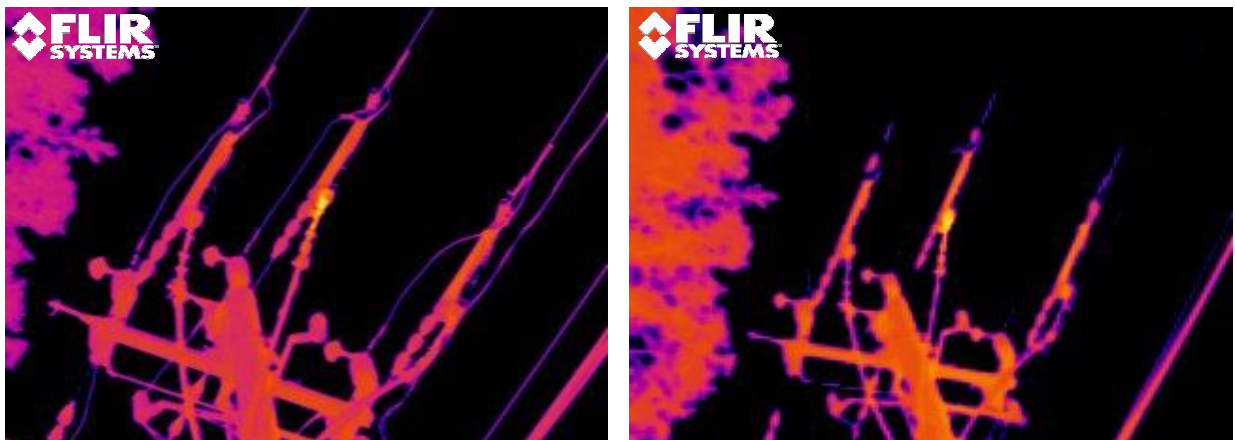
Figure 2 shows the medium (left) and low resolution IR images of the same set of switches.

Figure 2. Medium (left) and low resolution images of the same setup as in Figure 1.

The bottom line is all the infrared cameras would detect the problem, but without a telescopic lens on the low and medium resolution cameras, incorrect readings would have been obtained and the level of severity would have been significantly underestimated. The disadvantage of telescopic lenses, besides expense, is they reduce the field of view and enhance the optical leveraging. The latter means it is more difficult to get a good, stable image with a telescopic lens attached, as any small motion of the IR camera is magnified by the power of the telescope. This is why digital camera companies have patented image stabilizing telescopes for their cameras. The thermographer can still accomplish the task - it just takes longer with a telescopic lens.

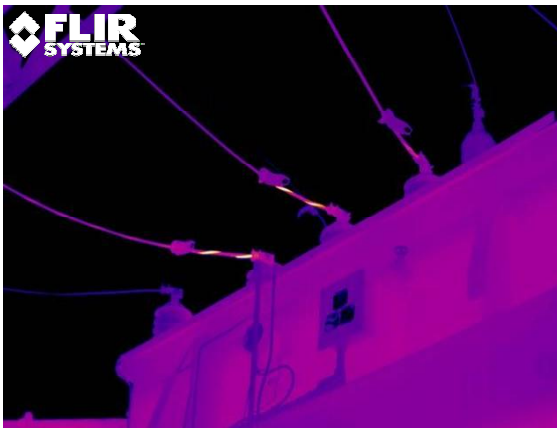
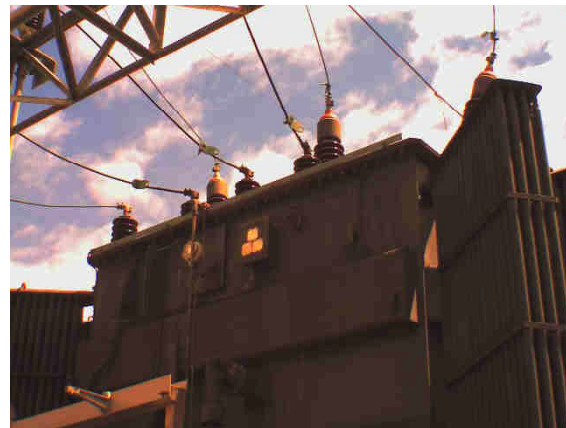
Figure 3 shows an IR image and visual image pair of a 115kV to 23kV substation transformer low side with definite problems on two of the phases. The jumpers from the bushings to the feed are stranded cables where some of the strands have broken over time or are not well connected. This causes overloading of the remaining good conductors resulting in significant heating. This is often termed "barber poling" for obvious reasons.

Measured load on this transformer was 40% of maximum. Range was 33 feet. Cable diameter is nominal 3/4". This was taken in early June when the weather was cool and electrical demand in the area was low. Figure 4 gives the medium (left) and low resolution IR camera images of the same scene.

Figure 3. High resolution thermal image of a 115kV to 23kV substation transformer low side. Significant thermal anomaly on left and center phase jumpers due to some strands broken or poorly connected. IR image effect is often termed “barber poling”.

But what about the temperature readings? Table 2 gives a comparison of maximum temperature readings for the left-most phase with barber poling. For this study, the results are even more dramatic than for the pole switch. Here, the ΔT measured with the high resolution camera is over 2.3 times that of the low resolution camera. And the problem severity according to the EPRI criteria is critical at 40% load for the medium and high resolution measurements!

The load corrected temperature rises are of great concern. We deemed the problem so significant we sent a report immediately to the utility that owns the substation transformer. Because, when air conditioning season hits, there is a very high probability of failure of this system, with load temperature rises at full load estimated as approaching 900°F.

Substation Transformer Jumpers at 11 Yards				
IR Camera	Temperatures			% Load
	T	ΔT	ΔT Load corr	
Hi Res	280°F 138°C	211 F° 117 C°	889 F° 494 C°	40
Med Res	243°F 117°C	172 F° 95 C°	724 F° 402 C°	40
Lo Res	127°F 53°C	90 F° 50 C°	380 F° 211 C°	40

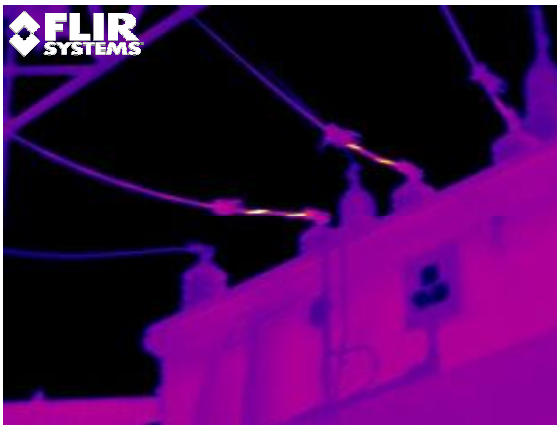
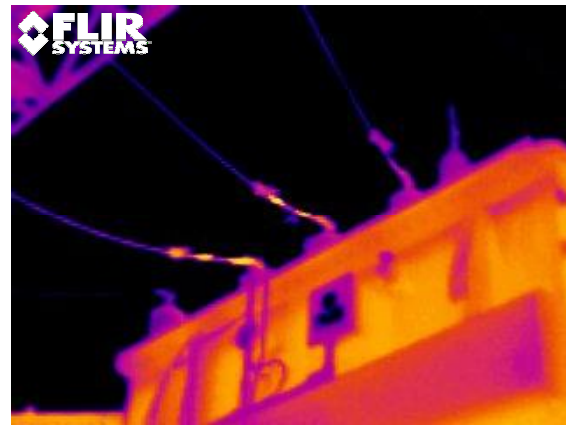
Figure 4. Medium (left) and low resolution images of the same setup as in Figure 3.

Again, the thermal anomalies were picked up by all the infrared cameras, so these problems would not have been missed.

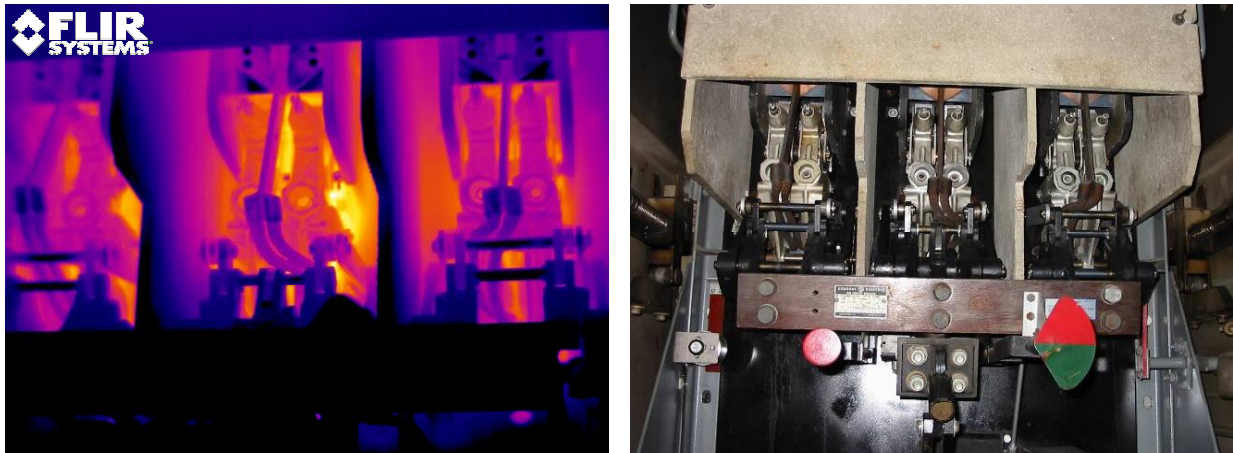
Figure 5 shows the high resolution IR and visual image pair of a 480 volt generator tie-in breaker at a paper mill. This breaker had a 3,000 amp load at the time of measurement, estimated at 75% of full load.

Figure 5. High resolution IR image and visual photo of 480 volt generator tie-in breaker.

We estimated the distance at 4 feet, though the problem was somewhat in the rear of the switchgear and could not readily be identified. It was definitely a problem with temperature rises somewhat lower than the above examples, but still significant. If the tie-in breaker fails, the paper mill production shuts down until it is repaired.

Table 3 gives the temperature data for this case study. Here, the differences among the cameras are less significant than in previous examples due to the closeness of the range and size of the target.

Generator Tie-in Breaker at 4 Feet				
IR Camera	Temperatures			% Load
	T	ΔT	ΔT Load corr	
Hi Res	210°F 99°C	85 F° 47 C°	134 F° 74 C°	75
Med Res	198°F 92°C	72 F° 40 C°	113 F° 63 C°	75
Lo Res	193°F 89°C	68 F° 38 C°	108 F° 60 C°	75

There is enough difference so the load corrected high resolution ΔT is right at the EPRI critical level, where the low resolution ΔT is still in the middle of the serious category. Having said that, the EPRI severity criteria are used here just as an example for comparison purposes. The Infrared Training Center does not advocate any specific set of severity criteria as there needs to be a lot more research done. Much of what is published is based on experience and a desire to have something to go on. There are many sets of severity criteria published and they are all different. See the paper by Giesecke for additional comments and insight on severity criteria.

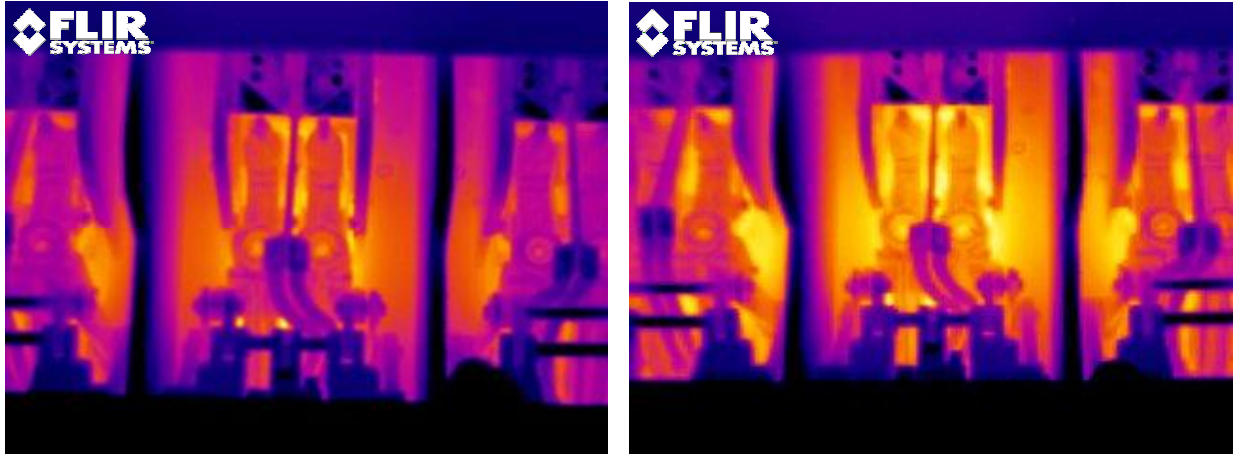
Figure 6. Medium resolution (left) and low resolution IR images of 480 volt generator tie-in breaker.
