Using IR Thermography as a Predictive Maintenance Tool in an Electronics Manufacturing Facility

Michael R. Montgomery
Level III Certified Infrared Thermographer

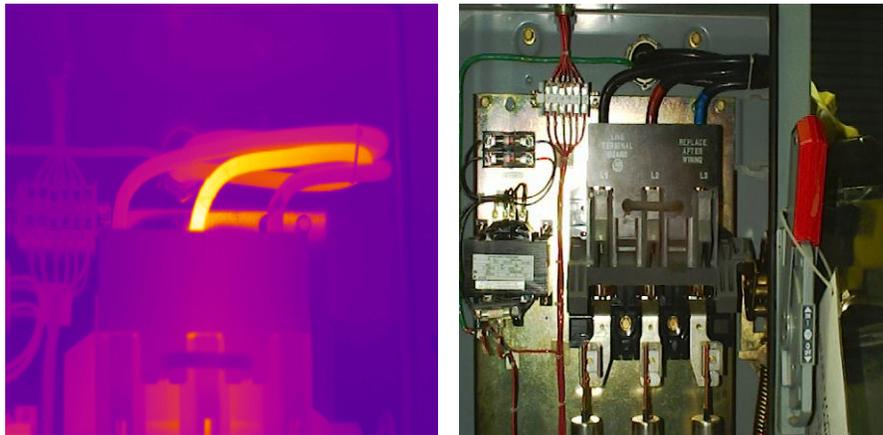
Chill Water Pump Disconnect / Starter

In this case, an anomaly has been found with the infrared camera. The infrared picture is recorded and a still photograph of the location of the anomaly is taken. A report is made and given to the Supervisor of the area where the potential problem was found. The Supervisor gives the report to the Electricians in the area for further investigation.

The Predictive tradesman opens the Maximo program and inputs a job called PM follow-up or PMF. The job fields are filled out from the PDM that was generated. A message is added to the PMF and the job is posted on the Maximo screen. This enables an area Electrician to be assigned on the Maximo screen to the PDM where a potential problem has been found. Thus, any follow-up work from PDMs can be tracked by the Maximo program. This includes the amount of time taken to complete the PMF, and any messages the area Electrician may record.

Once the PMF job is completed, the Predictive tradesman conducts another thermal inspection of the anomaly. A follow-up report is generated and given to the area Supervisor. This procedure is continued until the anomaly is no longer present.

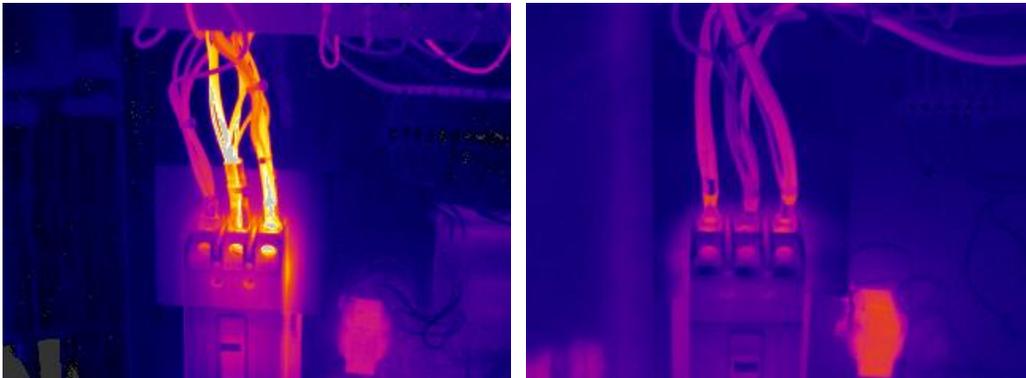
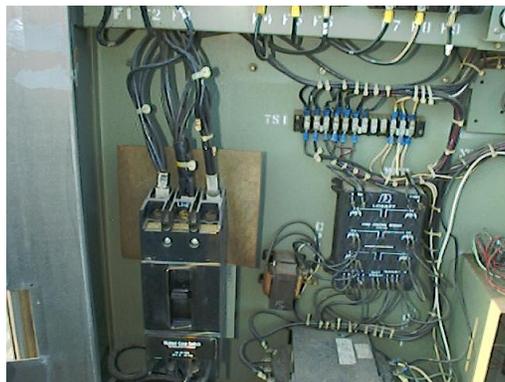
HVAC Main Circuit Breaker

Two of these anomalies were a loose connection and bad lug in the second phase and a loose connection in the third phase of the main breaker of an HVAC unit. This unit maintained a temperature of 68 degrees F in one of our Production departments. That temperature has to be constant to allow the ink paste in our Substrate Assembly lines to flow with the right consistency. The potential failure of the main breaker could have caused the HVAC unit to fail and therefore raise the temperature in the ink paste machine zone. This would have shut down all Substrate Assembly Production in that department.

The main breaker anomaly was repaired and another thermographic image was taken. The image showed no apparent anomaly.

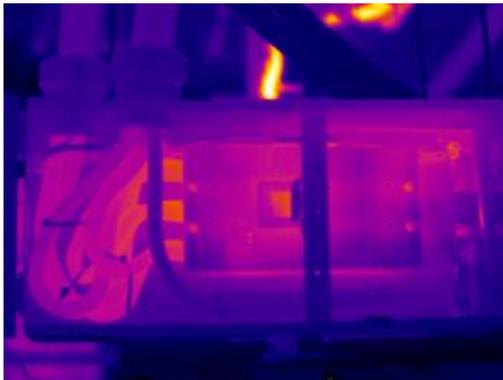
800 Amp Bus Duct Switch

Facilities can also be a top priority, if it is or will be affecting Production. Such as an 800 amp bus switch tripping out and shutting down production in our Integrated Circuit Silicone Wafer Fabrication facility.

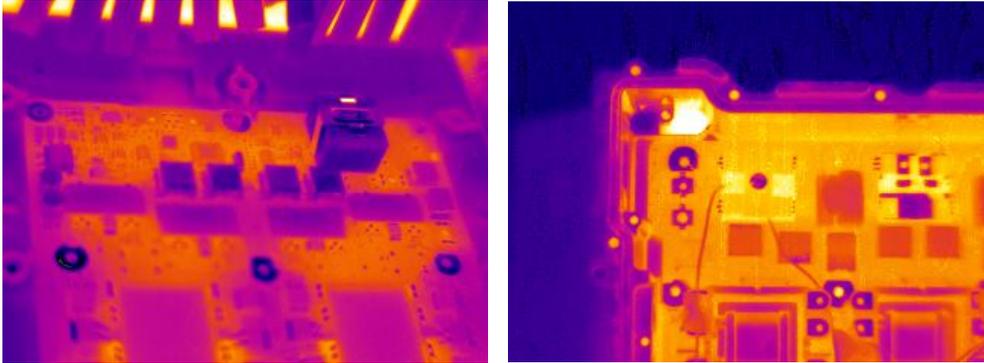
Engineering may have problems with circuit boards that are used in the assembly of a finished product or circuit boards used in Production equipment.

Infrared images used for troubleshooting circuit boards

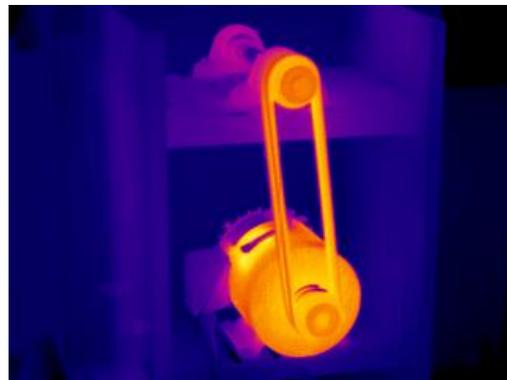
Exhaust Fan Assembly Motor

He asked if I could shoot the two-pulley fan assembly after the old belts were replaced. The infrared images revealed belts, pulleys, pillow block bearings and a motor that was apparently very warm.

We took infrared images from similar size exhaust fan assemblies. The other assemblies appeared considerably cooler.

apparent temperature of the components. The next day we contacted the Senior Facilities Plant Engineer for his advice. He took air movement readings at each piece of equipment that this exhaust fan was tied into. The results showed the fan was pulling more air than what was needed. The Facilities Electrician stated that this fan had been tripping breakers and blowing fuses. I measured the current with an Ampere meter. The motor was drawing 8.3 amperes at 480 volts.

Using a power transmission program, our Engineer determined the pulleys or sheaves were the wrong size. The current sheaves were too small and not a matched set. This sped up the fan and caused all the problems. The correct sheaves and belts were ordered. A larger driven sheave replaced a smaller sheave. The fan assembly now runs more efficiently.

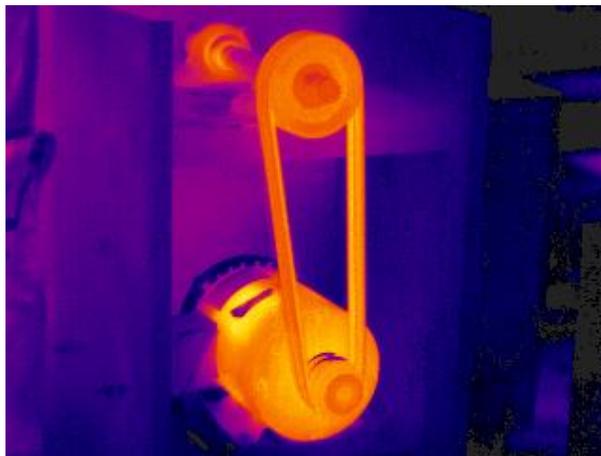
Fan motor with a larger driven sheave

The apparent temperatures were lowered by 50%. The motor current dropped from 8.3 amps to 3.6 amps and the energy usage was reduced by 53%. The electrical cost savings for this fan is \$1,744 a year. The infrared images show a much cooler motor, belts, sheaves, and pillow block bearings.

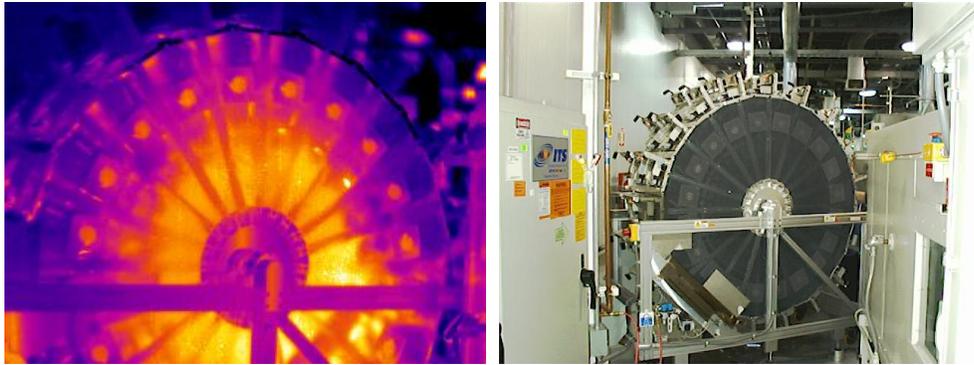
Product Conditioning Tester Wheel

This situation involved a product conditioning tester. The tester wheel is loaded with two products at a time, and is rotated up to load again. The tester simulates real condition power loads. The conditioner had a perforated covered side and a Plexiglas side when it was first installed. When the individual power conditioning units in the wheel began to fail due to too much heat in the interior, six inch muffin fans were added to both sides. The fans on the perforated side exhausted warm air; the fans on the other side drew in outside air. Later, the Plexiglas side was drilled with 1/4 inch holes for more air circulation. This dissipated some of the heat, but not enough of it. The power conditioning units were still failing, but at a slower rate.

The Maintenance Supervisor asked if we could get a thermographic image of the conditioning wheels. They wanted to see where the thermal energy or “heat” was concentrated. The image showed how many fans were still working and how the power conditioning units ramped up with energy as the testing wheel was rotated. Some thermal images were taken of these testing wheels for an Engineer assigned to this project. The latest solution was to use a portable A/C unit and duct the cooled air into the perforated side of the unit. The thermographic images show less thermal energy in the wheel since the A/C unit was ducted into the testing wheel. Holes were drilled to match the size of the A/C ductwork. Although I don’t have any statistical data for the failure rate, the Tradesmen and Supervisor have stated that the failure rate of the power conditioning units has notably declined. As of this paper, the Engineer has submitted a suggestion to have all fans exhausting the air from the interior.

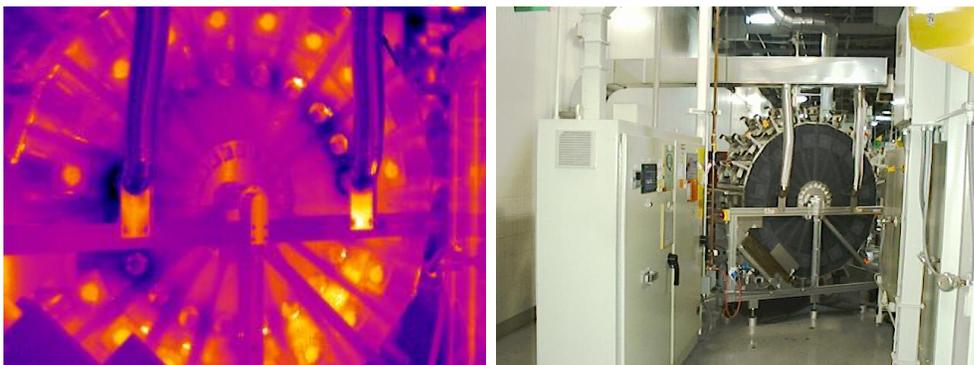
Wheel after A/C unit was added

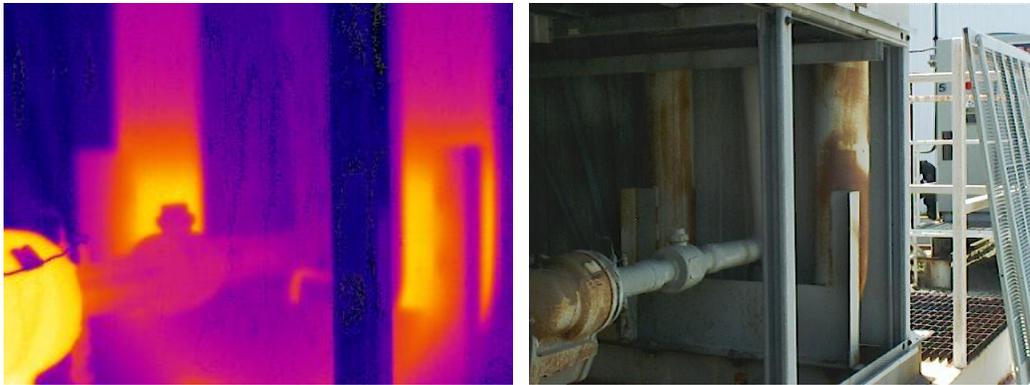
Compressor Oil Separation Tubes

There are two large industrial chillers that are located outside of our Predictive Technologies office. The Electrician assigned to monitor and maintain these units encountered a problem. He wanted to know if the problem was due to a low oil level. He asked if there was any way we could use the infrared camera to confirm that the oil level was indeed low. He had accompanied me on previous Facilities PDMs, so he was aware of the capabilities of the infrared camera. We proceeded to the chiller, took off the side panels and exposed the U-shaped compressor refrigerant oil separation tubes.

He started the chiller and let it run until the oil had risen in temperature. We waited until the upper piping had cooled. I took a thermographic image of the piping showing the warm oil settled to the bottom. The Electrician had marked the pipe for the normal operating level of the oil. Using his finger for a proper oil level indicator, I took another thermographic image to check the proper level. The oil was at the proper level. Not only was this a time saving tool, this also saved an additional labor call. Normally the Electrician would have had a Pipefitter to assist him. The Pipefitter would have had to remove two fittings and replace them with an oil level tube. The Pipefitter would then go through a procedure to determine the level of the oil. This procedure is spelled out in the Operating manual as the proper way to determine the correct oil level. This new method has been shared with other Facilities Electricians that work with A/C and chiller units.

Through the use of the infrared camera, the Electrician determined the oil pressure differential switch needed to be properly adjusted. Another cost avoidance application for the infrared camera.

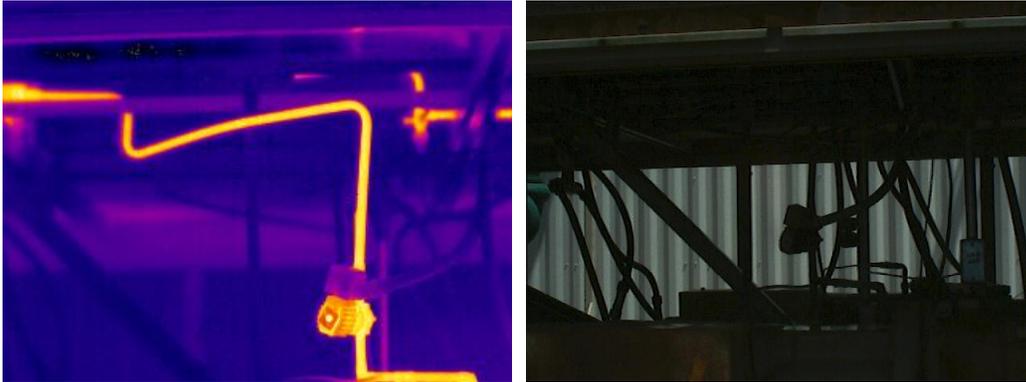
Compressor Oil Line Solenoid Valve

Four weeks later, the same Electrician came to me with a different problem on a chiller unit. This chiller had a low oil pressure alarm. He wanted to check the compressor oil line valve to make sure the solenoid valve was opening fully. He wanted to know if the thermographic image would capture the apparent temperature of both sides of the valve. The thermographic image confirmed the solenoid valve was working. The spot temperatures in the report indicated the same apparent temperature throughout both sides of the valve. This resulted in revealing a faulty oil pressure differential switch. Without the use of the infrared camera, the Electrician would have had to request a Pipefitter to disconnect the oil lines to determine if the valve was opening fully. As a result, we have used this method on other chillers with much success. Another cost avoidance application for the infrared camera.
