Applications of Infrared Thermography for Petrochemical Process Heaters

Robert K. Weigle
Level II Infraspection Institute
Certified Infrared Thermographer #6175
Jersey Infrared Consultants
PO Box 39
Burlington, NJ 08016
Tel: 609-386-1281
Fax: 609-387-4334

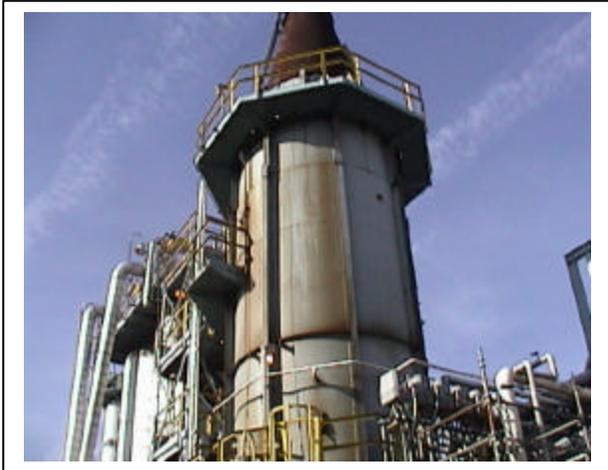
Typical Bottle Heater

Process heaters come in a variety of shapes, sizes and types. Two of the most common styles are the bottle and the box, or cabin. As indicated by the name, “bottle” heaters are circular, with overall diameters that normally range from 10 to 45 feet. The tubes normally run vertically and are located around the interior of the perimeter wall.

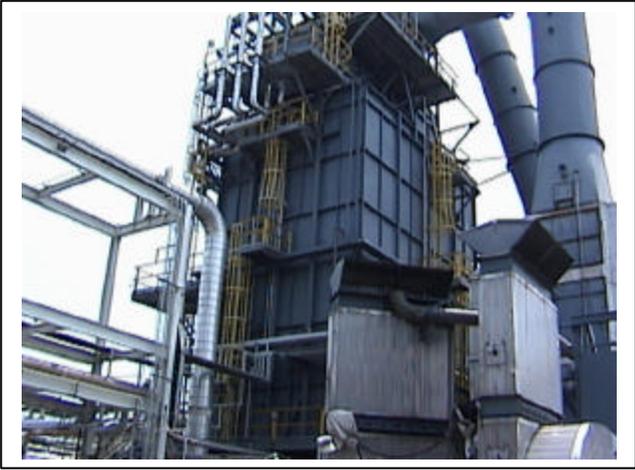
Typical Cabin Heater

Cabin style heaters can vary greatly in size, but have a rectangular footprint, and are generally at least as tall as they are wide. The tubes may run horizontally or vertically and generally are placed adjacent to the perimeter walls, floor and/or ceiling. It is also common in box (cabin) heaters to have tubes located away from the exterior walls.

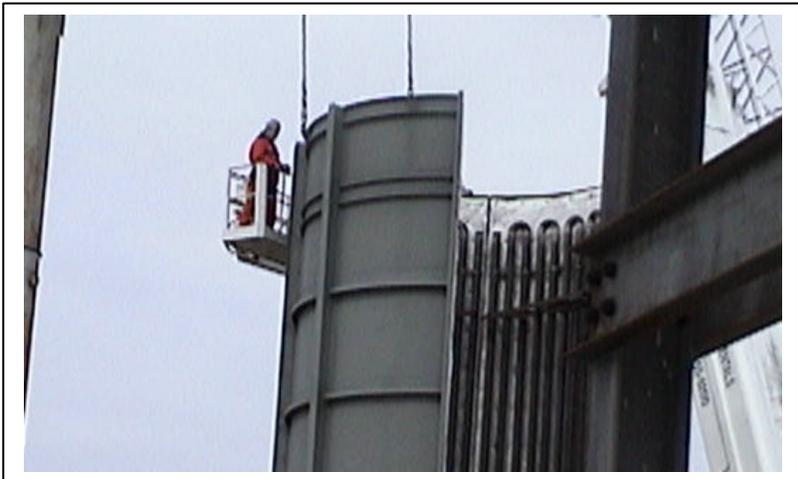
Internal Construction of Typical Bottle Heater

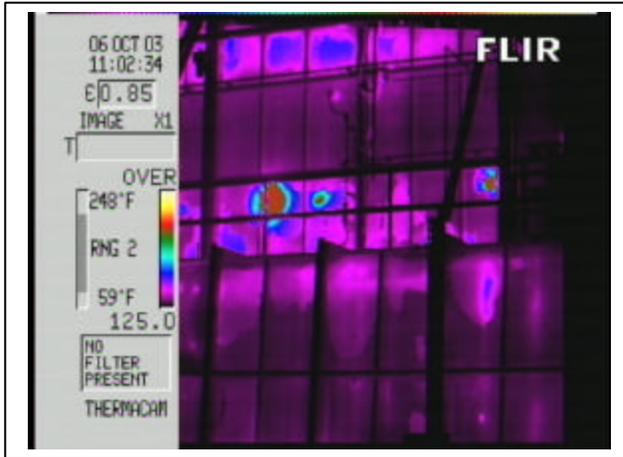
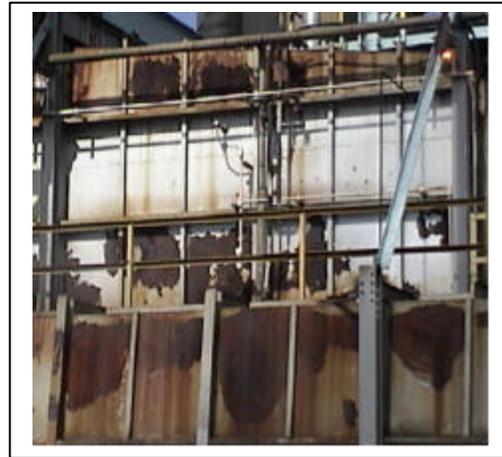
Thermal Image of Refractory Breakdown

Control Photo of Same Area

Another common problem associated with furnaces is refractory breakdown, which is the loss of the insulating layer directly inside the exterior metal of the furnace. This metal will suffer degradation if exposed directly to the temperatures present in the furnace. Over time it will weaken, corrode and eventually fail, causing breaches to develop in the exterior of the furnace. Since the initial breakdown in refractory causes a localized increase in the exterior temperature, regularly scheduled infrared inspections can detect and document these areas to pinpoint possible failure points before they actually become severe enough to affect operations.

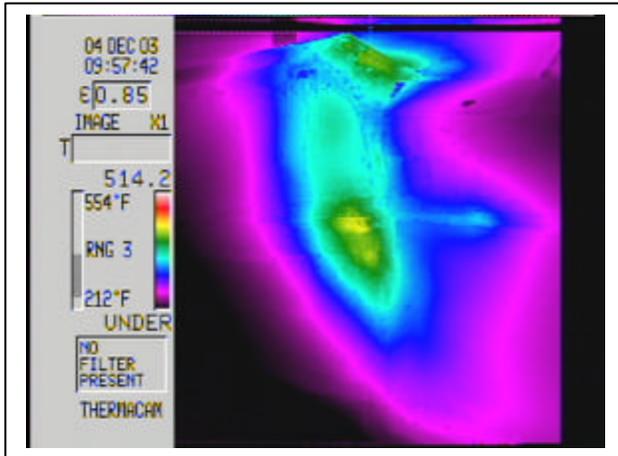
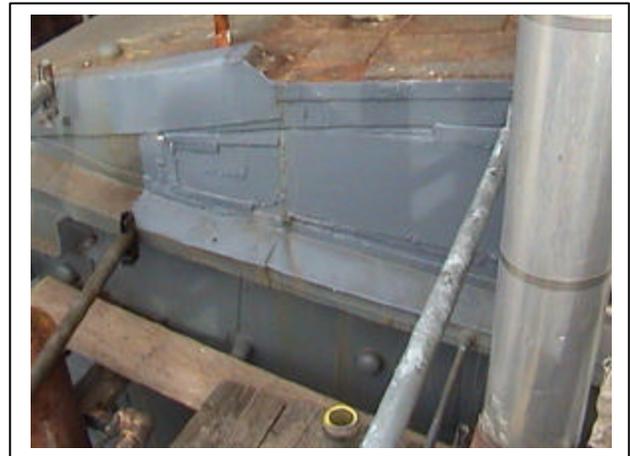
Thermal Image of Breach in Skin of Furnace

Control Photo of Same Area

External ruptures are another problem that can occur on the exterior of furnaces. They can come from a variety of sources, such as settling of the furnace, improper patching of the exterior, mechanical damage and refractory breakdown leading to high temperature spots on the exterior skin. These breaches interfere with the proper atmospheric conditions

inside the furnace, which are vital to its proper operation. The use of thermography can detect these areas with no need for endangering personnel with exposure to escaping hot gasses.

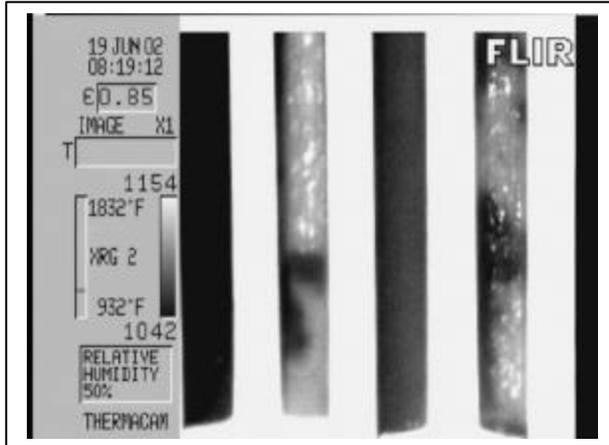
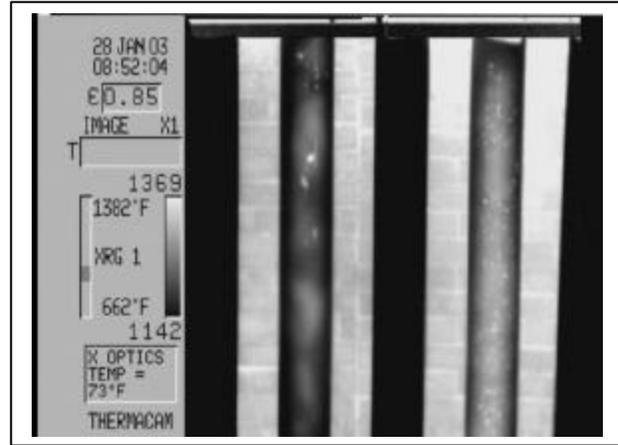
Typical Coking Pattern

Carbon, which is present in crude oil product, can settle on the inside of tube walls. These coke deposits reduce the internal diameter of the tubes, which results in decreased flow through the furnace. They also interfere with oil movement which results in a hotspot at the location of the coke deposit. These hotspots can be several hundred degrees hotter than the surrounding tube wall. Left untreated, these deposits can build up, causing a complete obstruction and subsequent melting of the affected tubes.

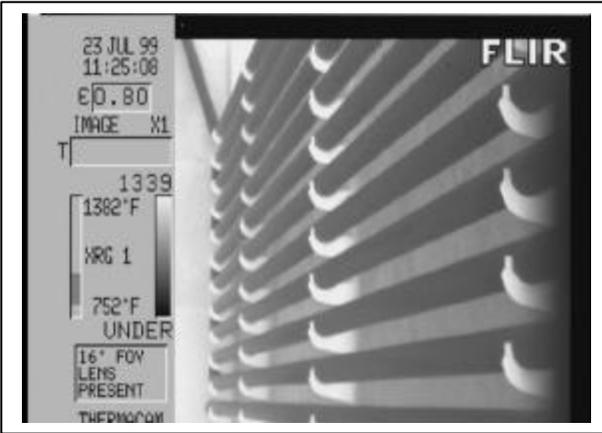
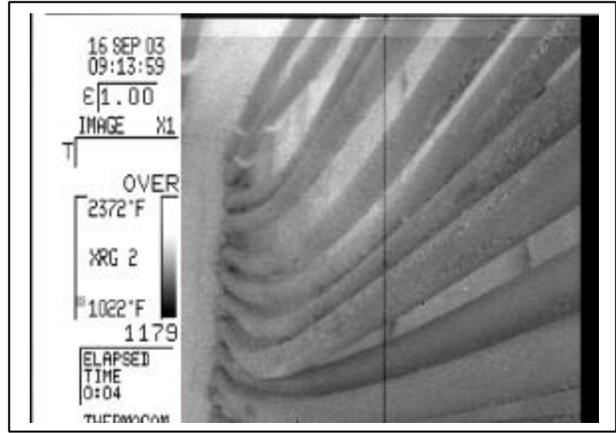
Typical Normal Tube Image

Typical Sagging Tube Image

Tube movement is another condition that is seen as a problem in heaters. Furnaces are built with enough tolerance to allow tubes to settle over time, so some shifting is expected to take place. Problems develop when there is excessive movement, which allows the metal of the tube to stretch. This stretching allows a change in the diameter of the tube or a change in the thickness of the tube's skin, which can cause weakening in the tube wall. Infrared thermography has been shown as a successful way to watch for and monitor tube movement. When thermal images of the subject tubes are taken from the same place and compared, over time, they allow for an accurate indication of movement over time.

Trigonometry, together with a known spot measurement size and precise distance to the target can be used calculate tube drift.

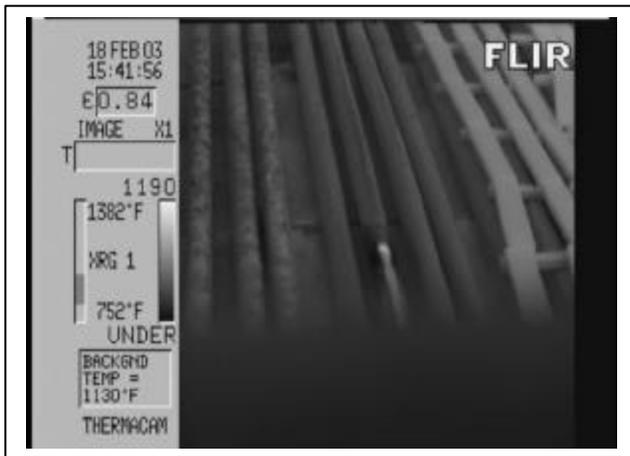
Thermal Image of a Small Product Leak

Individual tubes suffering mechanical or overheat damage can actually breach, which allows the ignition of the product stream that is vented into the interior of the furnace. If the leak is small and internal tube pressures are not affected much, a “pilot light” effect can happen. If the leak and pressure loss continue to increase, a catastrophic failure can occur. This generally leads to a loss of an entire furnace, which can lead to substantial down time.

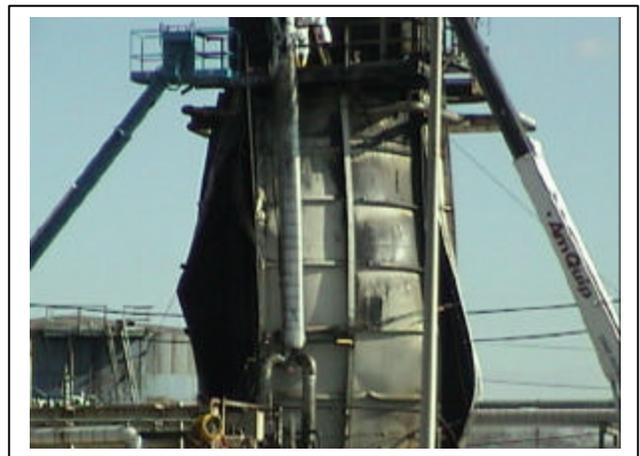
Photo of a Failed Furnace

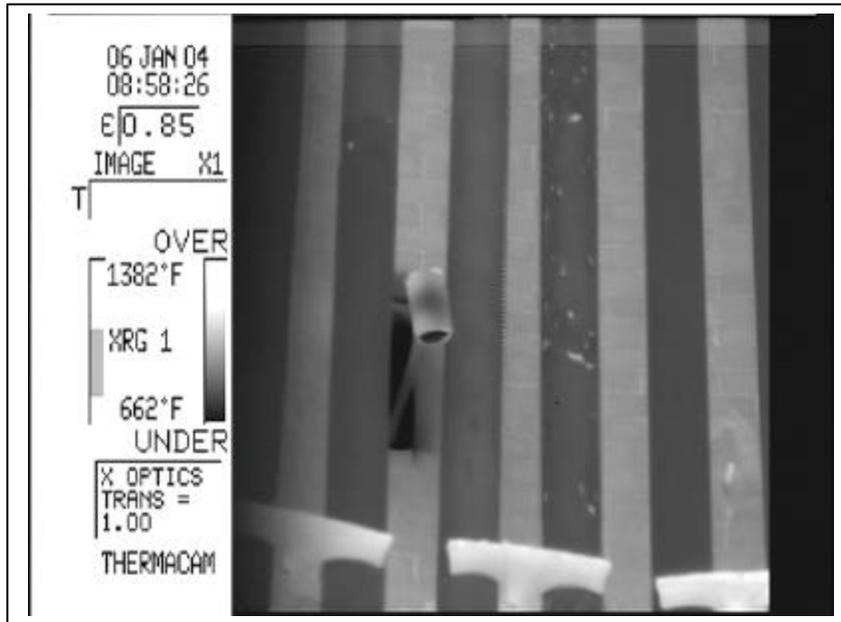
Thermal Image of a Coupon

Verification of accurate temperature data can be achieved with the use of a coupon. This coupon should be composed of a piece of the same material used in the construction of the tubes. It should be air-cooled and placed into the furnace to about the same depth as the subject tubes and maintained at a temperature close to that of the subject heater tubes. It should then be imaged as the other tubes are with all the variables accounted for. Thermocouples mounted on the back of the coupon allow for confirmation of accurate numbers.
