# **The Use of Infrared Thermography for Steel Process Development & Monitoring**

**Presented at IR/INFO 2003  
January 12 - 15  
Orlando, Florida**

**Authored By:  
Kenneth J. Roush  
Level III Certified Thermographer**

**The Timken Company  
Canton, Ohio**

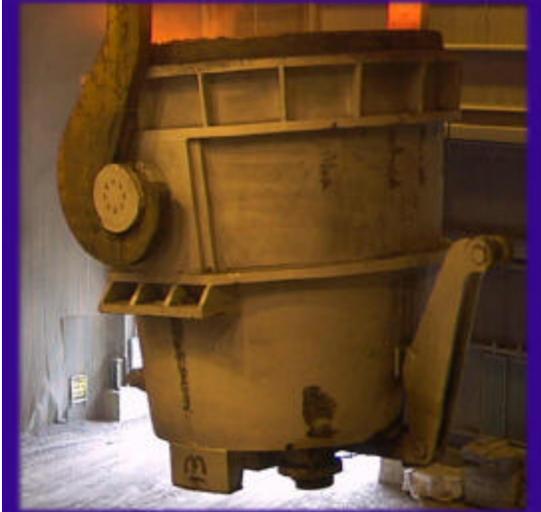
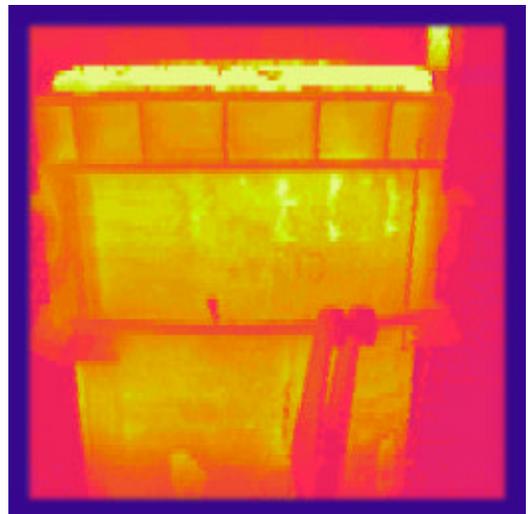
be beneficial to the melt shop by viewing full ladles of molten steel. Once the scrap metal is melted in a melt furnace, the molten steel is poured into a large (175-ton ) ladle for transfer to the next operation. It is at this point, that the exterior of the ladle is scanned with an infrared camera. A ladle of hot molten steel ( 3100 deg. F) can go in a number of directions in the plant. With infrared, the exterior shell of the ladle can be scanned for possible “hot spots”. If the interior of the ladle, or brick lining, is worn or cracked, the molten steel can penetrate to the outside shell and burn through. Needless to say, this could be disastrous to nearby personnel and

Having mentioned the safety aspect of viewing hot molten steel ladles, there is another benefit that can be realized by using infrared technology. After continuous viewing of the ladles over a period of time, the true life of the lining can be determined. At the present time, a ladle will see approximately (6) heats of steel in a 24-hour period. Before the use of infrared, a ladle would be scheduled for a re-line, with new brick, after about 35 to 40 heats. By continuously monitoring the ladle with infrared, the need to re-line a ladle may be extended past the 40-heat limit. If no exterior “hot spots” are being detected, the ladle can remain in service. With less re-lining required to maintain the safe operation of the ladle, large cost savings can be realized. The infrared image, shown at the right, was taken approximately ten minutes after the molten steel was poured into the ladle. This image shows some interior damage to the ladle lining, and is in need of a re-line real soon. The exterior surface is indicating “hot spots” around the middle area of the ladle. At this point, this is not a safe ladle to be using in the plant.

equipment. By detecting these “hot spots” early in the process, accidents can be avoided. The ladle can be diverted to a safe area and re-ladled into another ladle for transfer. Injury to personnel and equipment damage is avoided. The safety issue alone, is enough to justify the use of infrared imaging. If a ladle of steel is lost due to a breakout, the cost of that heat could run approximately \$70,000.00 in lost finished product value. Equipment loss, near the breakout, could also run into the thousands of dollars. One breakout could cost a company well over the cost of an infrared camera that would help prevent such an incident.

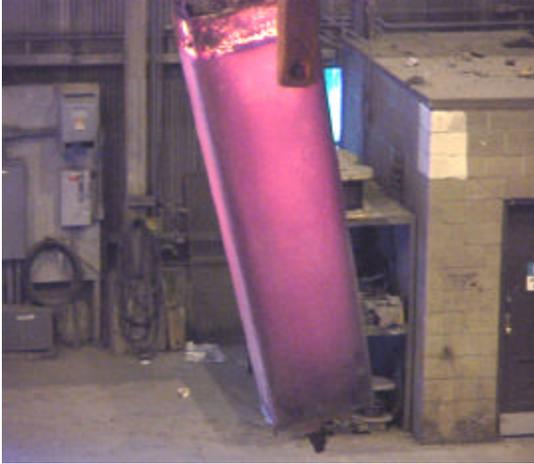
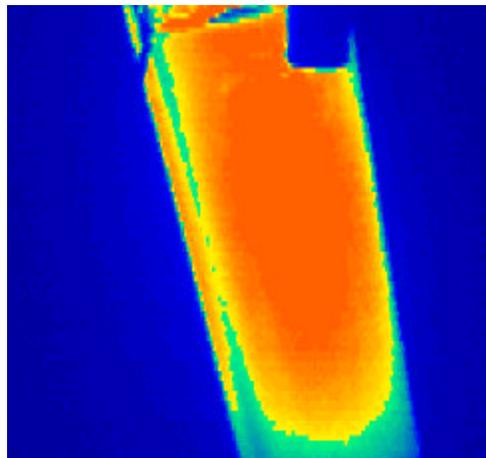
furthered processed into bars by a rolling process. A single heat of steel can produce 24 ingots like the one shown in the image at the left. Each one of these ingots weighs approximately 13,750 lbs. It is at this point that infrared imaging can be used to scan the surface. It is important that the entire ingot be as close to uniform temperature as possible. These ingots need to be rolled at a pre-determined temperature in order for the proper dimensions to be maintained. The more evenly heated, prior to rolling, the better the finished product will be. Here again, the use of infrared is very beneficial.

By scanning the exterior surface of the ingot, just prior to the rolling process, will indicate how well and how evenly the ingot was pre-heated. The ingots are actually held in a heated bunker until its time for processing. These bunkers must maintain even heating of the ingots. A scan of the ingot will indicate any areas that are cool and may cause improper rolling into bars. When improper heating occurs, the heating zones in the bunkers may need adjustments to increase the temperature in one or more areas. If the infrared scans continue to show uneven heating, a re-design of the bunker may also be required. The molds that are used to produce the ingots may also need re-designed. By going back one step in the process, it may be seen that too much heat is being lost after the molten steel is poured into the mold. By thickening up the corners and walls of the mold, the problem of lost heat is greatly reduced. An infrared scan of the surface of the mold will indicate any areas that are losing heat. Once the heat loss is minimized, a constant monitoring of the ingots will prevent further rolling problems due to heat loss. An infrared image of an ingot, that is ready for processing, is shown below. There are some cooler areas near the corners, but generally, the ingot is fairly evenly heated. The molds and the heated bunkers are doing a good job maintaining an even temperature across the ingot surface.

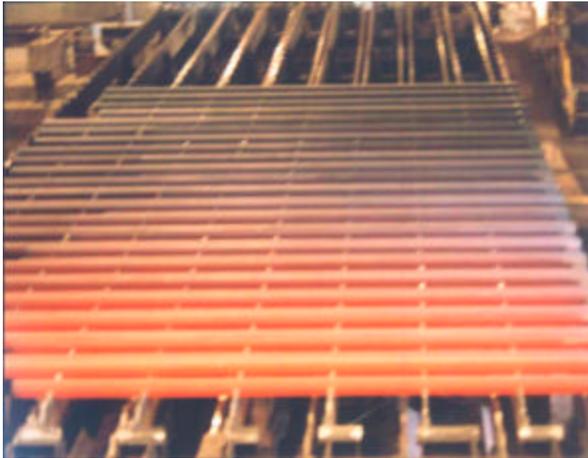
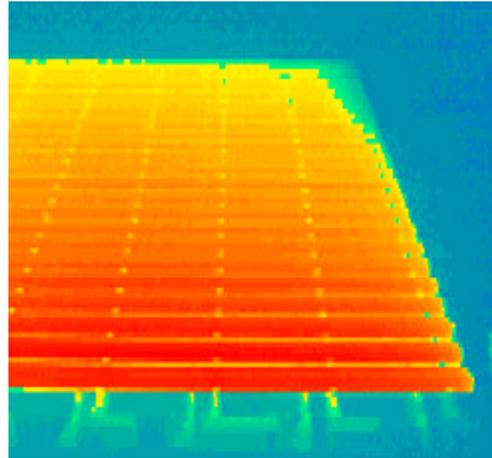
A major step in the production of steel bars, is the cooling process. Once the steel has made it to this point, the need to control the cooling process is very critical. Many of the steel properties are obtained during this stage of processing. Cooling rates must be developed in order to supply the customers with the exact steel properties that best suit their needs. To do this, the cooling process must be controlled by either slowing down or speeding up the cooling rate. There are a number of ways to accomplish this. The speed of the walking beam bed can be adjusted to move the steel slower or faster as needed. Air fans can also be used to blow cool air across the bed for faster cooling. Another technique that is used to cool the bars, is the spraying of a water mist over the entire surface of the bars. All these cooling methods can be manipulated to achieve the desired cooling rate. With the use of infrared imaging, the cooling process can be easily monitored. As can be seen in the above infrared image, the steel bars start out hot, at the bottom of the image, and slowly cool as they progress along the cooling bed toward the top of the image. At any point during the cooling process, a temperature profile can be obtained across the length of the bar to determine its temperature. Adjustments can then be made as to increasing the cooling rate or decreasing the cooling rate. Many heating and cooling processes have been established with the use of infrared technology. By storing the infrared imaging process on videotape, all newly developed heating or cooling processes can be kept for years and re-studied if needed at any time. All the temperature data is preserved along with all the images.

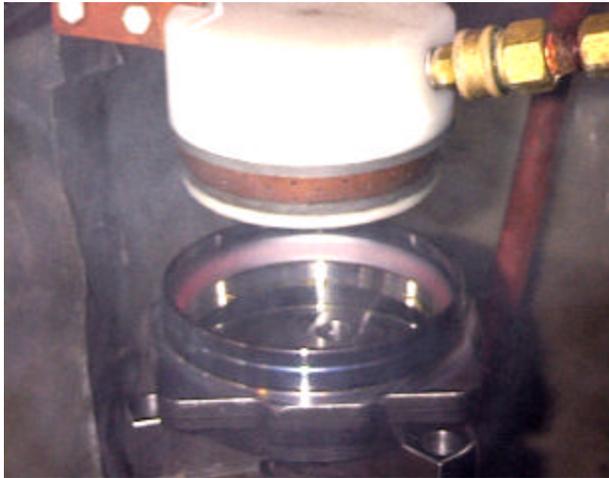
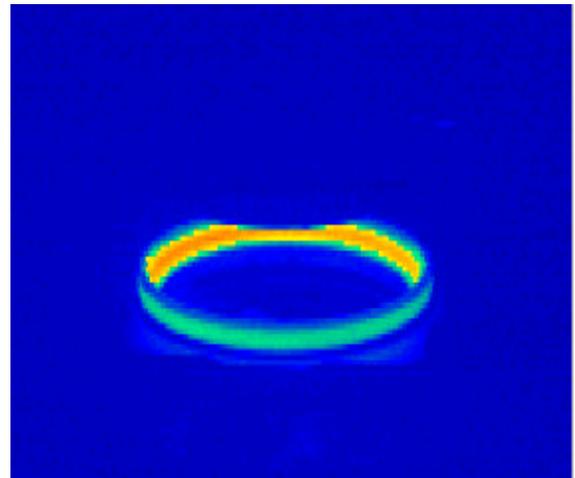
Induction heating and quenching are other processes that take place in a steel mill quite often. In this case, a steel bearing cup is being inductively heated to a temperature of approximately 1600 deg. F than quenched to achieve a certain hardness level. The following images show the cup just after it was inductively heated and the resulting infrared thermal image to the right. It can be seen in the infrared image that the inner

raceway of the bearing cup is receiving the majority of the induction heating. This is the area of the cup that will see the most wear and require the best hardening properties. The induction heating takes place fairly quickly and the duration of the quench is what dictates the development of the steel properties. In order to meet our customer's specifications, the proper steel properties must be correct. The above bearing cup is used on cars and trucks and will be fitted with a sensor pack that controls anti-lock brakes. This application warrants good quality parts for safety. Any deviation in the customer's specifications could have devastating results.

Here again, the use of infrared imaging can be used to check or monitor the induction process. With infrared, it can be determined if the process is heating the product to the proper level and how evenly this is taking place. The quench operation can also be monitored. Although not shown, another infrared image could be taken to show the amount of cooling that is taking place. From these images, adjustments can be made to the entire process to insure proper heating and cooling of these bearing cups. There are other induction heaters throughout the steel plant. A steel tube may need to be re-heated during a longer processing cycle to maintain its proper processing temperature. This tube can be passed through a heating coil to raise the temperature. An infrared image can be taken of this tube entering and exiting the coil. The picture below shows a hot tube entering and exiting the coil from the right. It can then be determined if the exit temperature is correct. Sometimes, correction to the coil power is required to increase the temperature. Once again, proper heating cycles can be monitored to insure accurate steel properties. The use of infrared thermography is very beneficial to controlling any heating or cooling cycle.

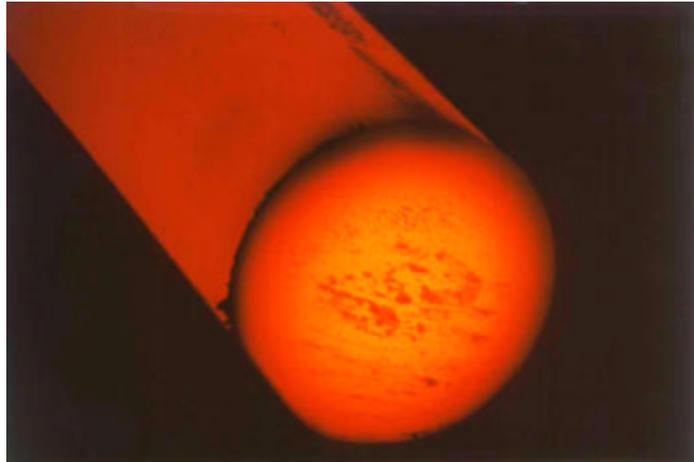
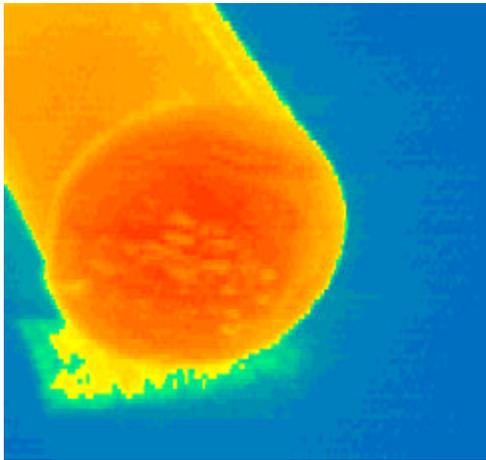
temperature can have bad effects on its internal properties. Therefore, with the use of infrared, the core temperature can be acquired very easily. The bar above has been cut, and an infrared image has been taken. A temperature profile across the bar will indicate

how well the bar was heated and a maximum core temperature will be recorded. The difference between the core temperature and the surface temperature can be established. With this data, the core temperature can be calculated at any point in the cooling process just by knowing the surface temperature. This information is very beneficial because you can now control the proper heating or cooling cycle.

Sometimes it is beneficial to take a bar and actually cut it to view the interior. One reason for this would be to verify that the bar is evenly heated and to determine the actual core temperature. Images captured by an infrared camera only capture the radiated temperature of the surface of the bar. But, in the steel industry, it is necessary to know what the core temperature is. A bar that is processed at the wrong

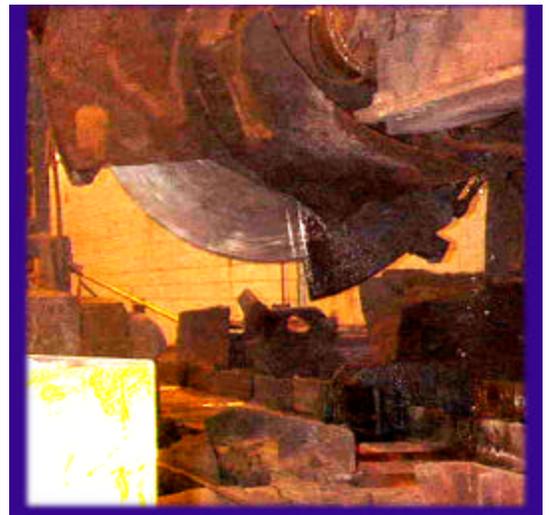
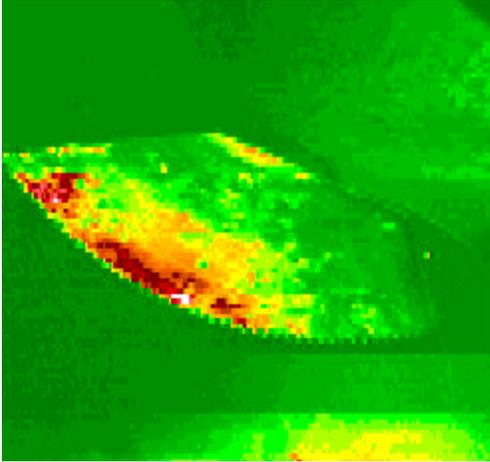
Shown to the right, is a picture of one of many steel cut-off saws that are located throughout the various plants. These saws are used to cut long lengths of steel product down to smaller sizes as it makes it way to the completion of the process. The need for small test samples are also required, and cut by these saws. Needless to say, the plant saws are used extensively and are very expensive to replace. An average saw blade could run approximately \$500.00 each. It is critical to try to extend the life of these blades as much as possible. In the image to the right, the saw blade is exposed from beneath its housing. This is the

area that does all the work and needs cooling water to prevent the blade from overheating. Infrared imaging was used to determine how hot the saw blades were actually getting. It is important that the blade be kept as cool as possible. A blade that is continually exposed to high temperatures will have a much shorter life. The infrared image, at left, was acquired just after the completion of a saw cut. Numerous tests were run to get a good average temperature of the saw blade near the teeth area. As can be seen, the hottest (red color) area is right at the critical teeth cutting area. With

the use of infrared imaging, adjustments were made to the cooling water supply system. A different type of coolant was used as well as repositioning of the water lines that supplied water to the blade. These changes lowered the blade temperature and increased blade life significantly. The cost savings for the company was well worth the effort of an infrared scan.

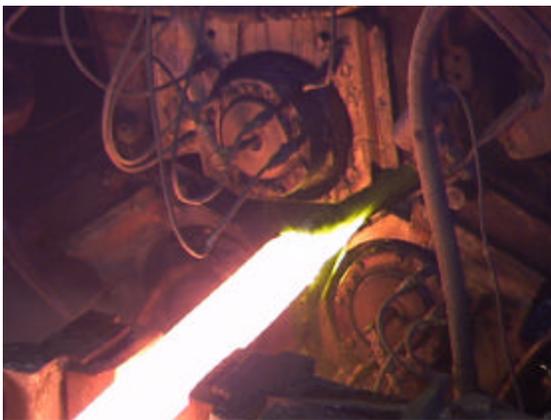
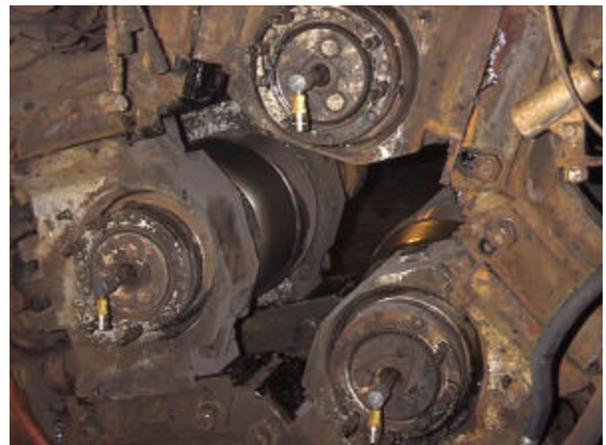
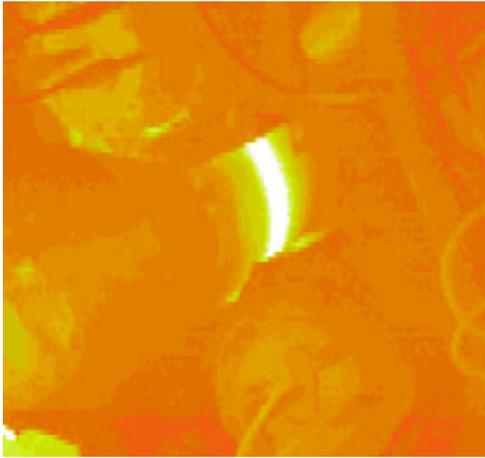
generation of heat. Here again, as it was with the cutoff blades, it is important to keep the rolls as cool as possible. The image to the left shows a hot tube entering the process rolls on a reducing mill. The temperature of the steel at this point is approximately 1650 deg. F. The image at

the right shows the same rolls after the passing of the steel tube. The outer surfaces of the rolls are continually exposed to high temperatures. These temperatures, if high enough, will cause cracking on the surface of the rolls. Once this cracking has taken place, the rolls will actually transfer the crack pattern to the steel being processed by the rolls. These crack patterns are then rolled into the surface of the steel later on in subsequent processing. The rolls must then be turned on a lathe to remove the

life of these processing rolls, it is necessary to try to keep the roll temperatures at a level that will not create cracking at the surface to surface contact area. At left, an infrared image is shown of the roll surface that has been heated due to the processing of the steel. This heating is happening on all three process rolls in this equipment. The amount of heating is recorded with an infrared camera. If the temperature is determined excessive, it will be necessary for additional water to be supplied to this area of the rolls. The temperature must be lowered in order for surface cracking to be controlled. Once this has been achieved, greater cost savings can be

crack defects. There is a point where the rolls can no longer be repaired and must be replaced. With a large steel mill, the cost could be very high. In order to try to extend the

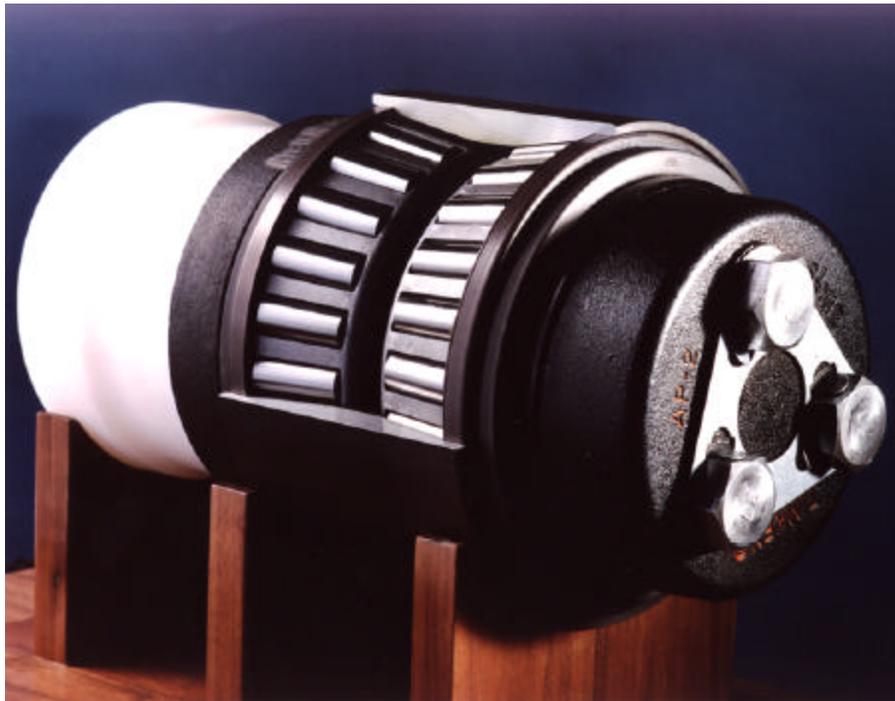
Pictured above is the Timken Company AP-2 Railroad Bearing. This bearing is used very extensively by the railroad industry on all types of rail cars. The AP (all-purpose) bearing was introduced to the market in 1954. The main attraction of this bearing was the fact that it permitted a simple conversion of existing railroad axles from plain bearings to tapered roller bearings. In the year 1958, it was determined that the AP bearing brought

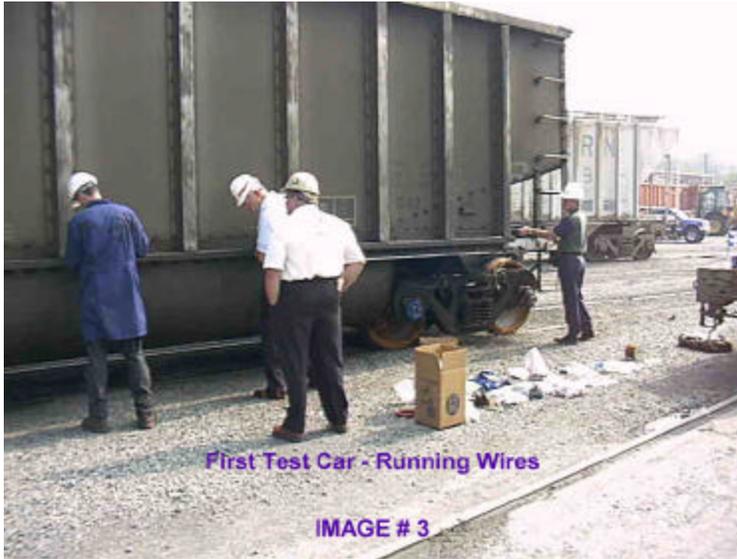
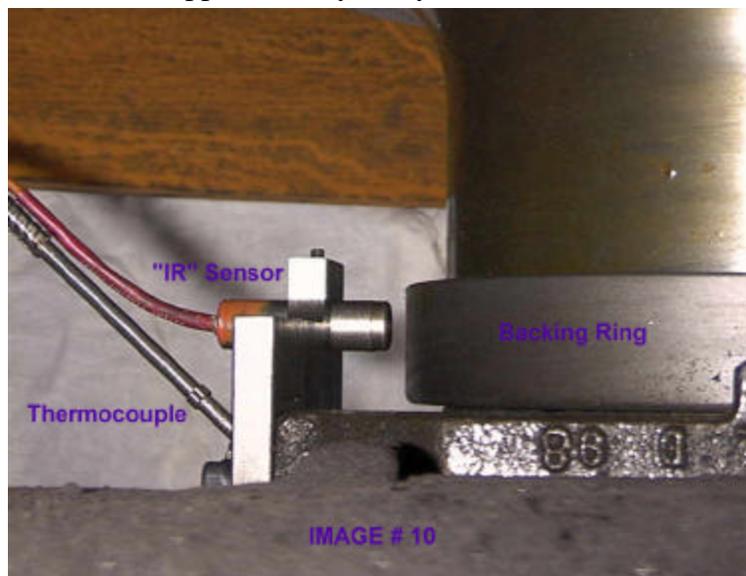
annual savings to the railroad industry of about \$288 million. In 1998, the AP bearing was subject to a temperature comparison test by a competitor. A large share of the railroad market was at stake. The test was set up to compare the heat being generated in the AP bearing vs. the heat being generated in a competitor's bearing during actual railcar operations. "Rail Side Detectors" or "Hotboxes" were also used as a temperature comparison tool. A rail car was wired (see below) with infrared sensors on all eight

wheels of the car. Four of the wheels had been fitted with the AP bearings; four of the wheels were fitted with competitor's bearings. The IR sensors were placed in a position that detected the temperature of the bearing back plate. This was determined to be the best location to compare bearing temperatures. This is also the location on the bearing that the Hotboxes see as the train is moving

along the track. The image below shows the sensors as they were mounted on a bracket near the bearing back plate. Each one of these sensors will constantly read the bearing temperature during movement of the rail car. All the temperature data is stored in a data box onboard the train car for later analysis. As previously mentioned, the rail car passes over "Rail Side Detectors" or , "Hotboxes" approximately every 10 to 12 miles. These boxes also read the temperature of the bearings on each wheel of the car. These temperatures were also compared with the IR sensor readings. In the first image on the next page, you can see the location of a "hotbox" as it is installed near the tracks. The train passes over it and a temperature is sensed. A more close-up look can be seen in the next image. This shows the lens in the "hotbox" which opens and

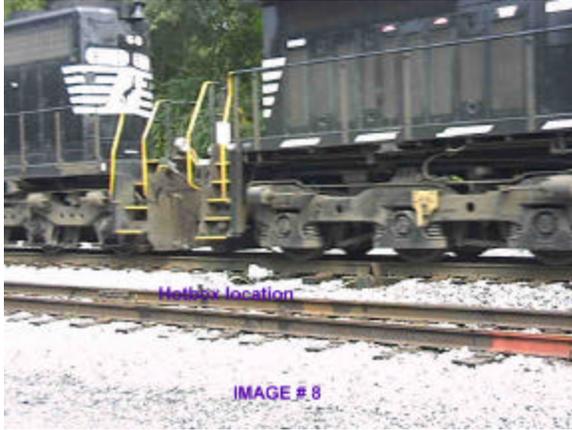
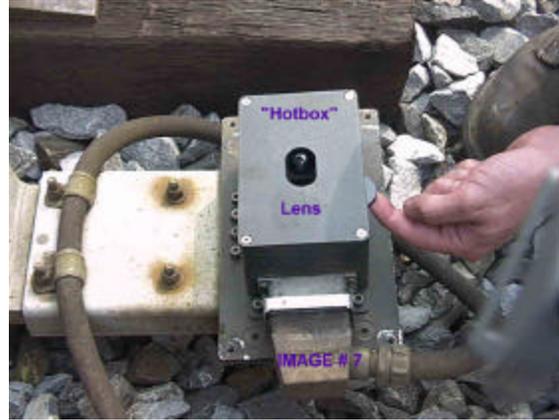
closes as the wheels pass by. The cost of these “hotboxes” run approximately \$8,000 each. The main goal is to sense the temperature of the bearings and pass the information on to railroad controllers.
