Detecting Contamination and Preventing Insulator Flashovers: Why UV Imaging Is a Critical Tool for Utilities

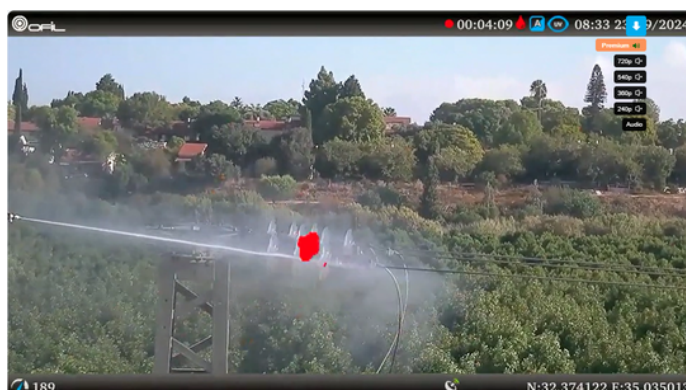
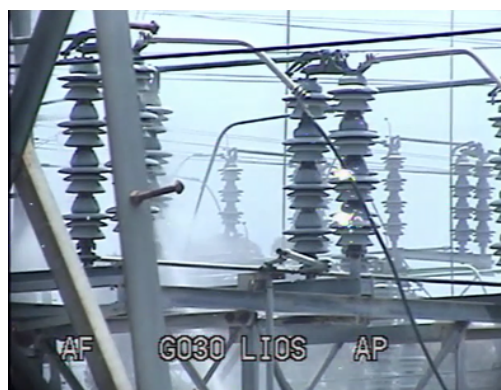
Before washing, UV imaging helps identify the specific contaminated areas, allowing maintenance teams to focus only on the affected zones rather than the entire installation. During washing, it enables real-time monitoring to ensure that discharges are being eliminated as cleaning progresses. After washing, UV inspection verifies that all contamination has been successfully removed and no corona activity remains.
