# Applications of sUAV's (Drones) for Marine Surveying

John (Jack) N. Allinson, II AMS  
Level III Certified Infrared Thermographer

Charles Hazouri, CMS  
Level III Certified Infrared Thermographer

Allinson Infrared Inspection Services, Inc.  
222 University Blvd. North #2  
Jacksonville, FL 32211

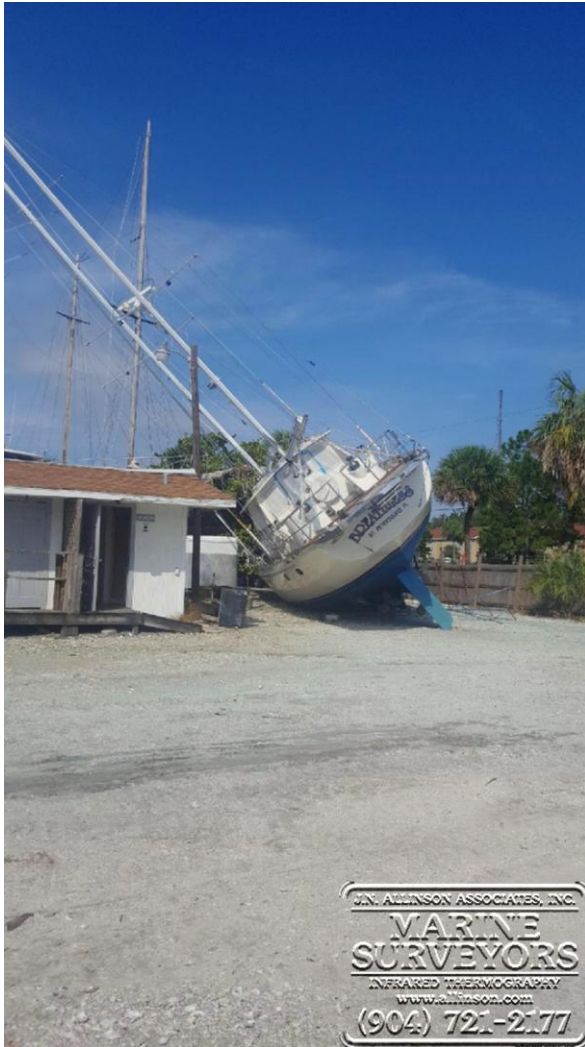
**Figure 1. Damage claim**

During a named storm event this sailboat rolled off its supporting stands onto its PORT (left) side. The hull sides were composed of a composite laminate sandwich consisting of an outer skin of fiberglass laminate, a low-density foam core and an inner skin of fiberglass laminate. J.N. Allinson Associates, Inc. was retained to do an Infrared Thermal imaging study to determine whether there was evidence of possible “core shear” between the outer skin and low-density foam core.

**Figure 10.** Example of a result of the Infrared Thermal imaging study. Here a thermal anomaly was discovered and “core shear” is being proven by percussion sounding with a phenolic hammer. The next step will be destructive testing to examine the bond between the outer skin and the low-density foam core. This area of the hull came in contact with the ground when the vessel rolled onto its PORT side (see Figure 1.)

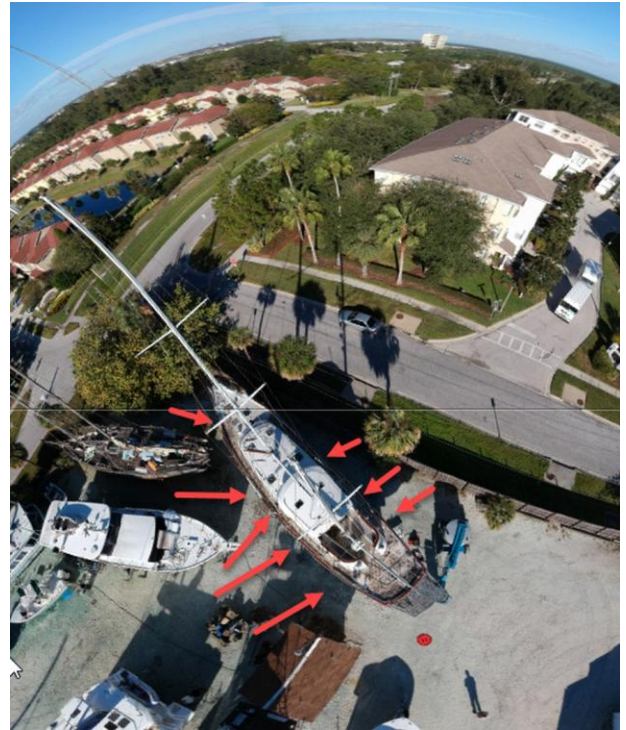
**Figure 2. Aerial view**

Taken with DJI SPARK drone using its panoramic feature that automatically orients the drone and camera to take forty-six (46) photos which are stitched together to create a 360-degree panoramic view. This stitched image was created from photos that were taken while the drone was approximately two hundred (200) feet above the ground. Red arrows have been added to the image to illustrate where the infrared thermal imager was positioned when taking images.

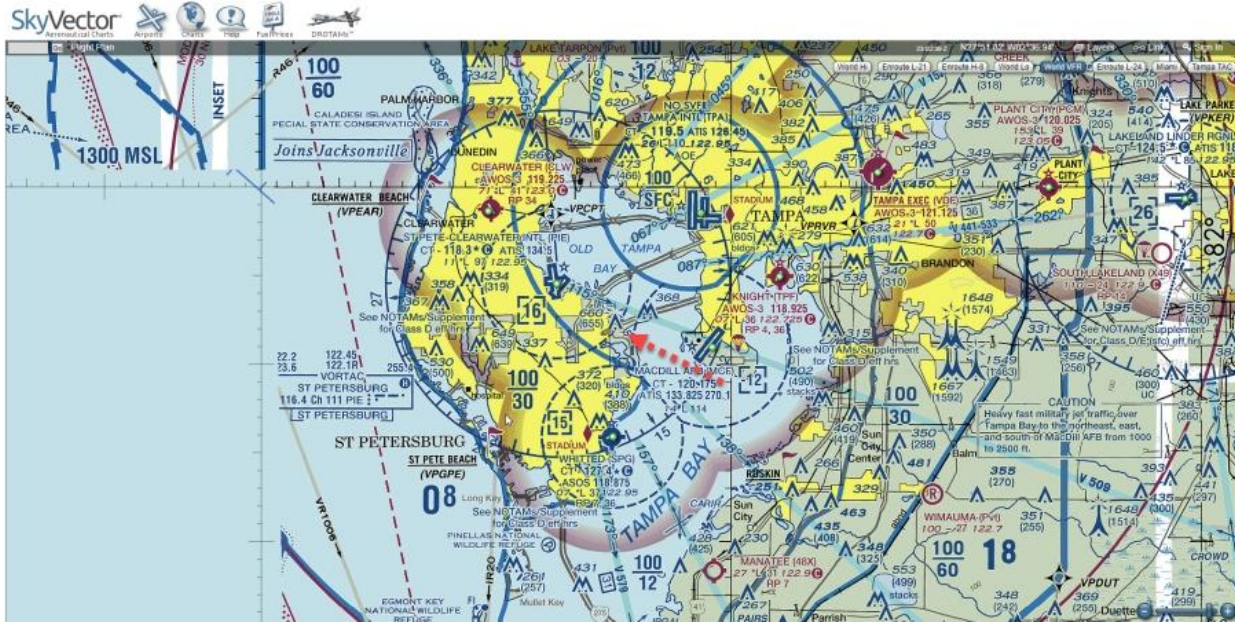
**Figure 5.** Aeronautical chart from SkyVector shows details of restricted areas that surround the study location. The red arrow in this image marks study location which falls outside of restricted areas.

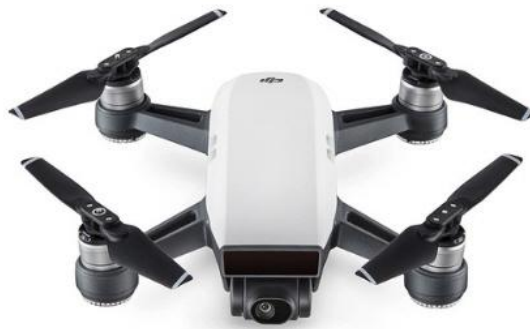
**DJI SPARK**

For this study the DJI SPARK was the drone of choice. Of the three drones, this one had the smallest footprint 143 x 143 x 55 mm and is less disruptive to yard workers. It has a 1/2.3" CMOS sensor that captures a 12 MP effective pixel image in a 3968 x 2976 image size. Video records a Full High Definition (FHD) at 1920 x 1080 image size at 30 frames per second which will capture the surrounding "normal paced movements" quite well and in a natural way.

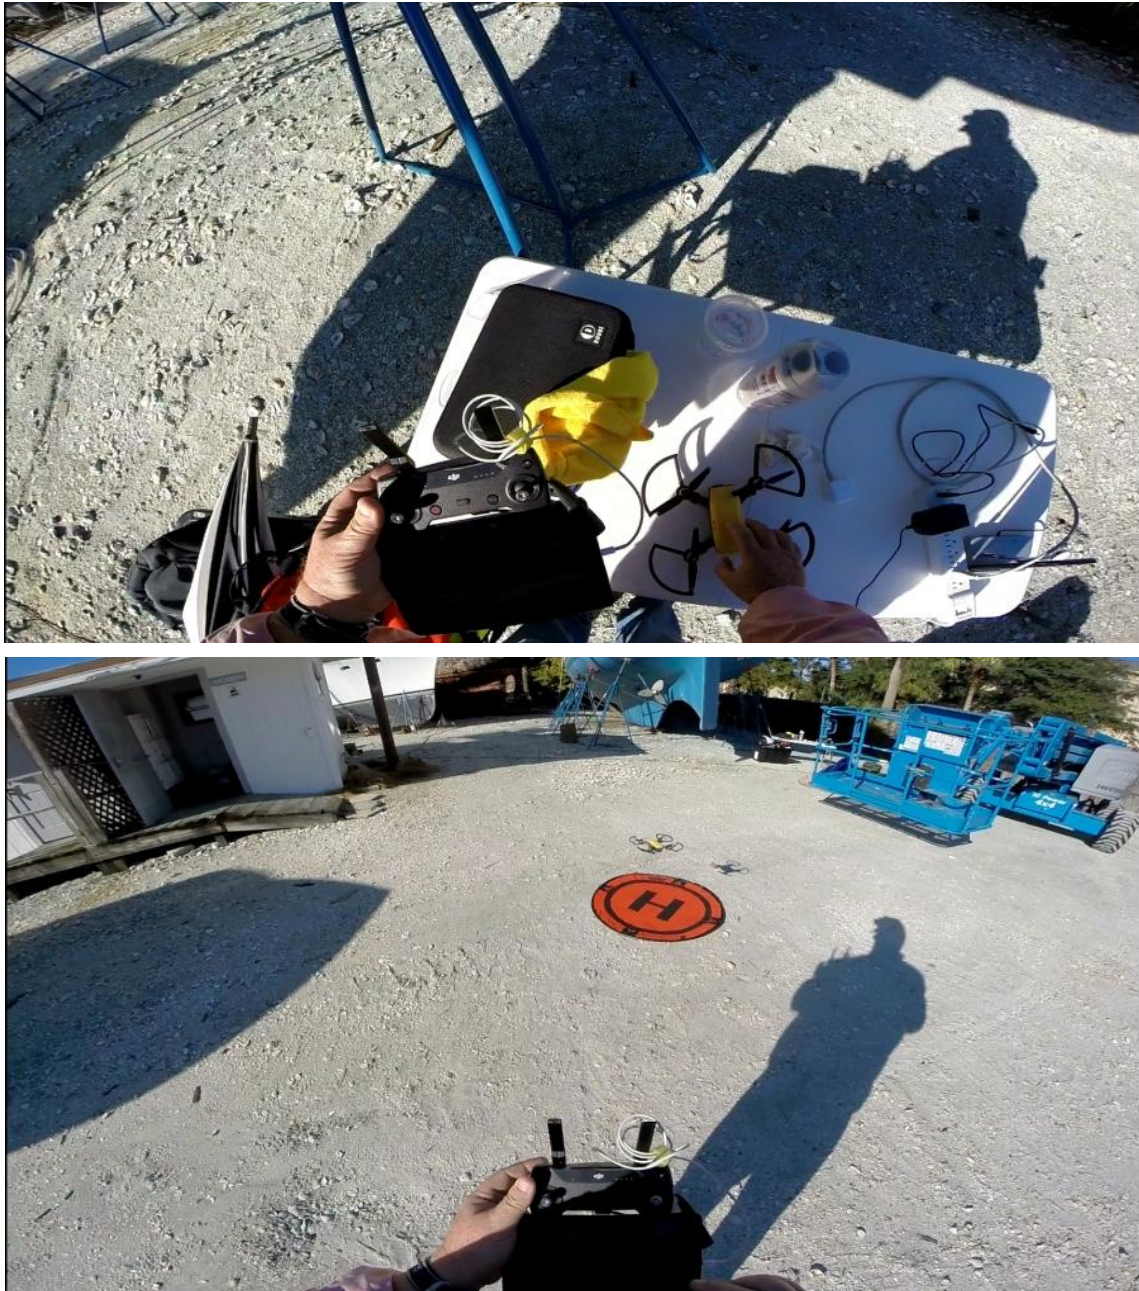
**Figure 8.** Drone size 143 x 143 x 55 mm (6" x 6" x 2") or slightly larger than Jack's hand (top photo). This SPARK was colored bright sunrise yellow for visibility and equipped with black propeller guards as a safety precaution.

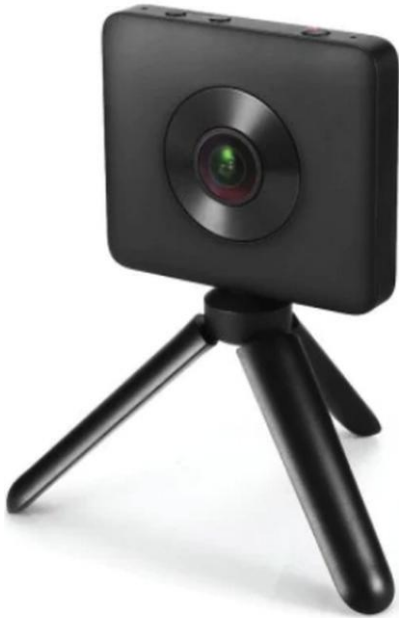
**Xiaomi Mijia Mi Sphere 360**

A camera normally has a field of view (FOV) that ranges from a few degrees to, at most, 180°. This means that the camera captures, at most, light falling onto the camera focal point through a hemisphere. In contrast, an ideal omnidirectional camera captures light from all directions falling onto the focal point, covering a full sphere. Jack uses cameras that have two (2) one hundred eighty 180° FOV images. These images are stitched together to create a Three Hundred Sixty 360° FOV image.

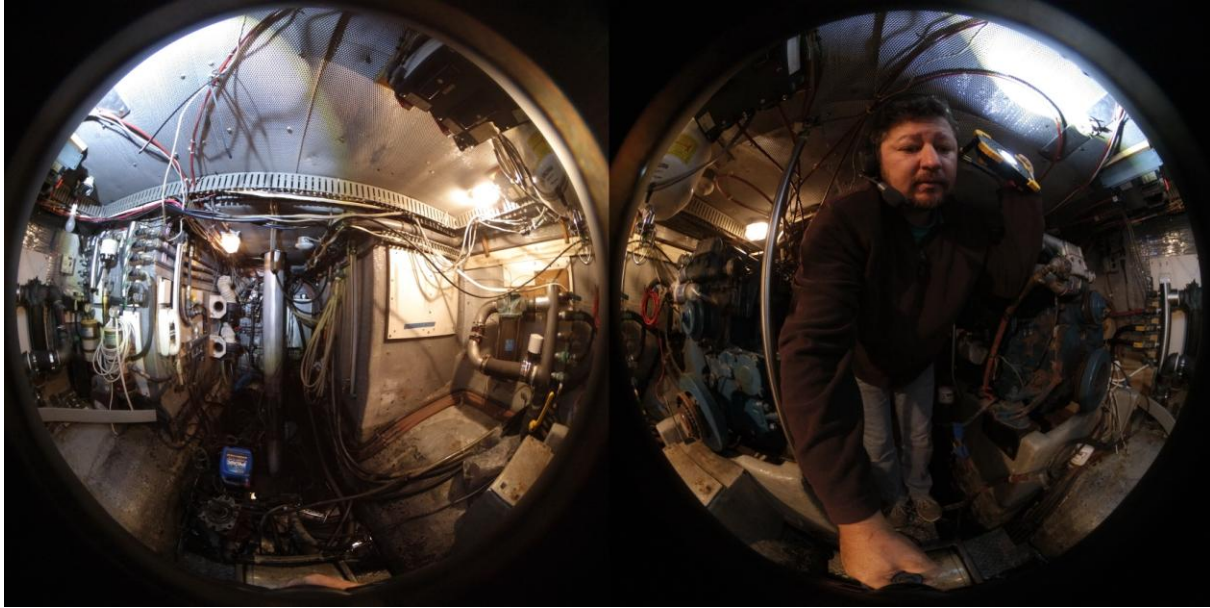
**Figure 11.** An unstitched view of the confined space for the engine compartment shows two (2) one hundred eighty 180° FOV images before stitching.

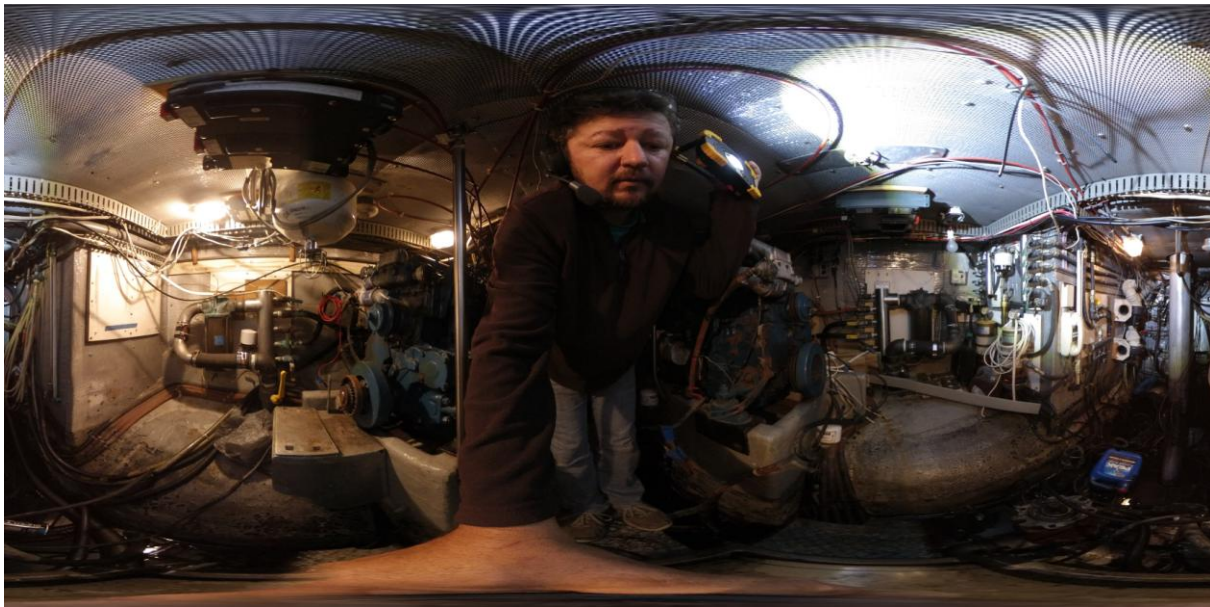
**Figure 12.** Engine compartment after stitching ready to be loaded into a 360° viewer.

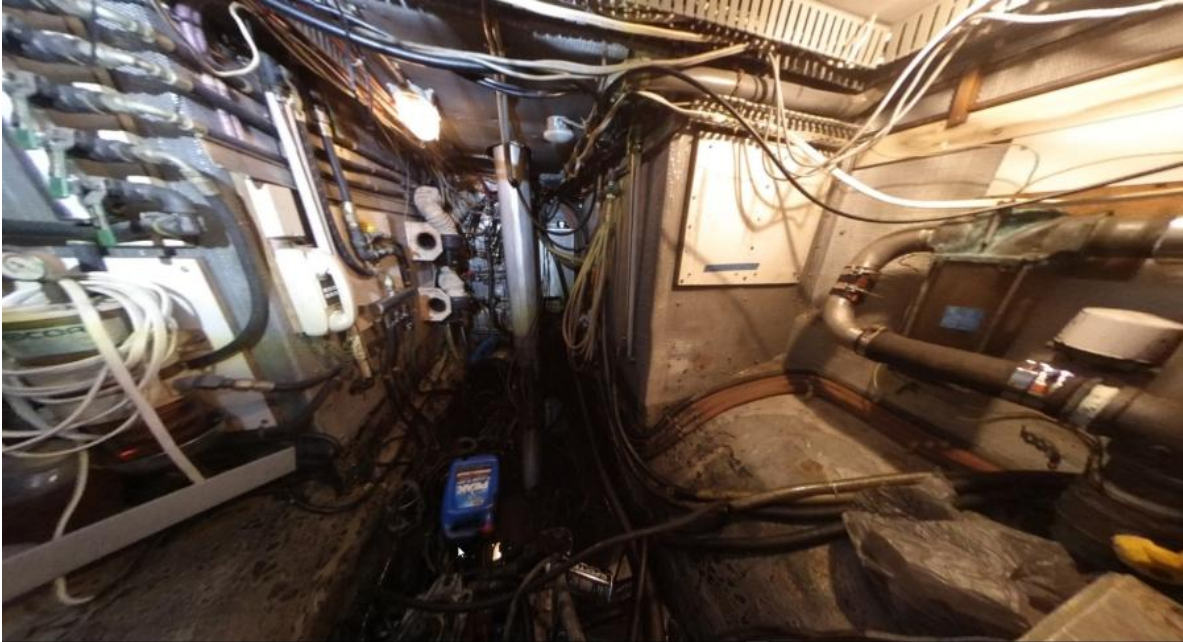
**Figure 13.** One of the possible views of the engine compartment from a 360° viewer. See <https://www.facebook.com/photo.php?fbid=1886875961340856&set=a.477315122296954.116071.100000554101945&type=3&theater>
