# **Inspection of Steam Reformers and Catalyst Tubes with Infrared Thermography**

Sonny James, Level III Certified Infrared Thermographer  
Owner, Senior Instructor / Managing Director  
NDE Institute of Trinidad, Ltd. / Thermal Diagnostics Ltd.  
15 Robertson Street, Les Efforts East  
San Fernando, Trinidad & Tobago,  
West Indies  
Ph: 868-653-9343 / 868-657-6572

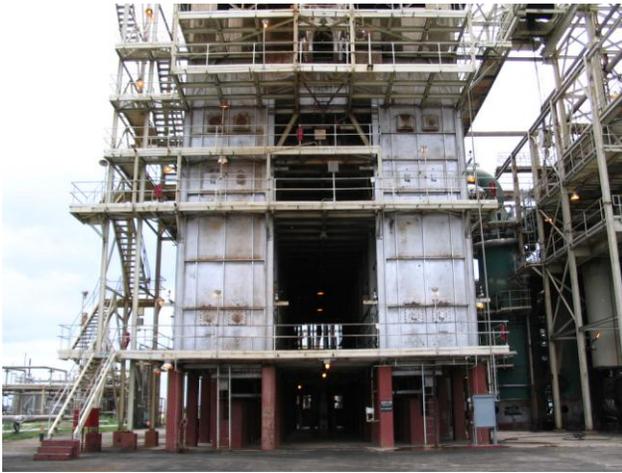
**Foster Wheeler horseshoe type design:  
One row of tubes per firebox/cell**

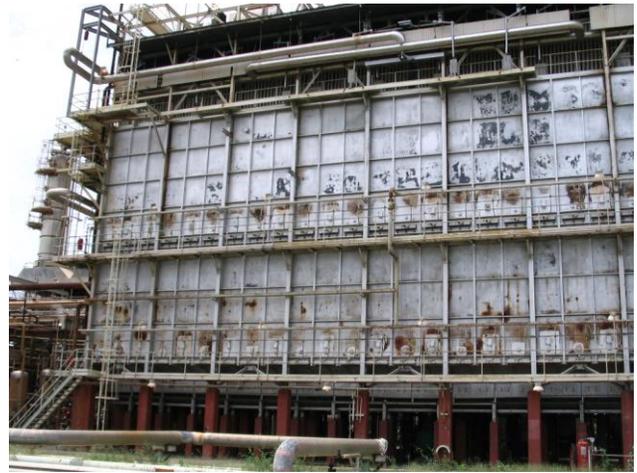
**Side view of horseshoe design reformer**

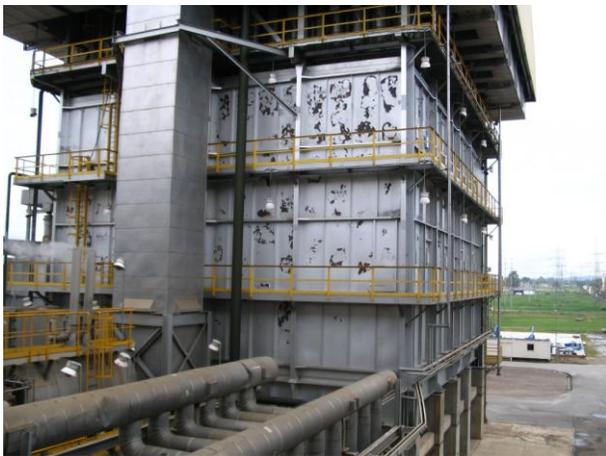
**Single firebox type design:  
Multiple rows of tubes in one firebox/cell**

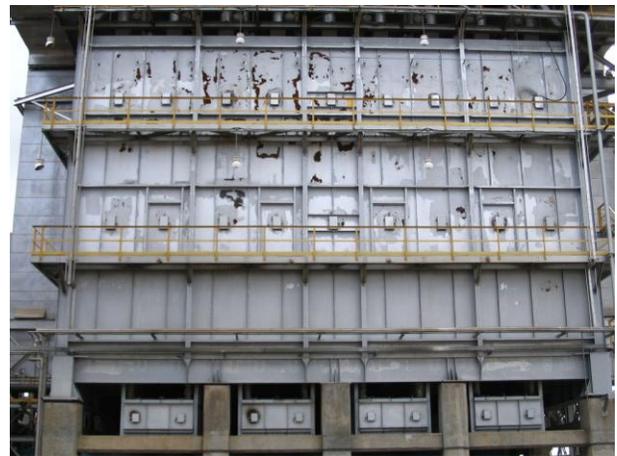
**Side view of single firebox/cell design reformer**

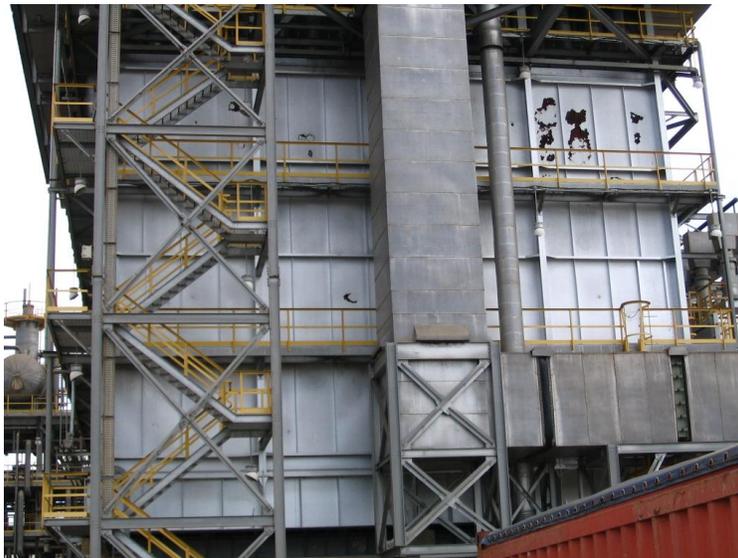
**Low emissivity silver/gray paint common on reformers**

The low emissivity of the paint not only poses a temperature measurement challenge, it also poses a relevant exception determination challenge. Surrounding a reformer is a melee of hot flanges, piping, and vessels which can easily be reflected off the surface of the paint resulting in false indications. Plant inspectors using spot radiometers often misinterpret reflection problems as true indications. Also, changes in paint surface conditions due to scrapes, scuffs, and charring can result in emissivity changes and can show a Delta T of  $>40^{\circ}\text{C}$ , easily confusing an inexperienced thermographer and leading to data misinterpretation.

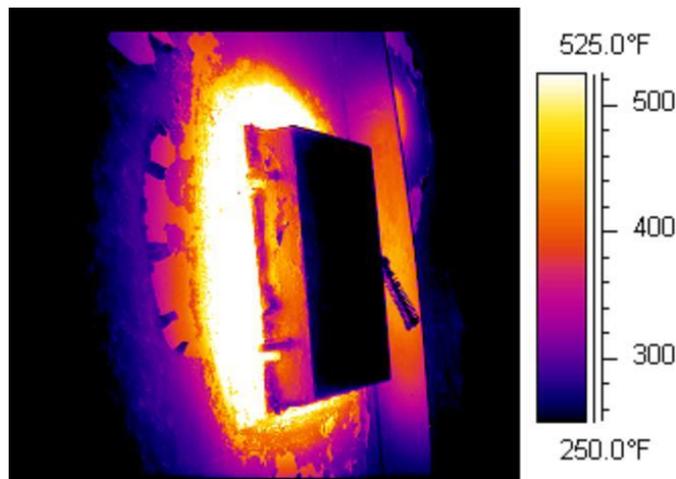
Thermal image of refractory failure located around a peephole

With reformers, the most common areas for refractory problems are at the peepholes, burners, manways, and penthouse roof flooring, although it is not uncommon to find problems in other areas.

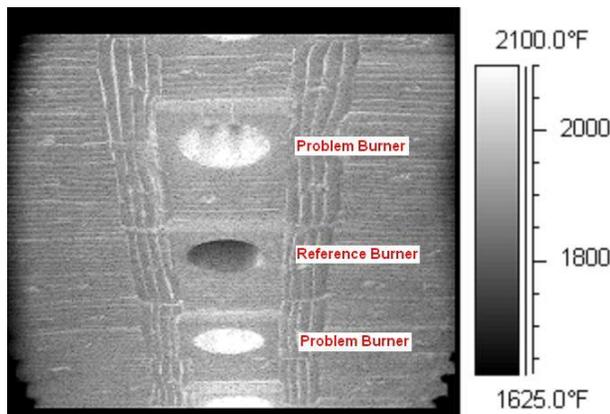
**Thermal image showing flame impingement on burner tiles due to improper or defective burner injector tips.**

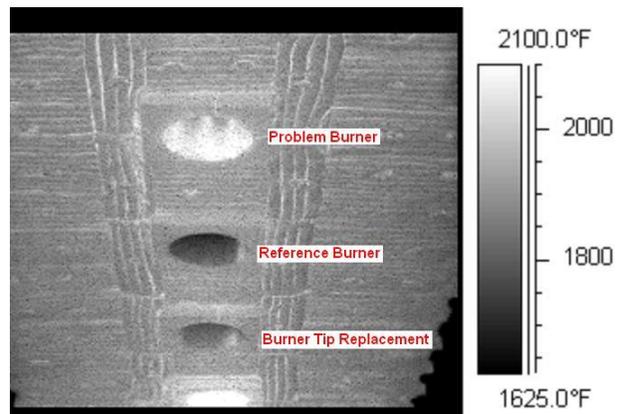
**Thermal image showing replacement of a new design burner injector tip, solving the flame impingement problem of the burner tiles.**

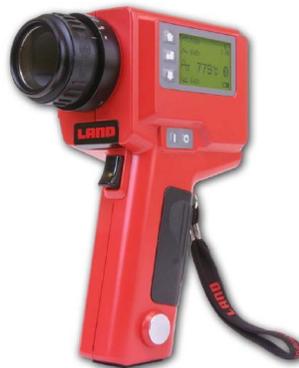
**AMATEK LAND Cyclops  
Single Point Pyrometer**

I have not been to a chemical or petrochemical plant yet that does not use a portable, handheld single point pyrometer to trend and monitor their tube temperatures. The main reason plant engineers and operators use these devices is because they are relatively inexpensive and “easy to use”. While these instruments are inexpensive, easy to use, and also very accurate and stable, they are almost never used properly by plant engineers and operators. This is because many have the notion that all they have to do is aim, pull the trigger and get a temperature. Many fail to understand that these instruments are infrared thermometers and are susceptible to the same errors as thermal imagers and other infrared thermometers.

Single point pyrometers are very useful to plant personnel and do help tremendously in “trending” reformer tube temperatures; however, knowing the limitations of the equipment and knowing basic infrared theory is extremely important and is required before anyone uses these devices to monitor their reformer tube temperatures.

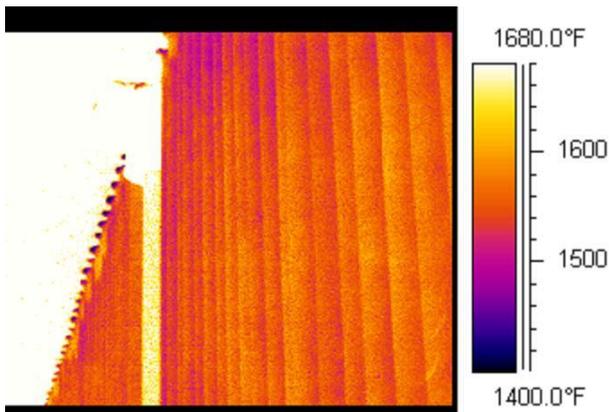
Side view of reformer tubes in a certain row showing normal thermal patterns.

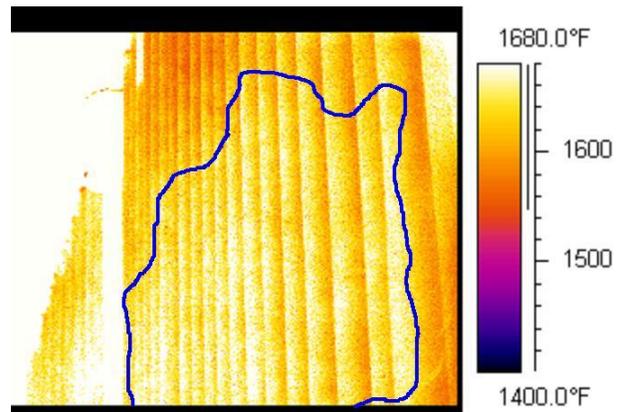
Same reformer, but a different row showing flame impingement problems due to damaged burners.

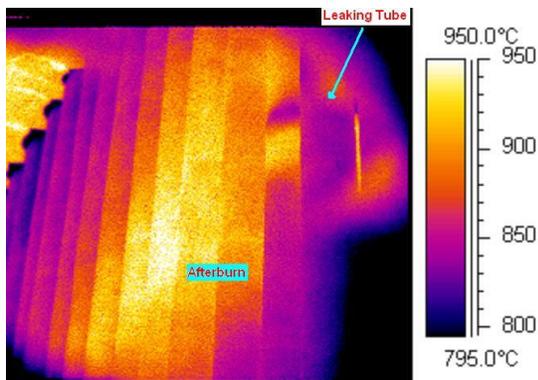
Leaking tube detected by cool band on adjacent tube and localized afterburning of hydrogen gas impinging on following tubes.

I am often asked if thermography can be used to locate reformer tube leaks. Finding a reformer tube leak is somewhat tricky, but not impossible. Although you may not actually see the leak, there are some telltale signs to look for such as localized flame impingement due to afterburning at a location where there is not supposed to be any; and localized cooling of the refractory wall or an adjacent tube indicating a surrounding tube is leaking.

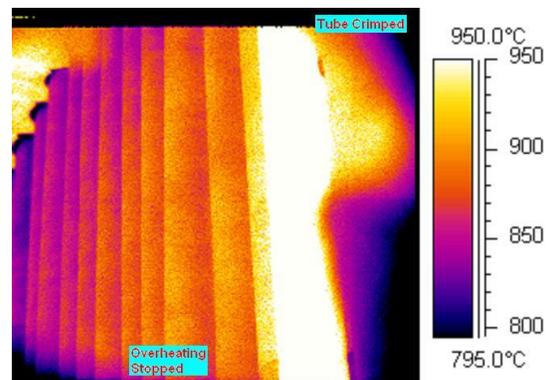
Same leaking tube crimped while online stopping the afterburning and tube overheating. No downtime and no failures.

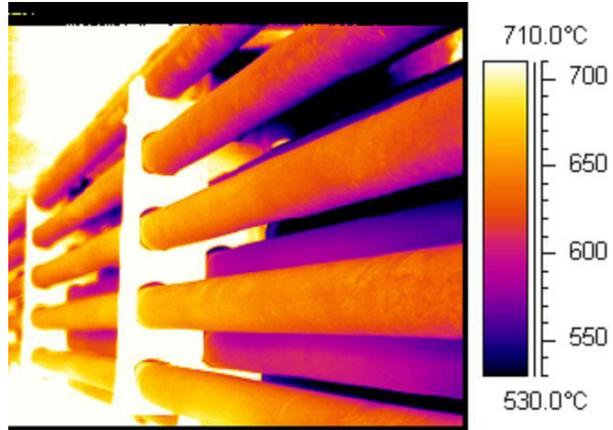
**Horizontal convection section reformer tubes in a horseshoe design reformer.**

As mentioned earlier, there are various designs of reformers. This means that there are also various tube configurations. A reformer can have vertical tubes or horizontal tubes, such as within the convection section of a horseshoe designed reformer.

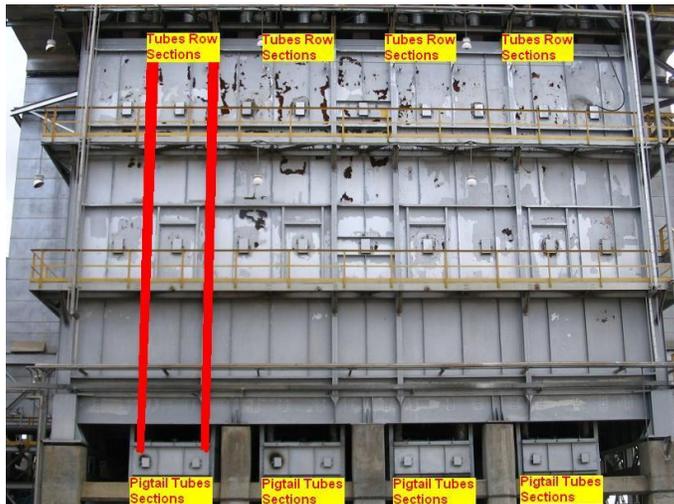
**Photo showing location of multiple reformer tube rows and pigtail tube sections within a single firebox reformer.**

There are also the “pigtail” tubes of a reformer which can be inspected. Pigtail tubes are the smaller tubes that are external to the furnace and connect the reformer tube to the supply and exit manifolds.

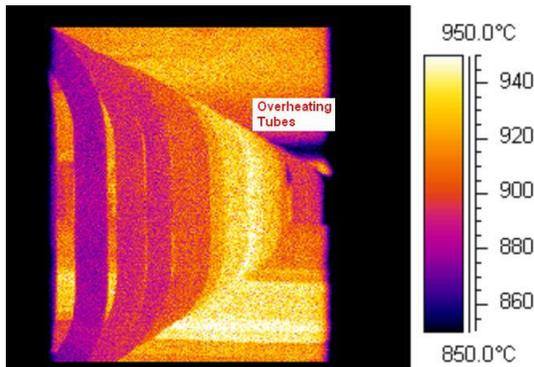
**Overheating pigtail tube section**

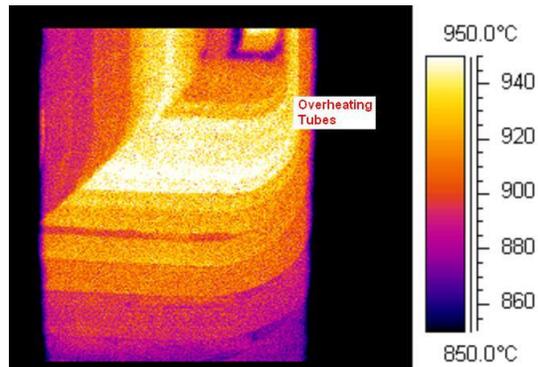
**Overheating pigtail tube section**

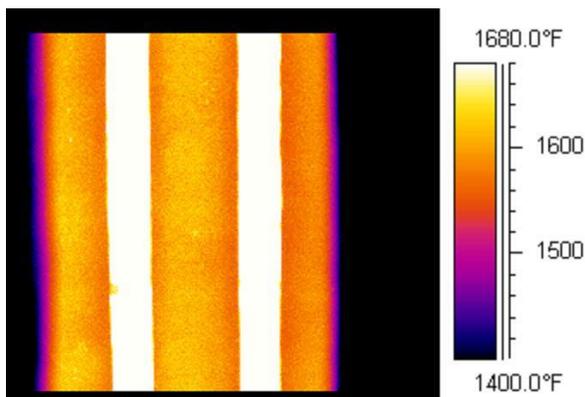
**Direct view of reformer tubes from peepholes give better temperature accuracy, but it is more difficult to diagnose problems due to limited field of view for a complete thermal profile.**

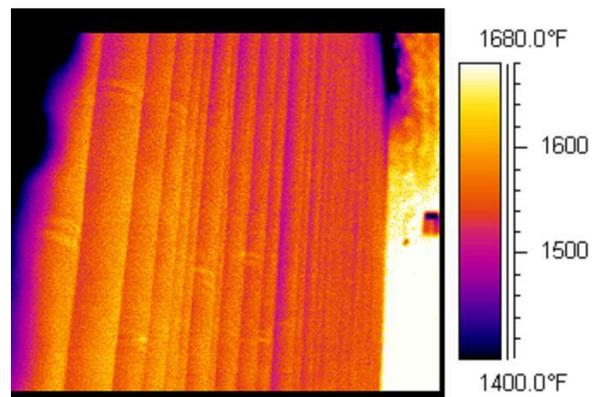
**Same reformer tubes. Side view from parallel peepholes gives a complete thermal profile, making it easier to diagnose problems, but it decreases temperature accuracy due to viewing angle.**
