# Canary Islands Underground Water Leak Detection Using Aerial Thermography

## Phase 1 Proof of Concept – Lanzarote Volcanic Urban Environment

This project documents a Phase 1 proof-of-concept study exploring the use of aerial thermography to support underground potable water leak detection in an urban environment. Conducted in a volcanic landscape with complex ground materials and buried infrastructure, the work was deliberately framed as a controlled technical investigation rather than a blind detection exercise.

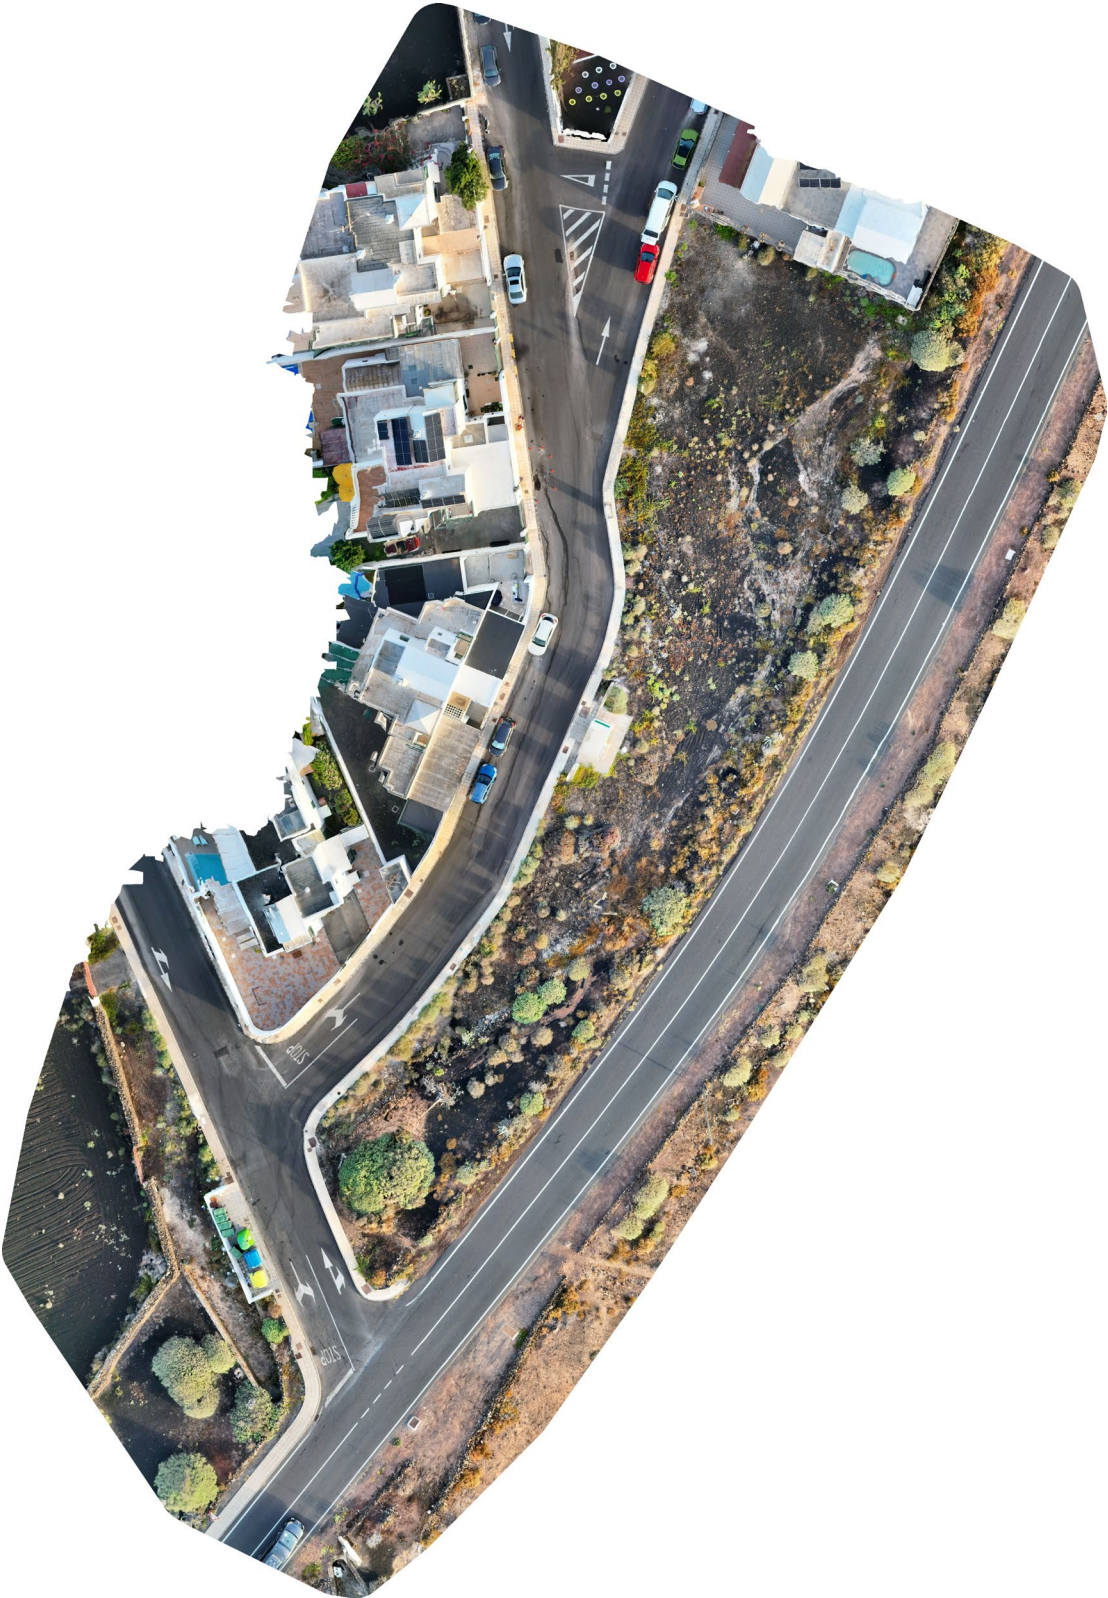
The objective was not to “find leaks” in the traditional sense, but to determine whether thermography, when applied with appropriate professional discipline, could identify surface thermal behaviour consistent with known leakage and, importantly, to define where the technique adds value and where it does not.

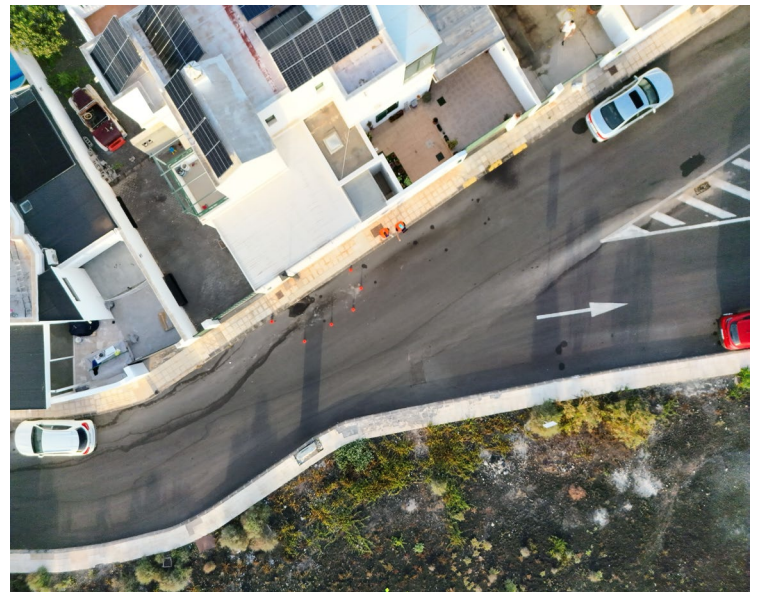
Dusk surveys were conducted after daytime solar loading to observe cooling behaviour and potential evaporative effects. While visually striking, these datasets proved sensitive to recent surface activity, shading, and transient conditions.

Dawn surveys, conducted before significant solar loading, produced the most interpretable results. Under near-equilibrium conditions, subtle thermal differences associated with retained heat in moisture-affected sub-base materials became clearer and more stable.

This finding was one of the most significant outcomes of Phase 1 and directly informs best practice moving forward.
