The Business of Infrared Home Inspections

Bart Bruni
Level 1 Thermographer #6455
Bestec Home Inspections
323 SE First Avenue
Hallandale Beach, FL 33009
Tel: 954-458-1104
Fax: 954-458-0607

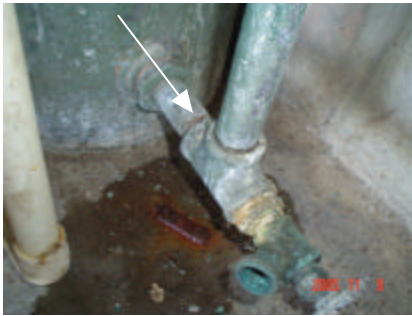
Leaking pipes

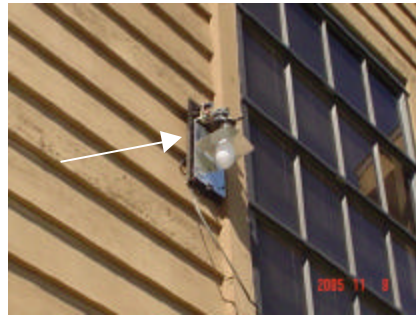
Broken light

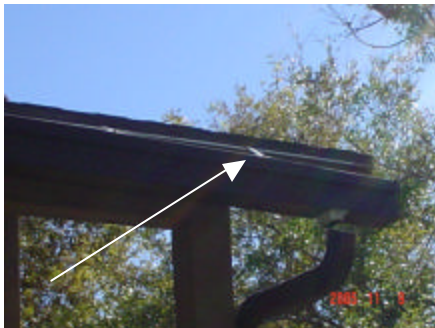
Gutter damage

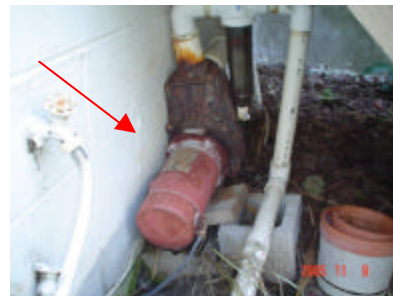
Replace pump and motor

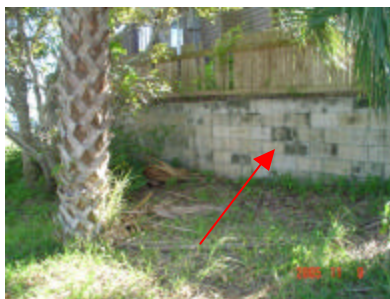
Retaining wall cracked

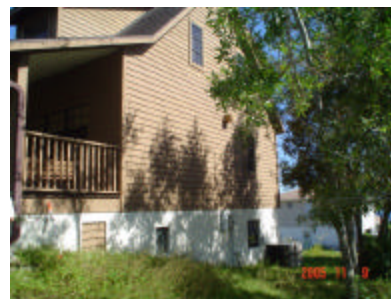
No access to entry of crawlspace

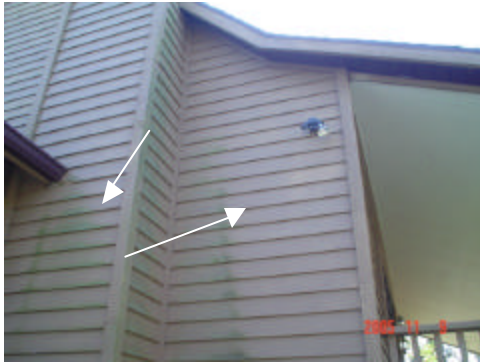
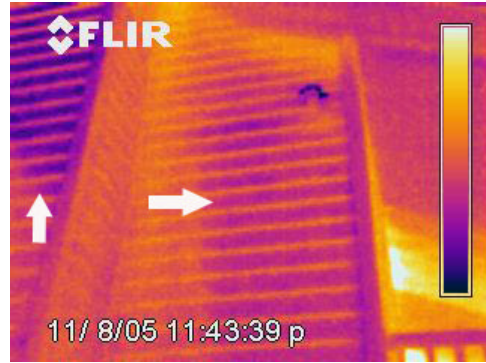
In this home, there was a false chimney enclosing the exhaust system for a wood burning stove. As you can see, there is a thermal difference.

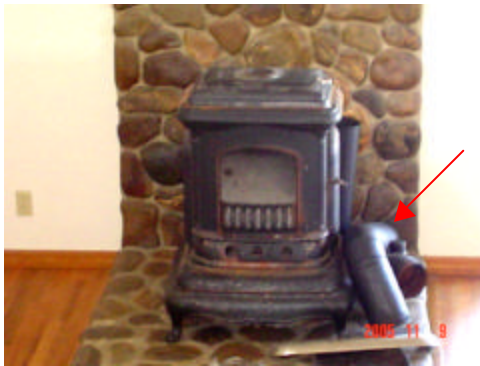
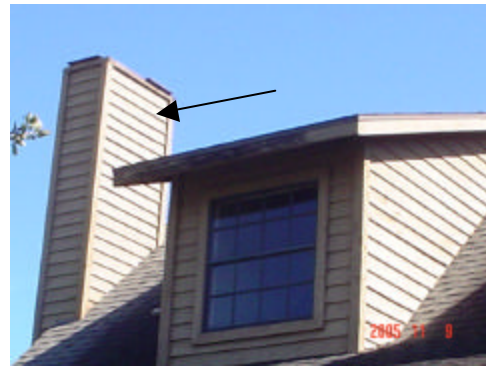
Inspecting further we found that the wood siding read 20% plus. The end result was that a “walk on roof inspection” was necessary and showed the top exhaust stack was not closed properly and thus water was leaking in.

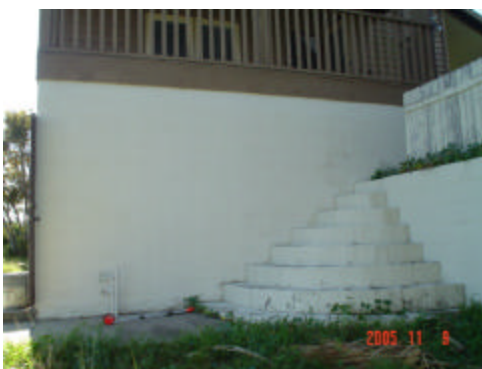
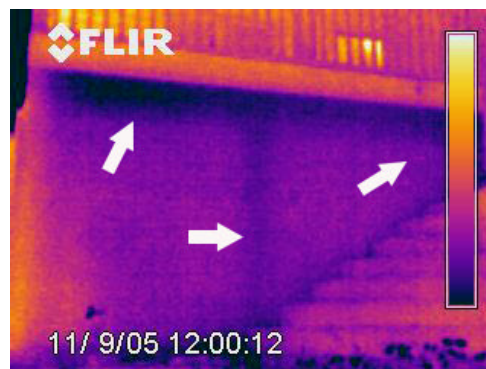
The basement wall has a moisture problem, which brought damage repair dollars to the buyer.

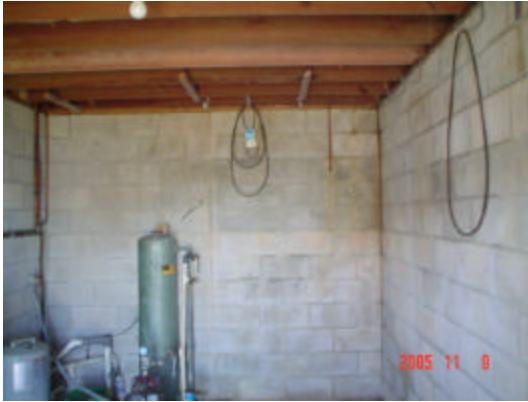
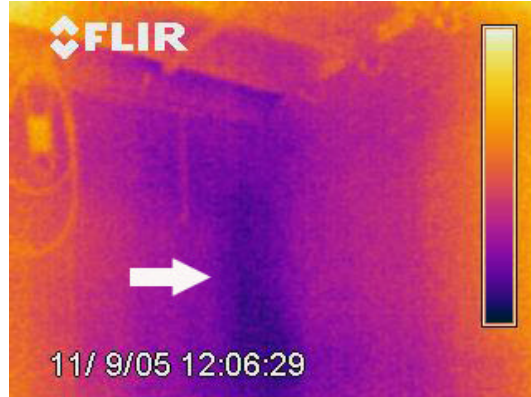
On the inside basement walls, infrared provided valuable moisture information

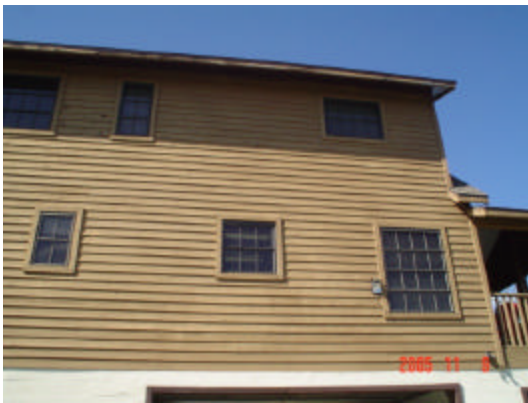
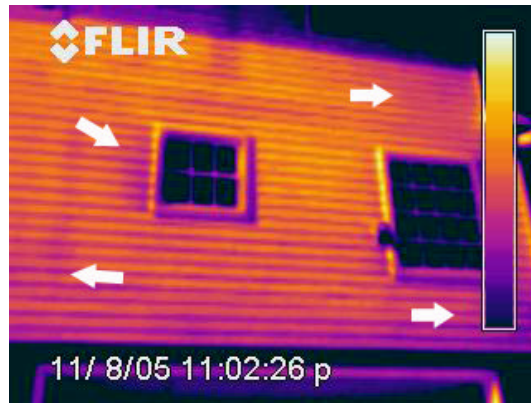
Moisture meter readings were over 20% in some of the wood siding where the arrows are pointing. The buyer used this information to finalize his offer to buy this home. This client spent \$1,500 on an IR Home Inspection and Termite Inspection and received tens of thousands from the seller for repairs.

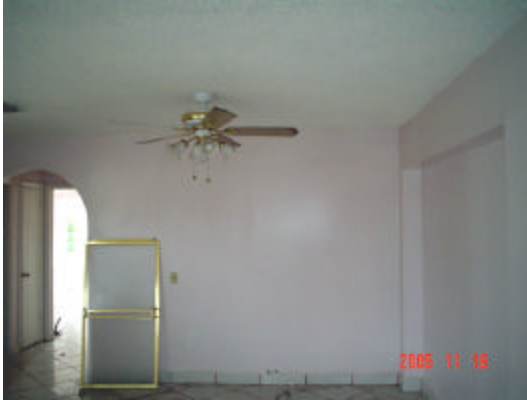
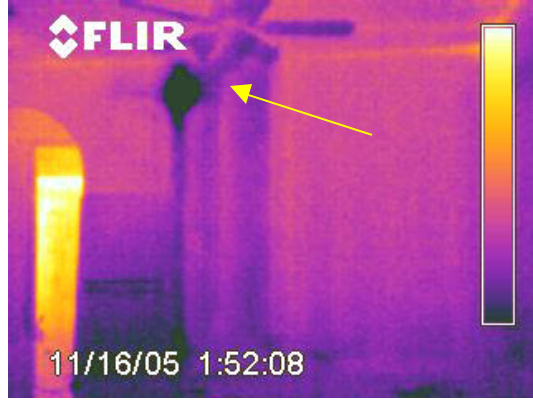
This home received major water damage during Wilma; however, the client and the insurance company wanted to know where the water was coming from. When I arrived, there was standing water in the house. A roof inspection had been performed and no breach in the roof system was reported.

The wall that had shown this anomaly is common to the A/C handler closet of which is leaking above the ceiling line.

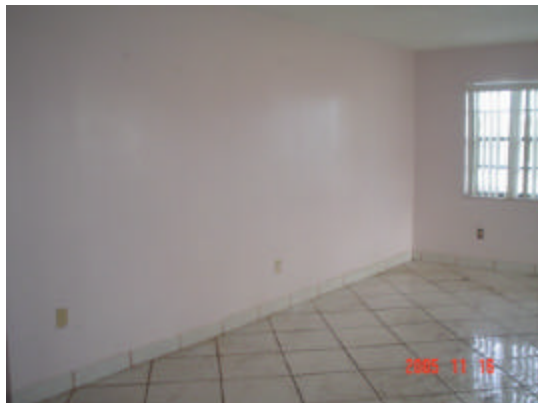
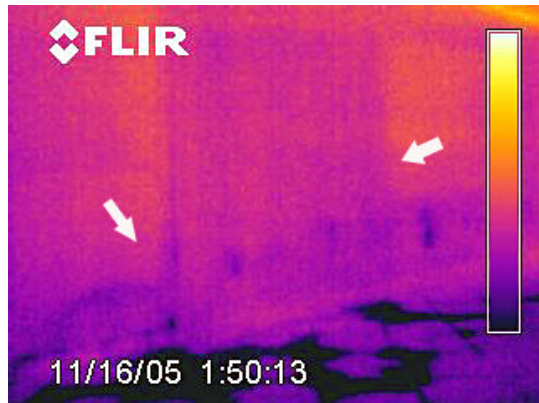
Standing water on the floor wicked up the wall. This was over 20% wet anywhere we touched it with our moisture meter. This was consistent to all the walls in this home.

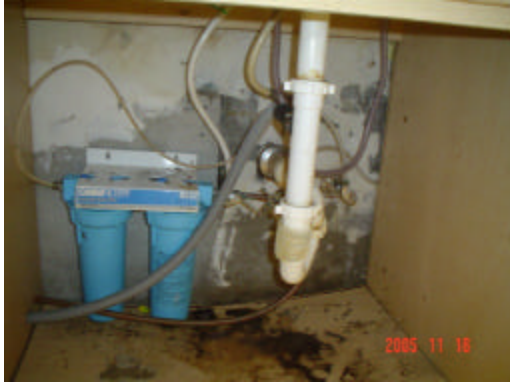
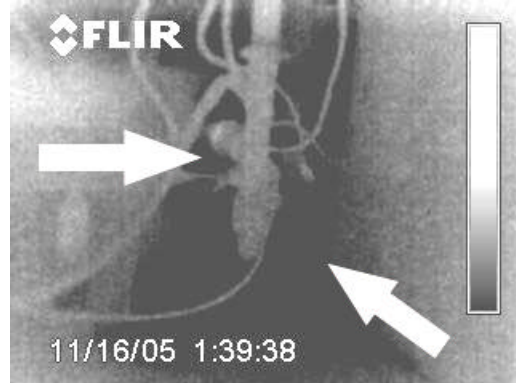
A leak in the water closet proved to another source

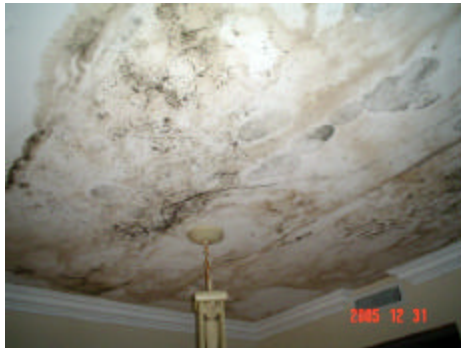
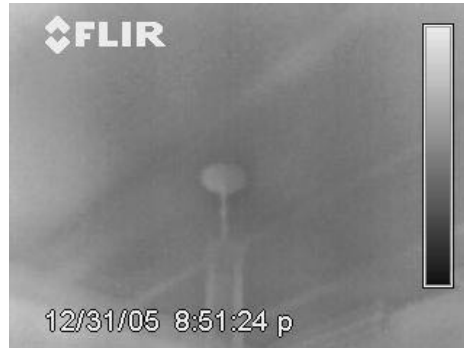
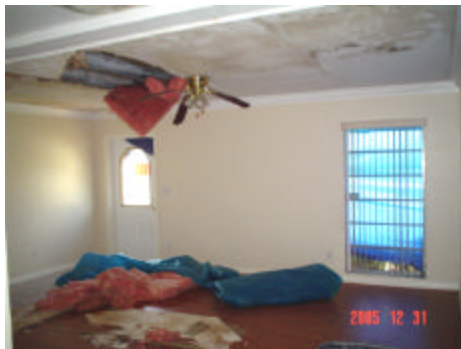
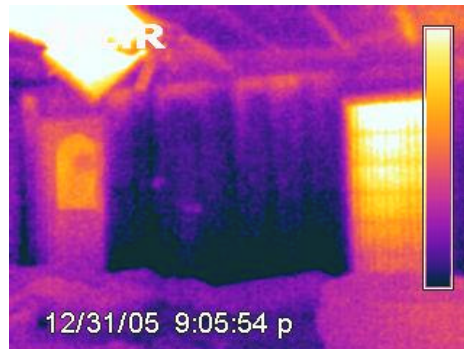
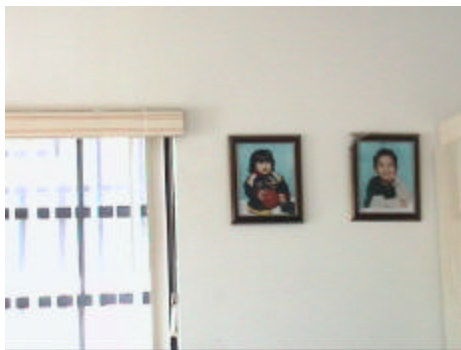
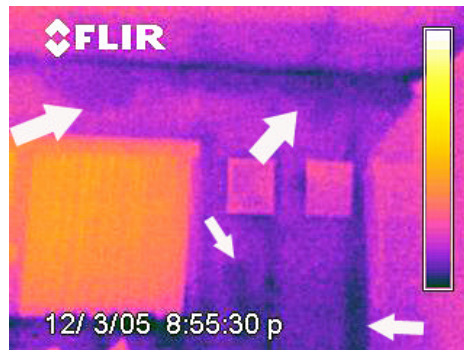
Here are other IR home inspection images that show typical moisture damage after a hurricane.

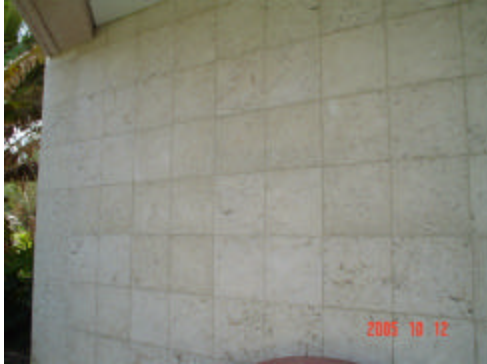
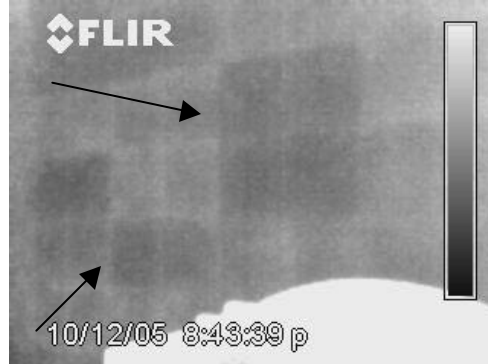
Chambers east exterior wall

***Infrared image showed dark tiles have a major temperature change. Moisture meter 20% wet. 100% humidity.**

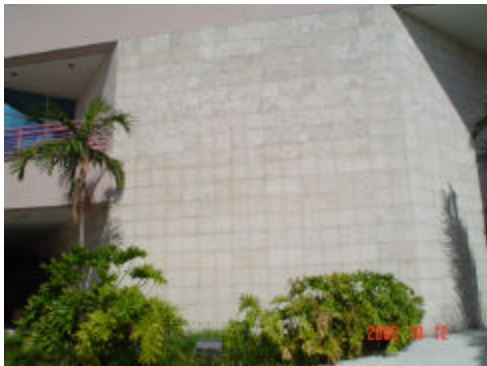
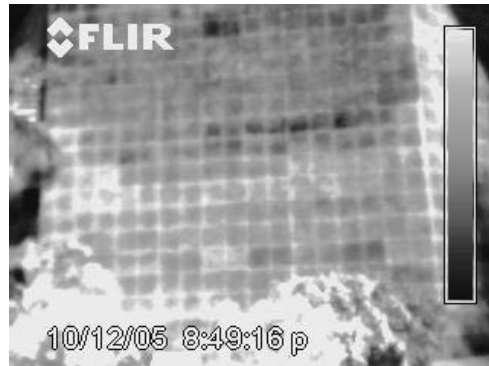
Chambers south exterior wall

***Major temperature difference in tiles**

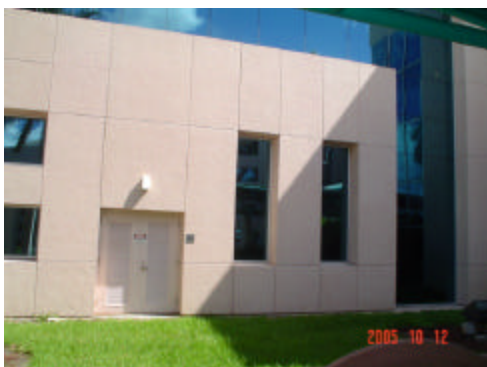
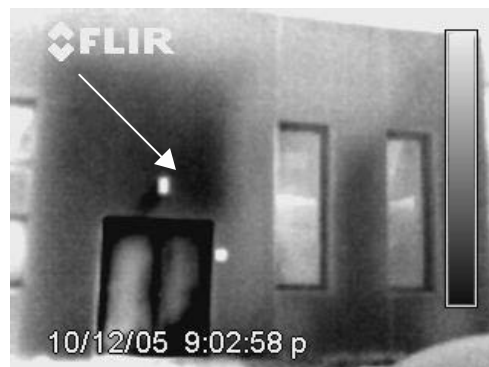
City hall south wall power room

Cool anomaly under investigation

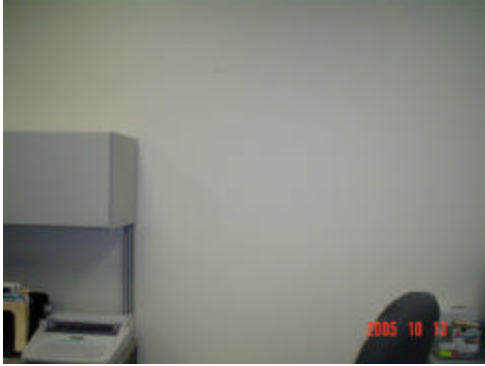
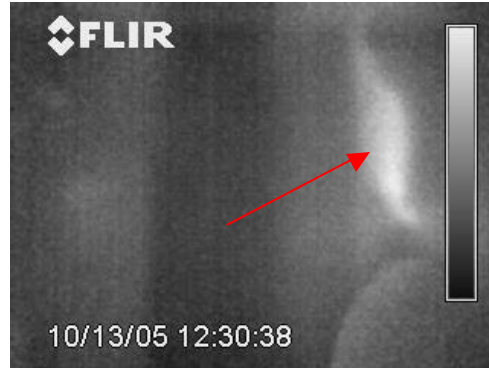
One of the interior ground floor offices in building A

*The light areas on the right of this image are an anomaly. The opposite side of this wall shows no visual reason for a temperature change such as this. Seek an electrical professional opinion.

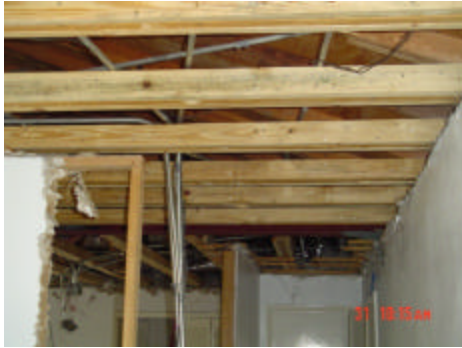
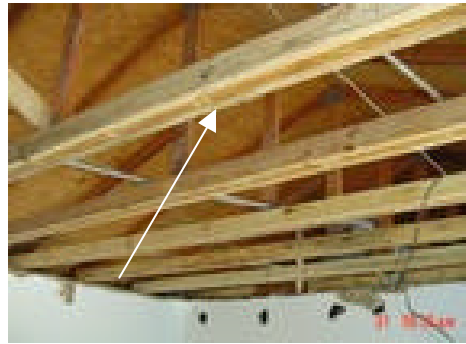
Termites had eaten this attic to the point of structural failure. The rafter beams had to be scabbed together with good wood.

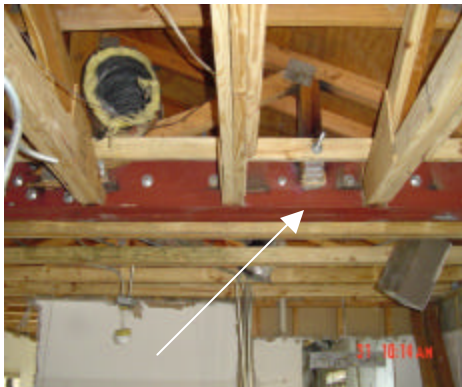
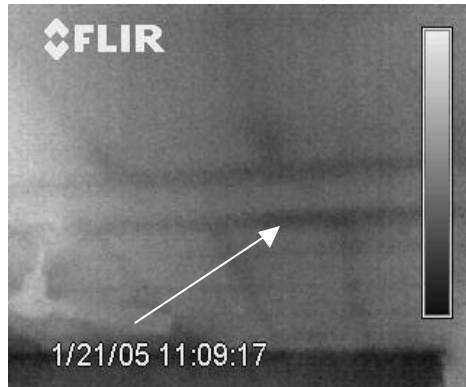
A girder was installed to save this roof. This IR image is what it looked like after all repairs were made. If you see this during an IR home inspection, report it. Those images were of a home that had been badly damaged due to a poor inspection program; this home was under the coverage of a major termite company. Apparently, attic inspections were not a part of their protocol. There was a lawsuit and the homeowner received a large cash settlement.
