# **The Use of Infrared and Solar-blind UV Cameras and UAS / Drones to Inspect Utility Transmission Lines**

James Brady, Level III Certified Infrared Thermographer

Brady Infrared Inspections, Inc.  
935 Pine Castle Court  
Stuart, FL 34996

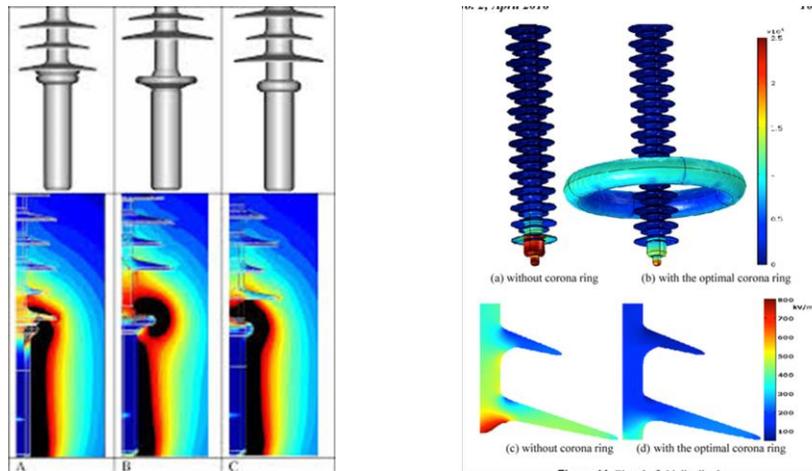
For corona activity to exist a high electrical (E) field is needed, combined with how the shapes of an energized component influence that field. Sharp edges, corners, points, tight radius and other irregular objects within a high E-field all have the potential to initiate corona activity. Figure 2 shows three different insulator configurations and the resulting electrical fields that are produced. The black, orange and yellow areas show the areas of highest gradient. Notice how each of the different shapes influence the gradient and show vulnerable parts of the insulator within the high electrical field.

**Figure 2: Left image showing electrical field surrounding three different shaped insulators. Right image shows the effects on the electrical field with a corona ring installed.**

When utilities are considering insulators they want to put in service for a specific voltage class, manufacturers will provide computer models to see where high E-fields exist and their interaction with the insulator. It is also used to determine if corona rings / field gradients are necessary. The right image in Figure 2 shows how useful corona rings are for dissipating and transferring the high E-field away from vulnerable parts of the insulator.

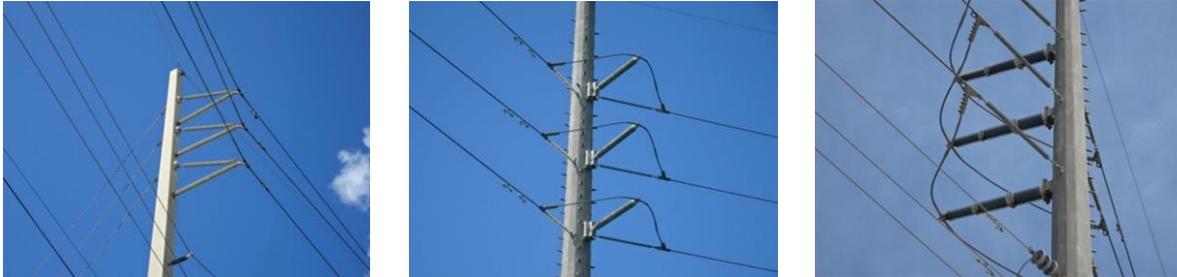
The transmission line under investigation is roughly 150 miles long with a voltage class of 138kV. A majority of the line runs along highway, with a small amount crossing water. Construction is a mix of polymer and ceramic insulators with vertical, horizontal, V-shape, and dead-end configurations. Some of the system is equipped with corona rings but most of it is not (Figure 4). The older sections of the line have insulators approaching 20 years in service.

**Figure 4:** shows typical pole construction of 138kV system with no corona rings. Left image shows 45-degree bracing configuration of polymer insulators, common on most poles. Middle image show a typical dead-end layout using polymer insulators. Right image is a dead-end structure with a mix of ceramic post and polymer dead-ends.
