# **Using Ultrasound and Infrared Technologies for Metal-Clad Switchgear Inspections**

Adrian Messer, Manager of US Operations  
UE Systems, Inc.

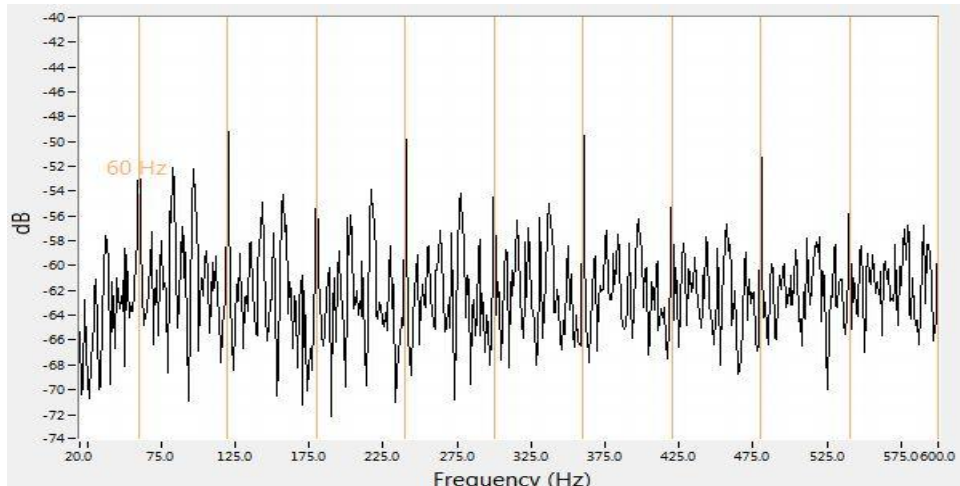
**Recorded ultrasound of corona as seen in an FFT spectral view**

When the recorded ultrasound of corona is looked at in a spectrum analysis software, very prominent 60Hz harmonics can be noted. If the sound recording is done outside of North America, one would see very dominant 50Hz harmonics. Additionally, in between the 60Hz harmonics, you would see what is referred to as frequency content. Frequency content is basically harmonic activity between the more dominant harmonics. As the condition worsens, there will be a loss of the dominant 60Hz harmonics, and uniformity in the amplitude of the recorded ultrasound will decrease.

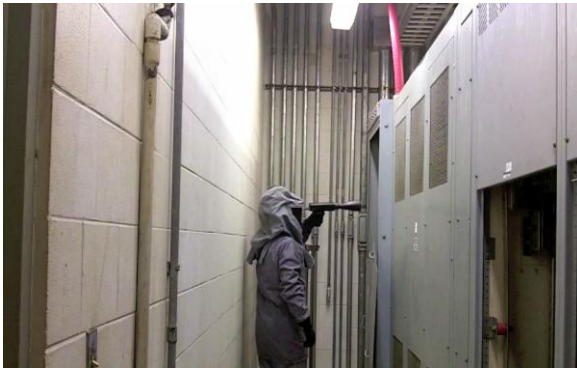
The following images show findings from an ultrasound inspection on a metal-clad piece of switchgear. Ultrasonic noise was detected from the B-phase and was further investigated.

**Ultrasound inspection in progress**

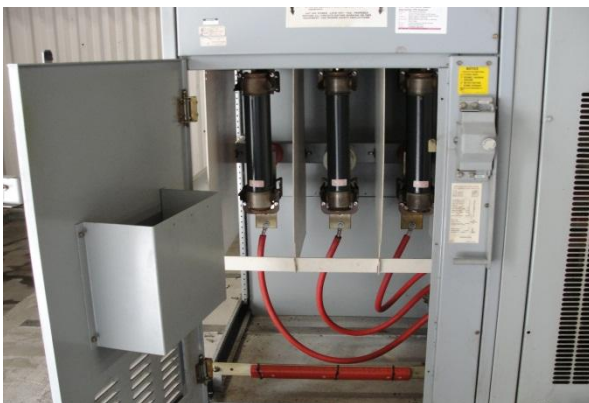
**De-energized switch, open front of cabinet for visual inspection**

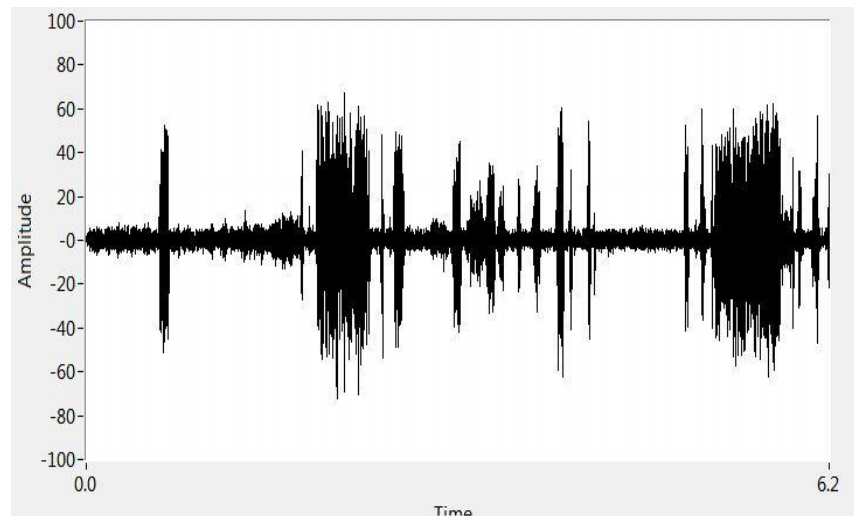
**Arcing as seen in the Time Wave Form. Notice the lack of uniform harmonics and the sudden starts and stops of the discharge**
