Infrared Inspection of Electric Utility Equipment: Documenting Common and Not-So-Common Thermal Exceptions

James Brady, Level III Certified Infrared Thermographer
Brady Infrared Inspections, Inc.
935 Pine Castle Court
Stuart, FL 34996
Ph: 772-288-9884

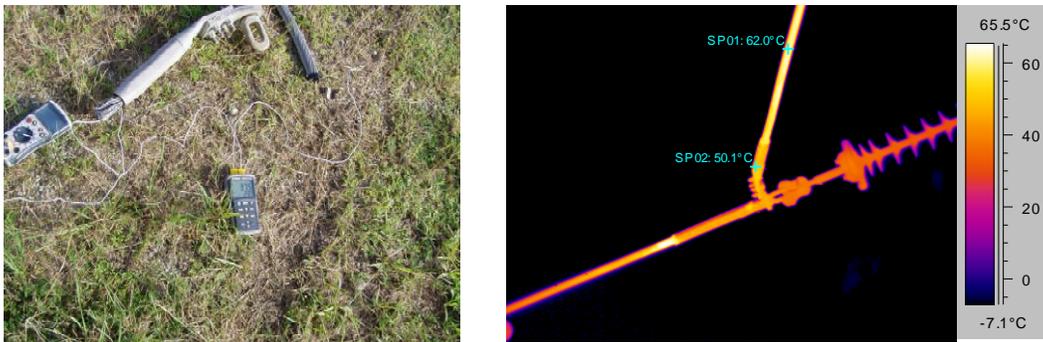
To accomplish this project, a dead-end connection with a tag end of conductor cable that was recently removed from the field was used to calculate an emissivity of our target (figure 9a). The target was circular in shape with a diameter of roughly 2-inches. The ambient outdoor temperature was used as a background temperature for each connection location we examined. A set-back distance of 9 to 10 feet was calculated so that a 1/4-inch spot size would be achieved to capture our temperature readings from the sides of our circular targets (figure 9b). Naturally, bucket trucks had to be used to access our inspection points. For those of you who have never been in a bucket truck navigating through 230kV energized power lines at 50 to 80 feet above the ground, I can attest that it rivals any amusement park ride out there.

Figure 9a (left) shows a dead-end connector with two independent thermal couples measuring target surface temperature that was used to determine the emissivity of the connection's surface
Figure 9b (right) shows a thermogram of a dead-end connector and conductor
