Using a Building's HVAC Systems and Infrared Technology to Solve Water Intrusion Problems

James Brady
Level III Certified Infrared Thermographer

Brady Infrared Inspections, Inc.
935 Pine Castle Court
Stuart, FL 34996
Ph: 772-288-9884

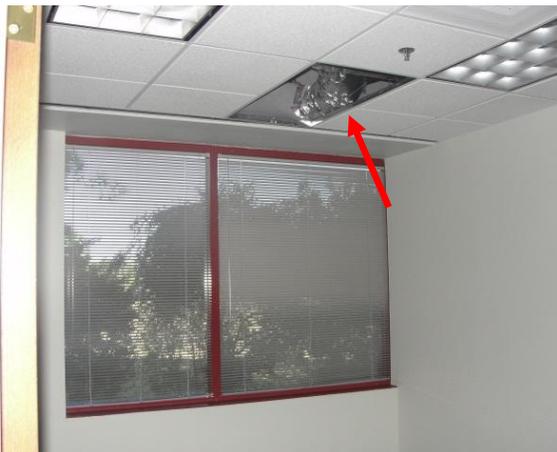
Ceiling tiles and ceiling tile / fiberglass insulation assembly were pulled away from the interior side of pre-cast panels in each office space on each floor to assure proper air flow to the back side of the pre-cast concrete panels (Figure 10).

Figure 10 (right): Typical office space showing two ceiling tiles removed to promote proper air flow throughout building.

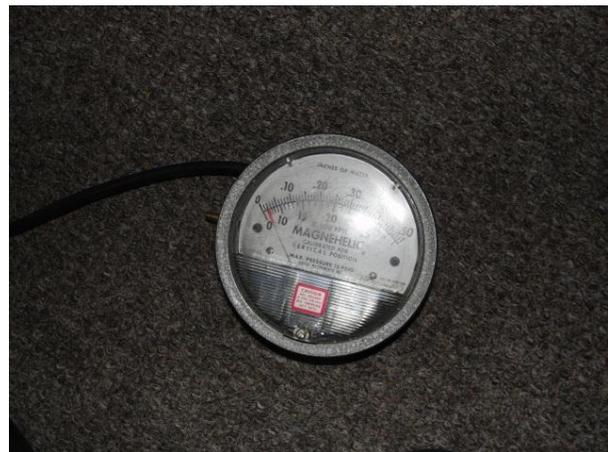
Figure 11 (left): A magnehelic was used to monitor building pressures during the inspection. Shown here, the building is just slightly on the positive side of neutral at +.02 inches of water.
