Thermography Inspection of In-floor Radiant Heating Systems - Case Study

Wayne Swirnow, President
Level III Certified Infrared Thermographer

Case Background

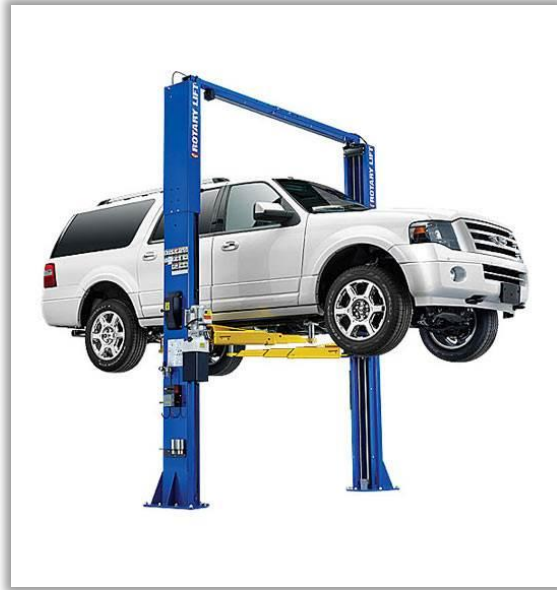
Figure 1

The customer supplied a template (Figure 2) showing the pattern of mounting holes for each of the two lift support columns shown in Figure 1.

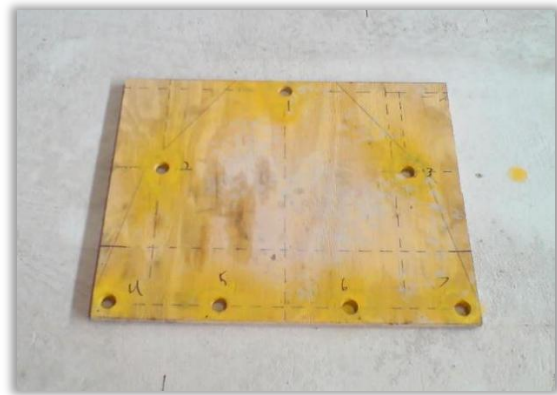
Figure 2: Lift support mounting template

In total, there were eight lifts to be installed with two columns per lift. Each column required seven mounting holes for a total of 14 holes per lift or 112 total holes to be drilled without hitting a heating pipe. The pattern of the holes could not be changed and the distance between with columns was fixed by the overhead bar which joined the two columns together. Should a single mounting hole need to be moved away from a heating pipe, the entire lift assembly would have to be moved. The overall layout of the lifts was tight, so there was limited flexibility on the order of an inch or so in adjusting the absolute position of each lift to avoid hitting any buried heating tubes. It was not possible to move a lift such that it would move over one complete set of pipes.

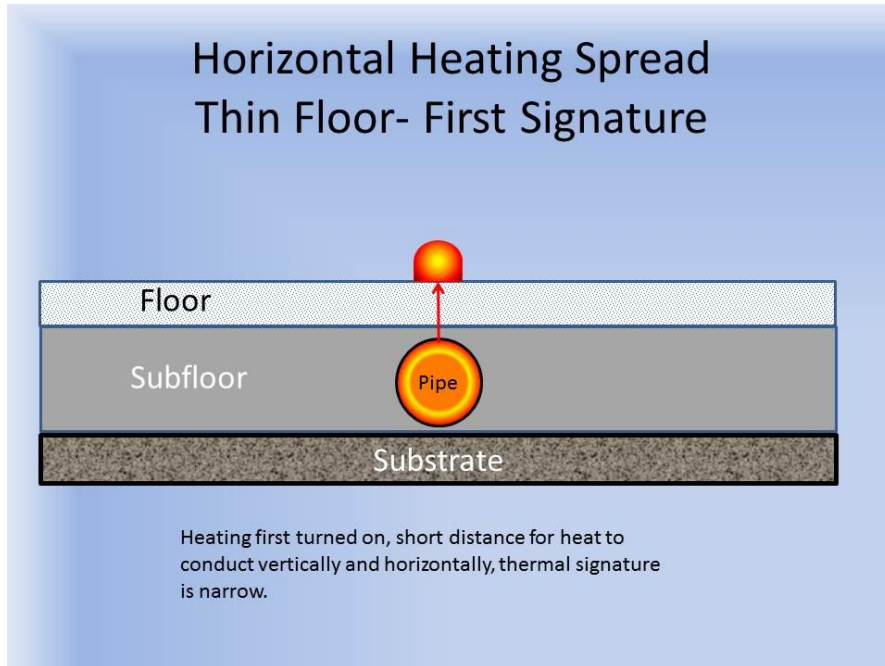
Figure 5

This example (Figure 5) as the pipe warms up; heat conducts vertically to the surface of the finished floor and also conducts out radially from the pipe. Because the distance from the pipe to the surface is short, there is typically a very narrow, well-defined heat signature as the floor just begins to warm.

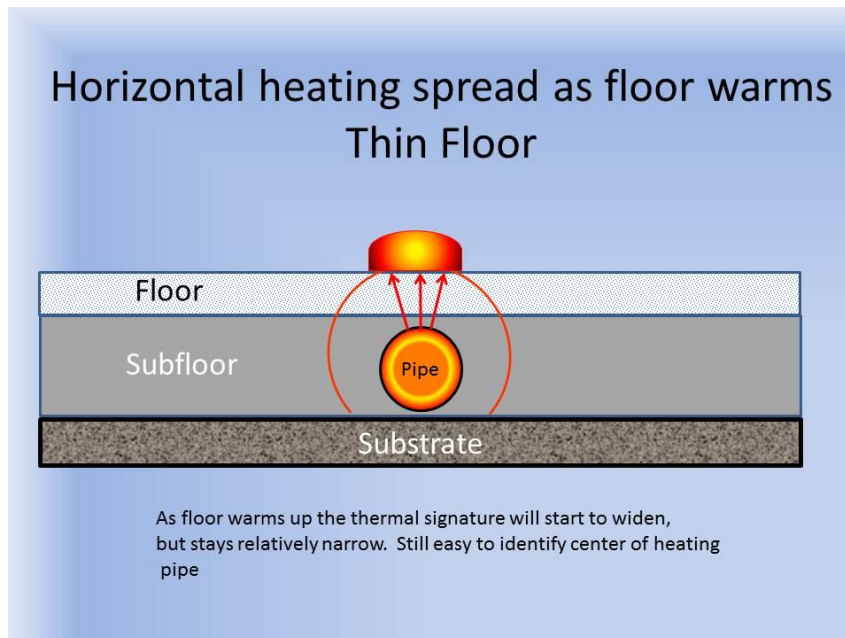
Figure 6

As time progresses, heat will continue to spread horizontally through the floor material and eventually cause a wider thermal signature on the surface as shown in Figure 6.

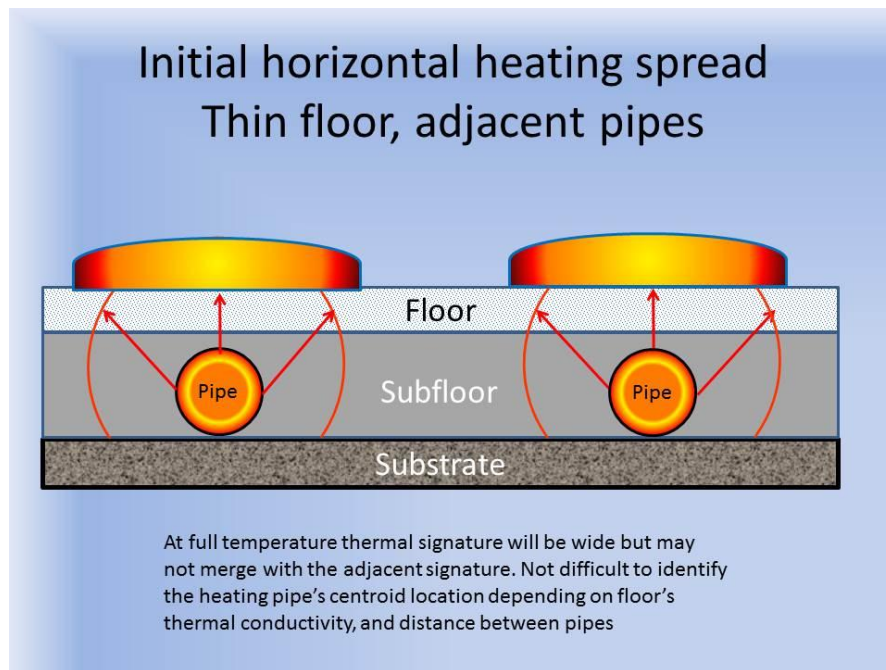
Figure 7

As the floor reaches full temperature, a thin substrate floor will have wider signatures, but often the signatures do not bleed together, maintaining an area of high thermal contrast between the heating pipes as shown below in Figure 7.

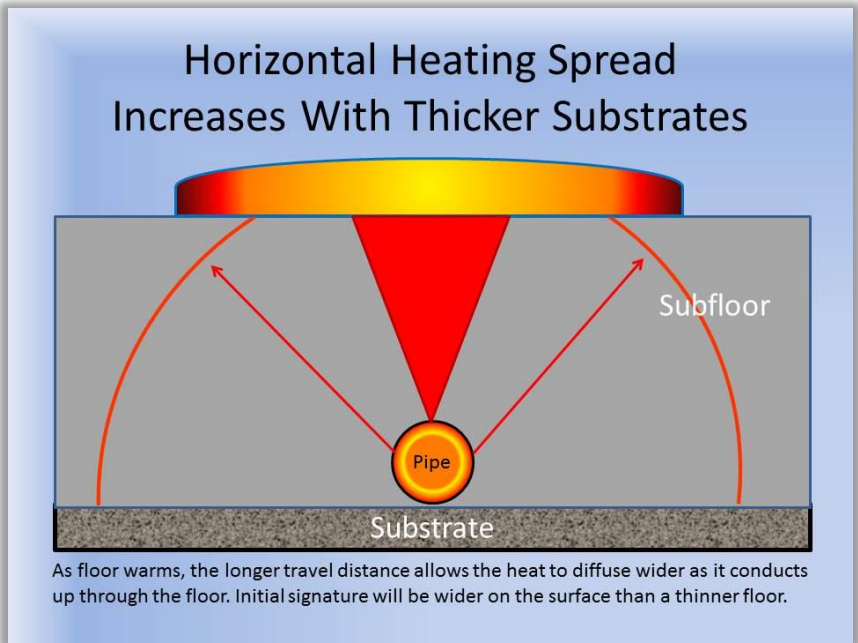
Figure 10

In contrast to a thin floor, a thick subfloor behaves differently because of the increased distance from the heating pipe, which is usually located at the bottom of the material to the floor's surface, Figure 10.

Because of the increased distance for the heat to conduct through, there is more opportunity for it to spread horizontally as it is conducting vertically to the surface. This results in an initial heat signature which may be significantly wider than what is seen on

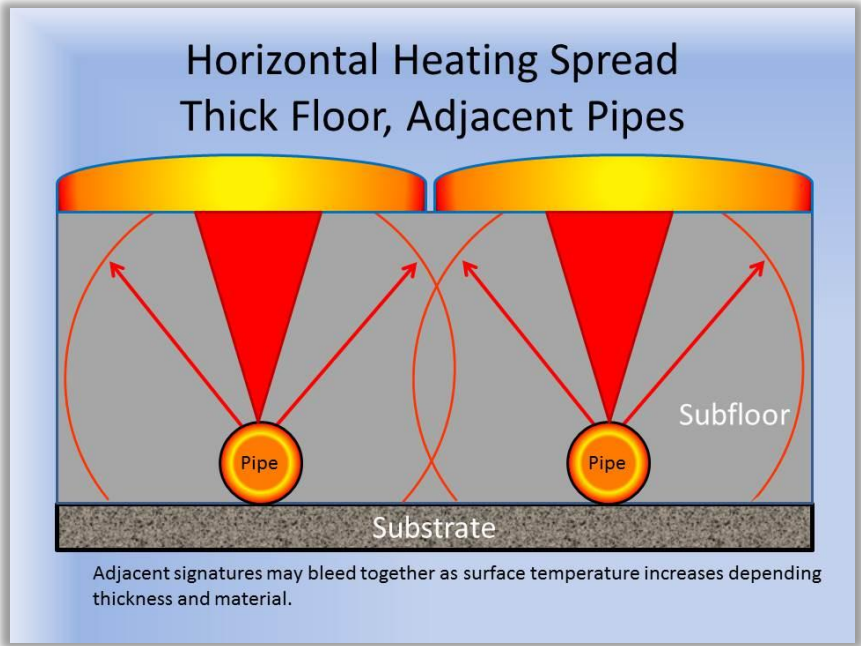
Figure 11

a thinner floor. As the floor warms up, signatures may bleed together (Figure 11) reducing the high contrast area between the pipes and making it more difficult to isolate individual heating lines and pinpoint the center locations.

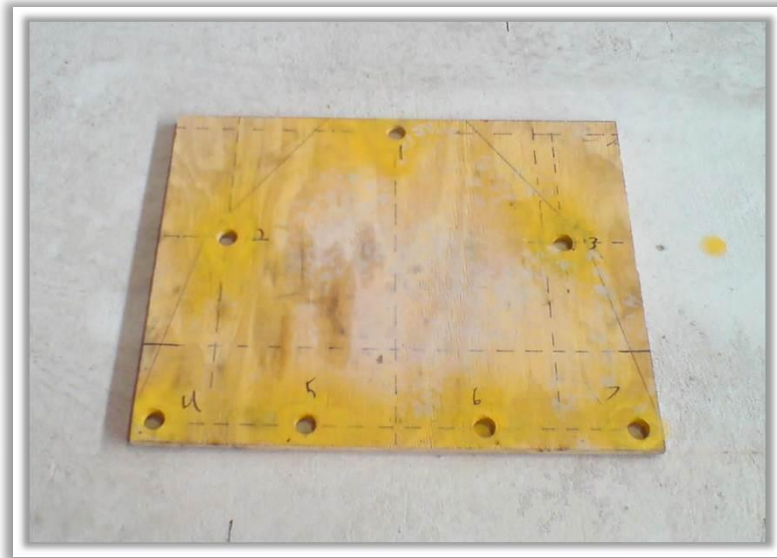
Figure 14: Support column template

The car lifts were placed in a very tight configuration and the approximate location of each lift footing was marked on the floor. Figure 14 shows the wooden template used to simulate the footing of each column and Figure 15 shows a thermogram of the template on the floor. The floor was starting to get warm.

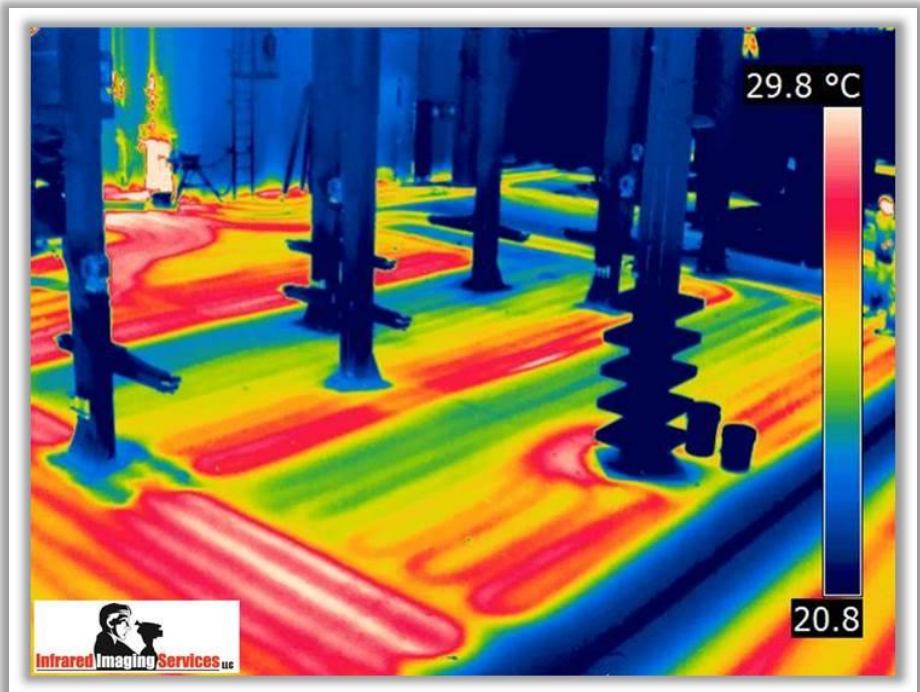
Figure 21

The project was a success with all lift support columns mounted and drilled into the flooring without creating any leaks in the radiant heating pipes. Figures 21 and 22 give you an overview of what the lifts looked like once they were all mounted onto the floor.
