Detection and Classification of Surface and Subsurface Structural Deficiencies Using Mobile Infrared Thermography and High-definition Visual Imaging

Kyle Ruske, Masato Matsumoto, PE, Int. PE, Shuhei Hiasa, PE

NEXCO-West USA
8300 Boone Blvd, Suite 240
Vienna, VA 22182

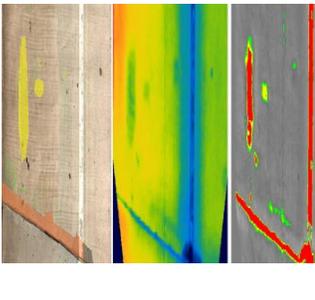
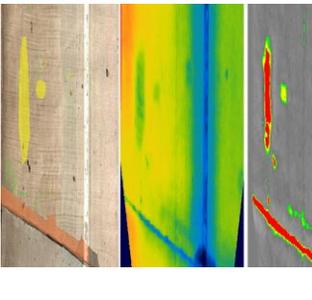
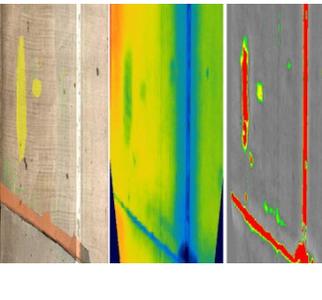
4

Temperature differentials in sound and unsound areas, processed images. (The left-hand side leads towards the parapet wall, and the right-hand side leads into the lanes of traffic).
