How a Fenestration Professional in New England Benefits from Use of Infrared Thermal Imaging of Doors & Windows

Jay Ray, founding member of IFSPA and R. Olsen
Maine Infrared Solutions
40 Orchard Lane
Otisfield, ME 04270
Ph: 207-749-2741

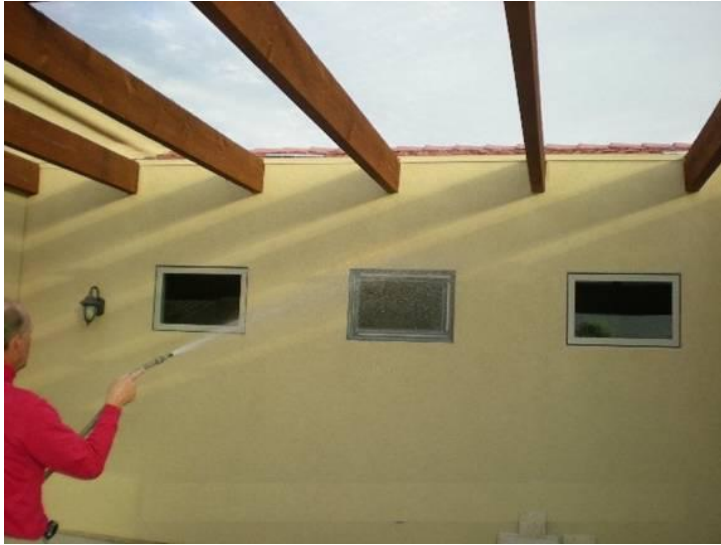
An initial, non-certified, non-calibrated water test using a garden hose is, in most cases, all that is needed to find the problem.

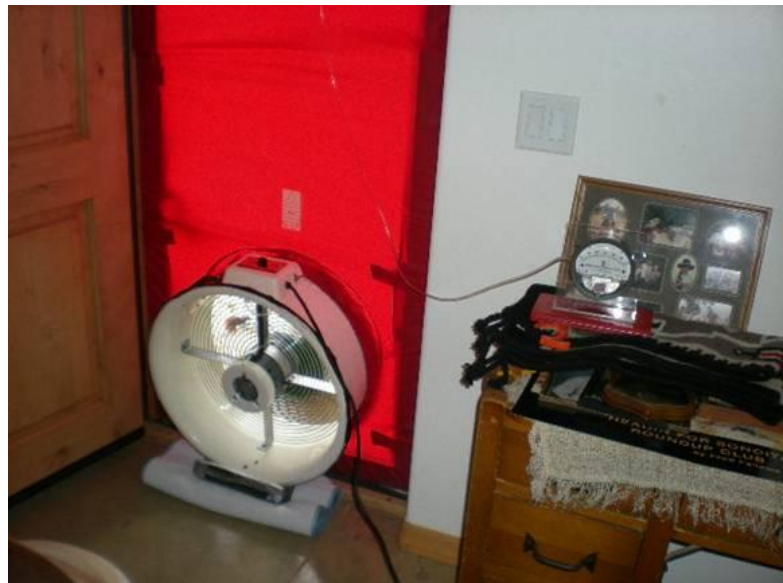
Other times, a blower door is employed in addition to the above water test to create a negative interior pressure similar to a storm.

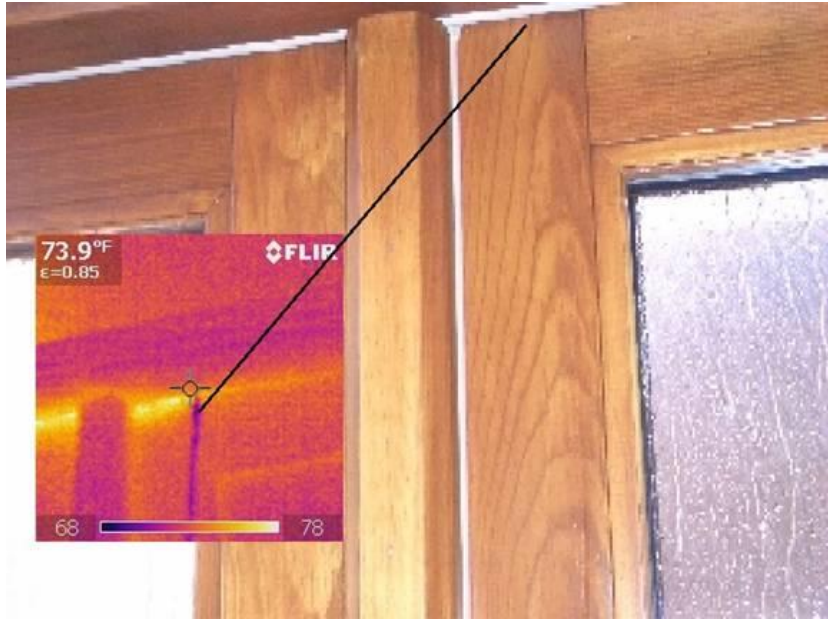
For years, we have represented the window and door manufacturers and our prime concern was water entering through the unit. When a unit leaks when it is not supposed to, the manufacturer is held responsible in the eye of the homeowner.

This is easy to discover and the repair / remediation process is standardized by the factory. The thermogram that follows shows a glazing juncture failure where water is coming around the bottom of the insulated glass unit (IG) on a door.
