Diagnosis and Repair of Failing In-floor Electric Radiant Heating Lines

Lee Durston BS, CBST
Forensic Building Scientist
BCRA
2106 Pacific Avenue, Suite 300
Tacoma, WA 98402
Ph: 253-627-4367

Abstract

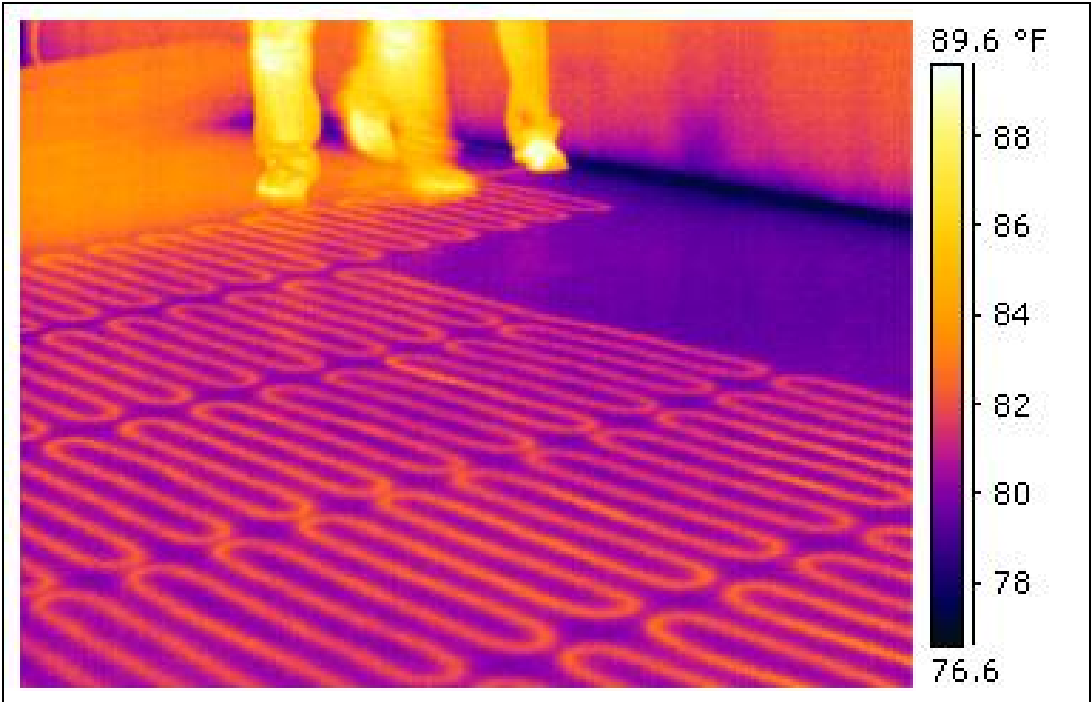
Thermogram of electric radiant heating mats

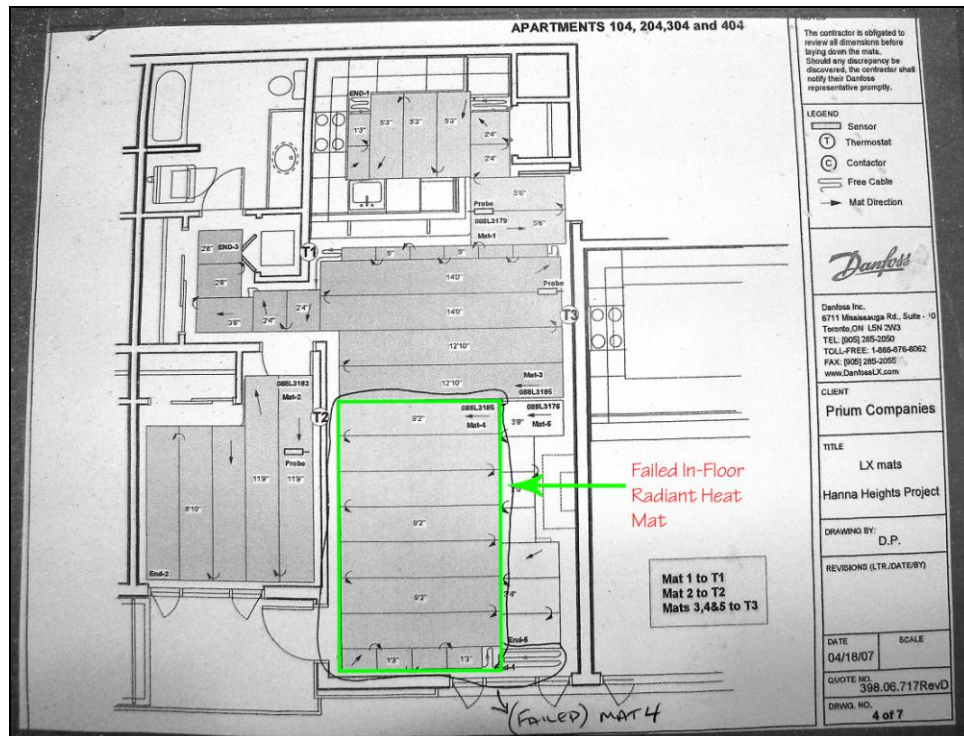
Floor heating design layout

Infrared inspection revealed no aberration in heat radiance along the mat except where it could be attributed to a difference in coil depth. When hard wired (disabling automatic shut-off) to the breaker, the mat stayed on and infrared showed it to be functioning correctly.
