# Applying Infrared Imaging Techniques to Marine Surveying

John (Jack) N. Allinson, II BS  
SAMS® Accredited Marine Surveyor AMS®  
Level 1 Certified Infrared Thermographer  
J.N. Allinson Associates, Inc.  
222 University Blvd. North #2  
Jacksonville, FL 32211  
Ph: 904-721-2177  
www.allinson.com

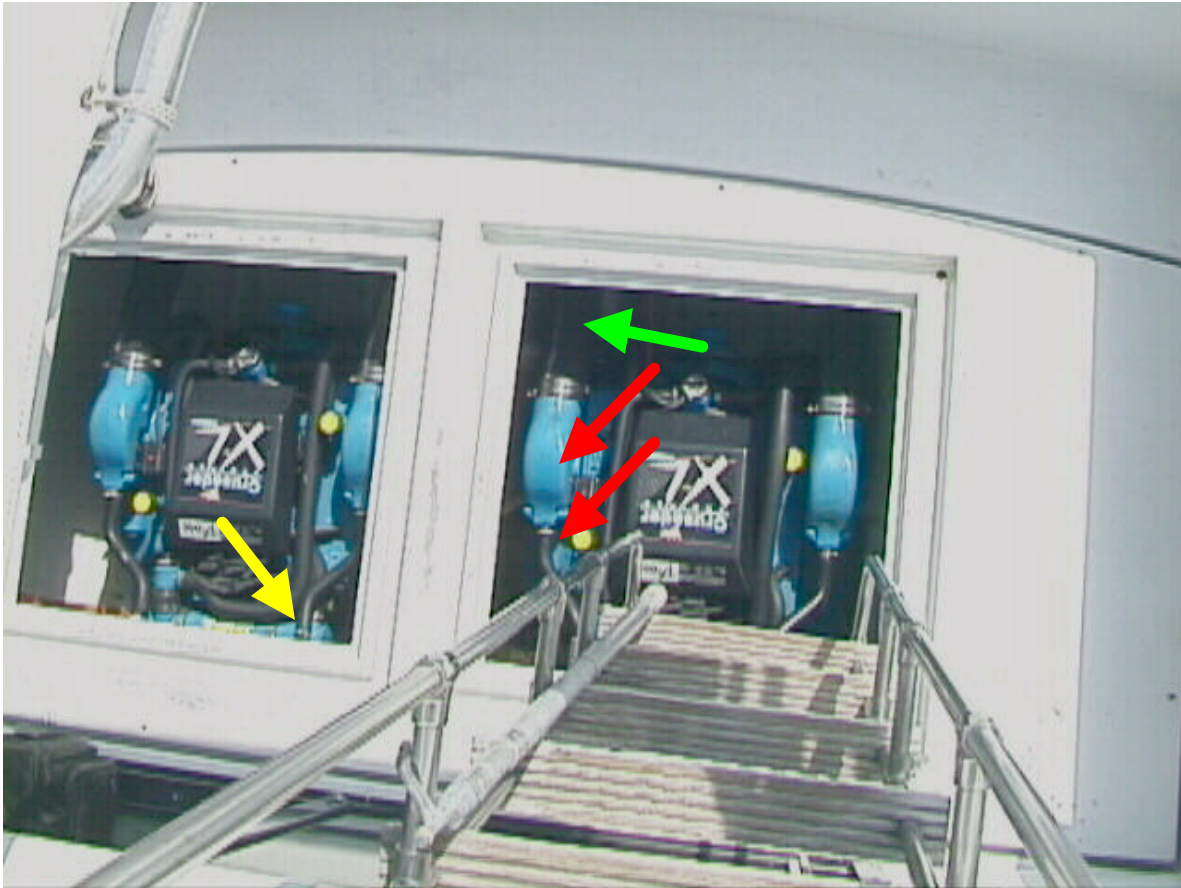
**Figure 1.** Looking down from above into the engine compartment. Here are two gasoline powered engines. Each engine has an open (raw water) and closed water cooling system. The raw water system takes the water that the boat is floating in, passes it through a heat exchanger (yellow arrow) for the closed water cooling system. Then, raw water mixes with combustion exhaust gases at the exhaust manifold (red arrows) and routes the cooled exhaust gases and raw water mixture overboard (green arrow) through an exhaust hose.
