# Trestles Anyone? A Thermographic Nightmare

Jon L. Grossman  
Hi-Tech Inspection Services, Inc.  
7520 NW 54<sup>th</sup> Street  
Miami, FL 33166  
Phone: 305-639-1820  
Fax: 305-639-1928  
www.hi-techinspections.com

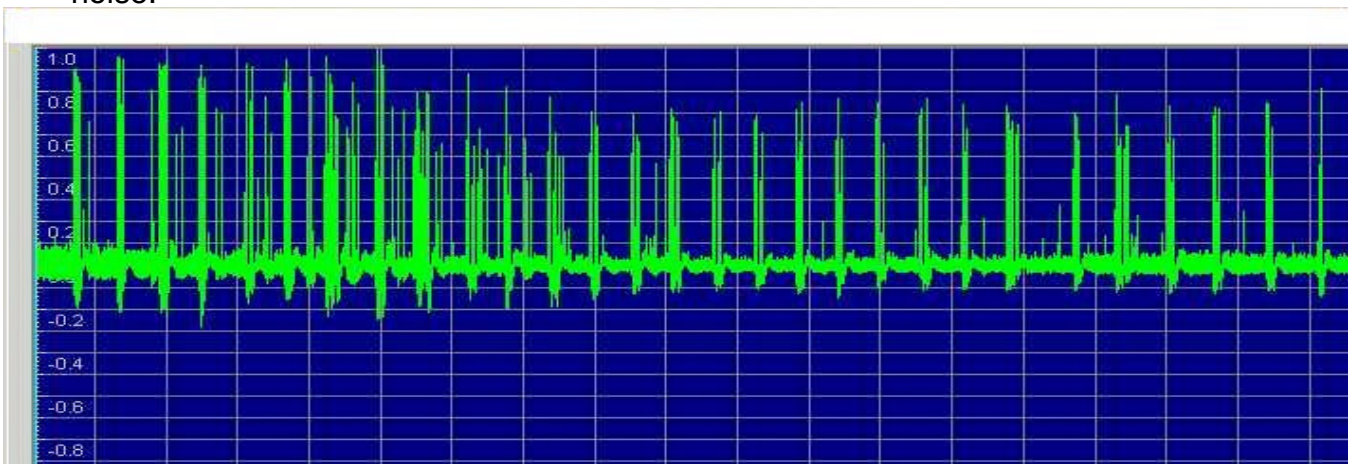
The image above is a waveform segment from an AED200L audio file of termites during head banging activity which takes place when the termites feel threatened

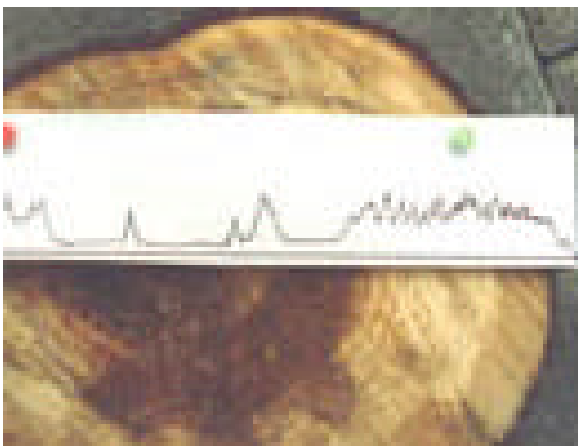
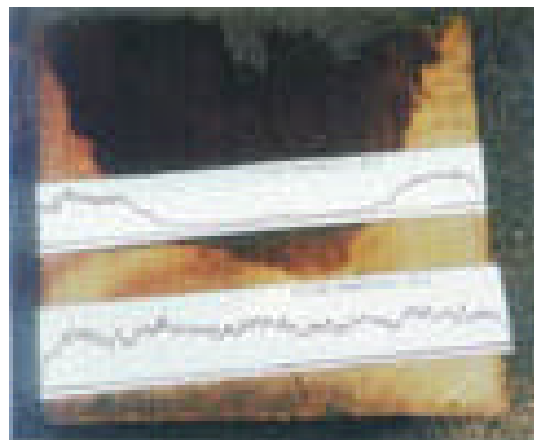
**The Resistograph graphic images of timber sections, clearly evidence the soft areas and voids found within the member**

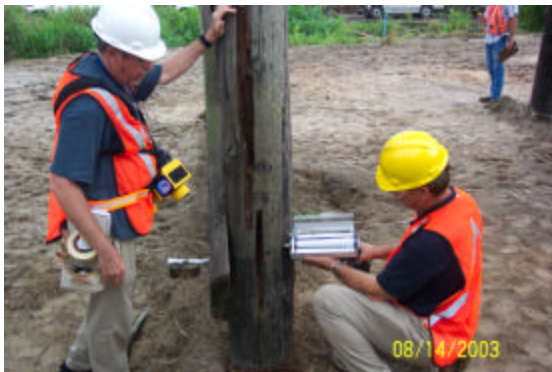
The resistograph image, above, of Bent 5, Piling 1 shows a typical grain pattern of wood in the area marked within the red oval. In addition, the graphic shows a void area of approx 1.5” in the area marked between the red arrows.

The digital image at left shows the Resistograph being employed on Bent 5, Piling 1.

Evidence of live termite activity is being recorded in the upper section of a Piling 1.

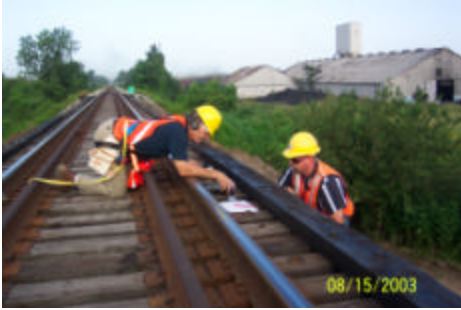
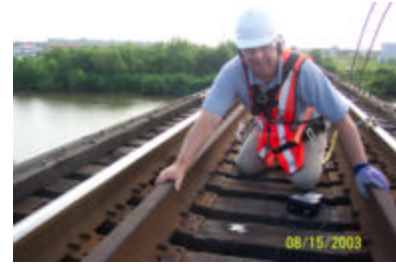
Digital images at left and right show acoustic inspection in Section A.

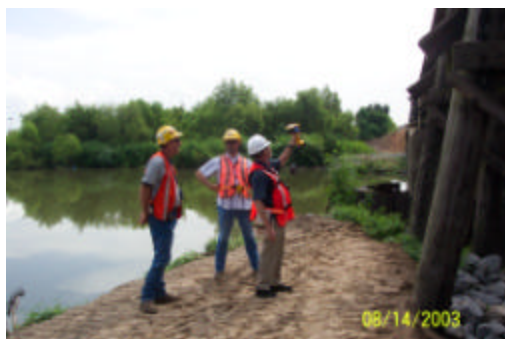
The digital image at left shows the IR camera in use in Section A near Bents 17 & 18.

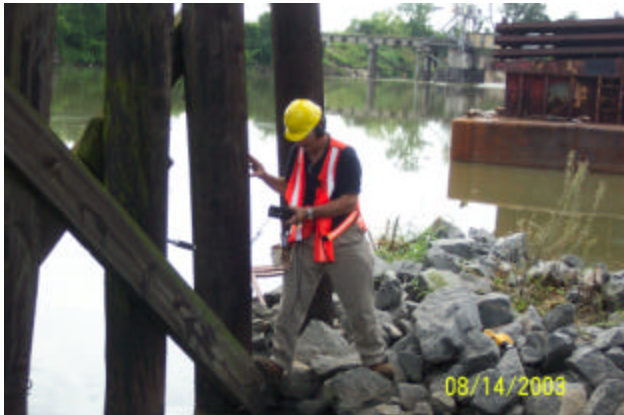
**“A” – Bent 20:** Acoustic means indicated Stringers 1, 2, 3 & 4, as well as Stringers 5, 6, 7 & 8, contained evidence of live termite activity.

The digital image at left shows AED2000 acoustic readings being taken near Section A, Bent 20.

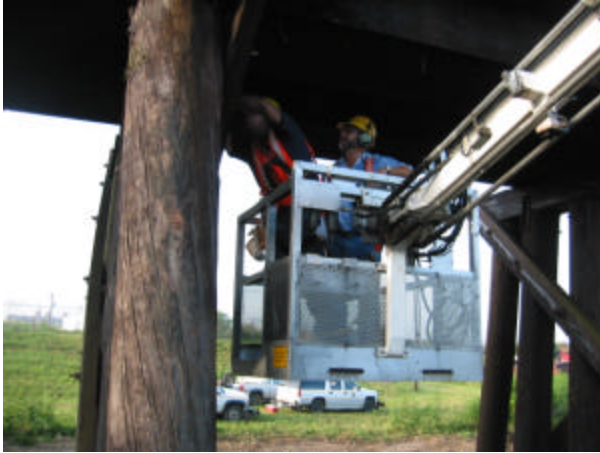
“C” – **Bent 13:** Mud tubes were located in Piling 1, extending into the Cap on the right side. Live termite activity was located in 3 ties.

Digital image at left shows the piling and caps structure being inspected in Section C.
