Infrared Thermography as a Diagnostic Tool for Roofing Systems

R. James Seffrin, Director
Infraspection Institute
425 Ellis Street
Burlington, NJ 08016
609-239-4788
www.infraspection.com

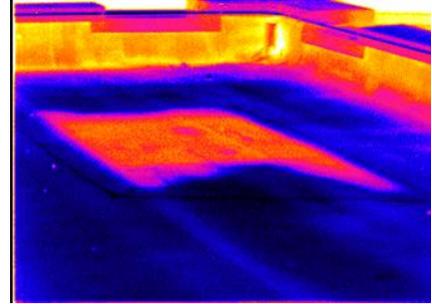
In cool weather climates or in locations where roofs receive an appreciable amount of solar loading, thermographers often rely on thermal conductivity to drive the inspection. Water in roof insulation reduces R value causing higher thermal conductivity. This higher thermal conductivity allows excess heat flow through the roof whenever there is an appreciable temperature differential between the air below the roof deck and outside air.

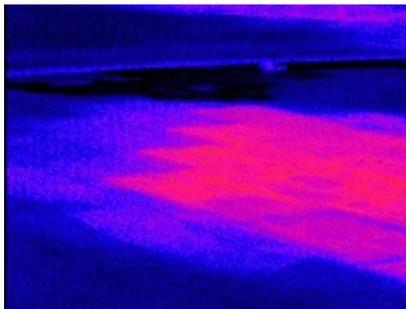
For most locations in the US, thermal imaging is performed post-sunset from the exterior of the building following a clear day. During an infrared inspection, a thermal imager is maneuvered across the roof in an organized fashion to ensure complete coverage. Ground-based infrared inspections are most often performed on foot using a handheld thermal imager to view the top surface of the subject roof(s). As an alternative, a thermal imager may be operated from manned aircraft such as a helicopter or airplane, or they may be performed using an unmanned aerial system or drone.

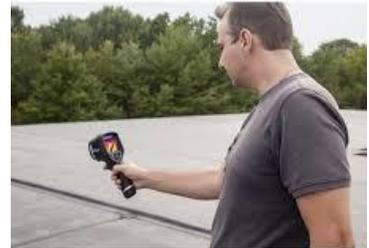
In order to help ensure accurate data collection, subject roof surfaces should be clean and dry at sunrise on the day of the inspection. In most cases, infrared inspections of roofing systems are conducted after sunset following a clear day with little or no wind. The actual time at which an accurate infrared inspection can be commenced will depend upon a number of factors including, but not limited to: amount of solar loading during the daytime, rate of air temperature change in the afternoon, evening cloud cover, and wind speed at the time of the inspection.

During the infrared inspection, thermal patterns which cannot be explained in terms of construction details, roof surface conditions, or external influences such as air exhausts are considered thermal anomalies. For walkover inspections, it is customary to outline the perimeter of thermal anomalies with spray paint and record them with the thermal imager. Should invasive verification be possible at the time of the infrared inspection, the thermographer can outline only those areas of the roof that are confirmed to contain wet insulation.

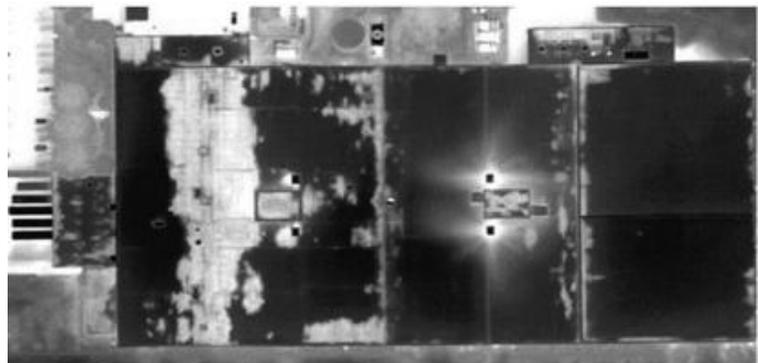
Image courtesy Stockton Infrared

For aerial inspections, thermal imagery is generally recorded to video files or to still images taken with the thermal imager. This imagery is then analyzed after the aerial mission has been completed. Areas of the roof found to contain thermal anomalies may then be invasively tested and a written report of findings compiled.

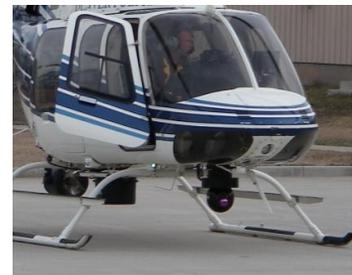
Infrared inspections have been performed from manned aircraft for well over 30 years. Given the altitude that such missions are conducted from, thermal imagers were often high resolution units similar to those used by military and law enforcement personnel. The resulting imagery was often remarkably clear and capable of detecting thermal anomalies measuring as little as one square foot in size.

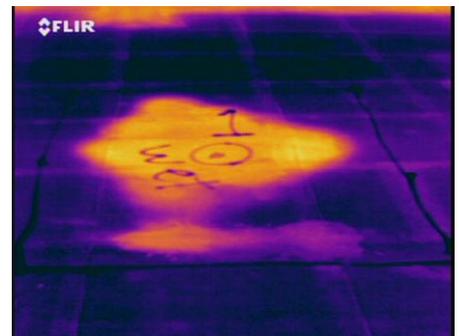
Presently, the majority of infrared inspections of flat roofs continue to be of the walkover type. Such inspections afford an average rate of coverage of 10,000 to 20,000 square feet of roof per hour. Walkover inspections allow for the detection of small anomalies that would be missed during an aerial inspection. It is also possible to mark the location of problem areas directly on the roof surface with spray paint or chalk. For infrared inspections where real time verification is available, it is possible to mark only moisture-damaged areas thereby saving time and possibly obviating the need for a return visit to the roof.
