# Decreasing Substation Failures with Ultrasound Technology

Adrian Messer, Manager of US Operations  
UE Systems, Inc.

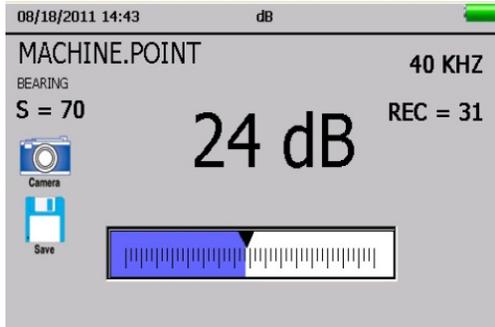
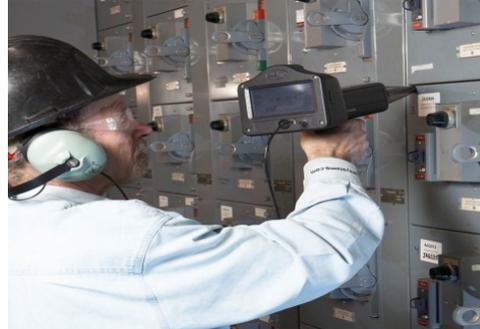
Airborne & structure-borne instruments give the inspector the ability to sense high frequency sounds that are not in the audible range, or the range of normal human hearing. Similar to the way that infrared cameras extend the sense of the inspector's vision, ultrasound instruments extend the sense of the inspector's hearing and allow the inspector to hear sounds that are not in the audible range. Ultrasound instruments translate high frequency sound into an audible sound that is heard through the headset by the inspector. The translated sound is then measured as a decibel level which is indicated on the display of the instrument.

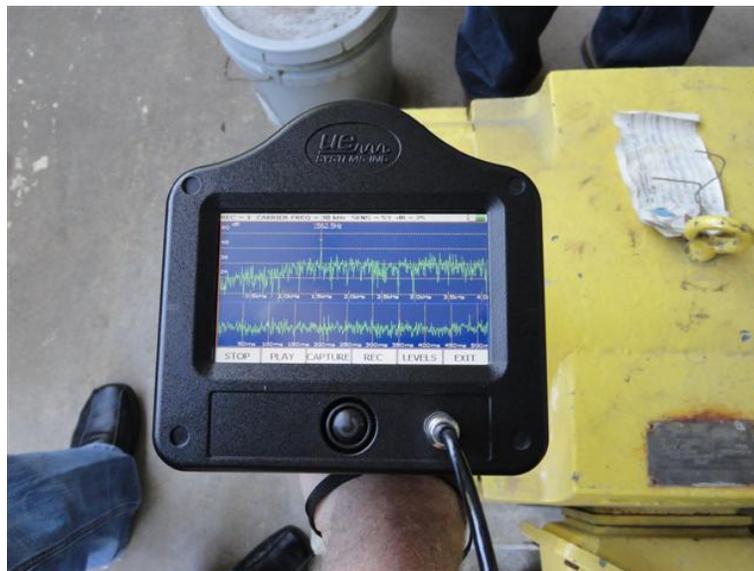
For further analysis, some instruments have on-board sound recording. Ultrasounds can then be recorded, and played back in a spectral analysis software to diagnose and confirm sounds heard by the inspector. Newer model instruments, such as the Ultraprobe 15000, actually have on-board spectral analysis. This allows for on-the-spot analysis and comparison of electrical emissions in the field. The analysis of recorded ultrasounds is the best, and preferred, method of diagnosing electrical emissions. This method reduces the subjectivity of only using what is heard through the headset to determine the severity of electrical ultrasound emissions.

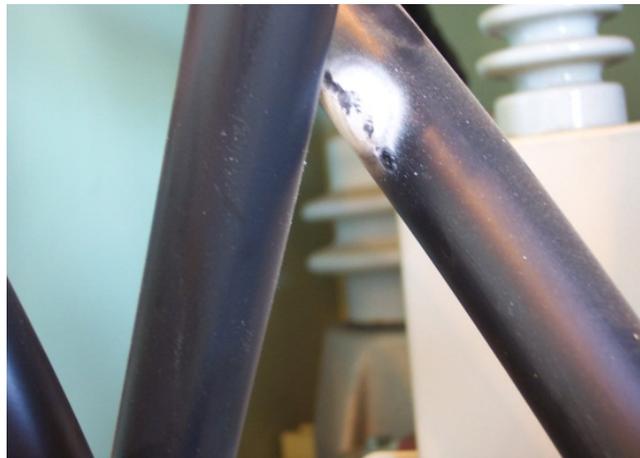
**Corona, over time, deteriorated the connection and eventually led to tracking**

Corona discharge occurs from the ionization of air surrounding an electrical connection. This event will only occur in voltages exceeding 1000 volts. Ionization produces no heat; therefore, it is not detected with a standard infrared camera. Corona, when not corrected, will only lead to a further breakdown of the insulating material and connections. This is primarily due to the byproduct of the ionization process, nitric acid. Another threat caused by corona discharge is ozone. Damage to insulating materials, O-Rings, seals, and internal breakdown of transformers can occur as a result of ozone created by corona. It is heard as a steady, uniform, static-like buzzing sound.

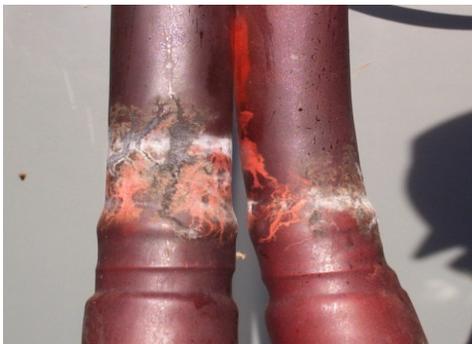
**Tracking between two connections led to arcing**

Tracking occurs when there is a low current pathway to ground across an insulator. Many will refer to tracking as “baby-arcing.” This event is common where there is severe breakdown of the insulating material and loose connections. Tracking can occur in low, mid, and high voltages and characterized as a steady buzzing sound with periodic “crackling” and “popping” sounds. Further damage is done when tracking is not corrected, and will rather quickly lead to arcing.

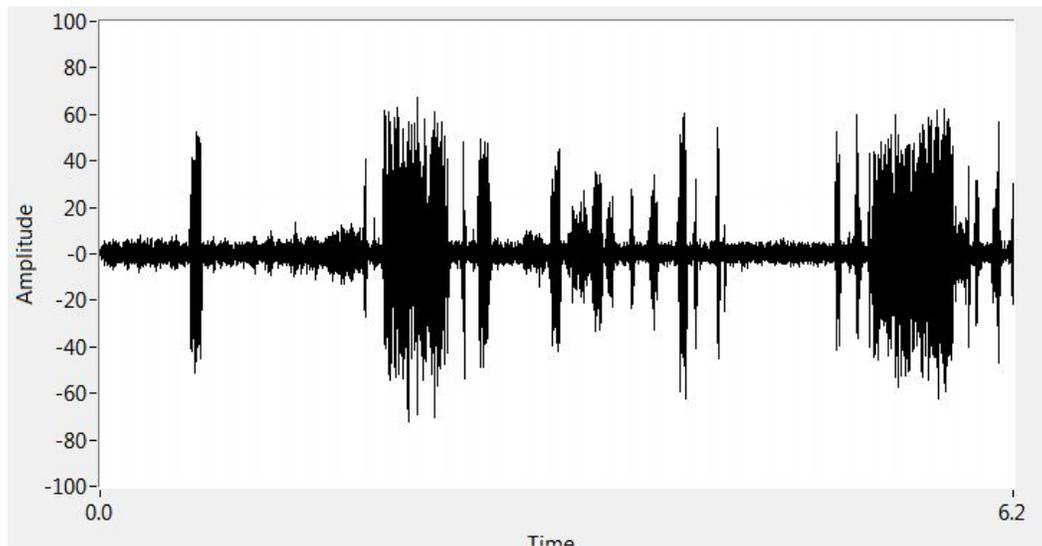
**Arcing as seen in the Time Wave Form. Notice the lack of uniform harmonics and the sudden starts and stops of the discharge**

Arcing happens when there is a discharge to ground across an insulator. Arcing causes severe damage to equipment, plant/facility operations, and people. Melting of connectors, damage or loss of insulation, and fires usually result from electrical arcs. Arcing can easily be heard and detected with ultrasound. The sound characteristic for arcing is rather erratic bursts of discharges and popping sounds. These are identifiable when looking at a recorded ultrasound of arcing in the Time Wave Form.

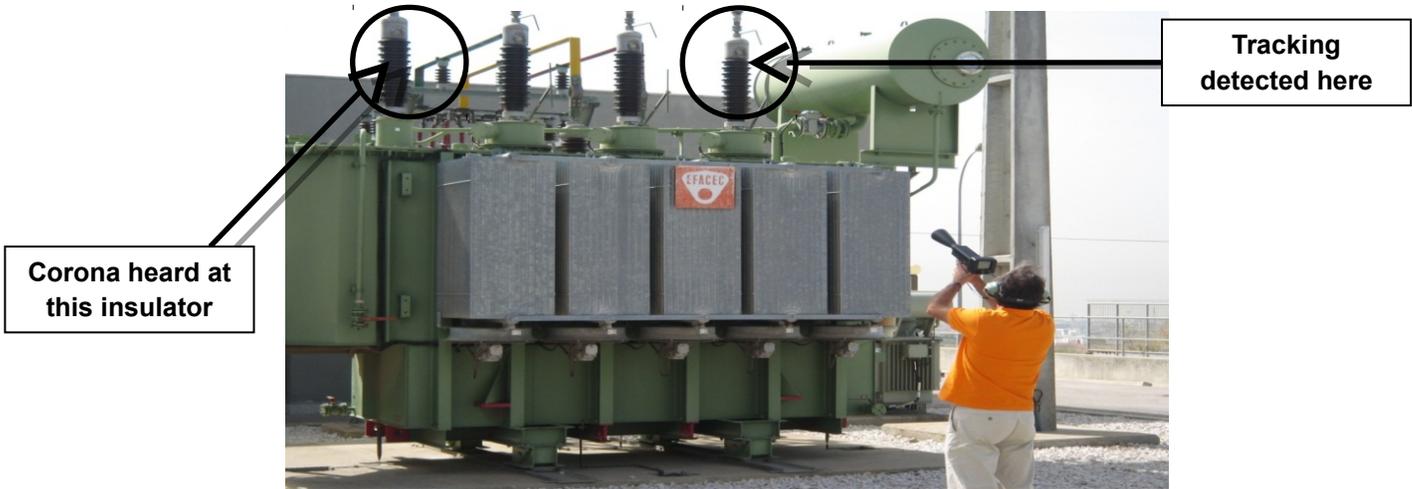
In the example below, ultrasound inspection was performed on a substation. The picture shows where two sounds were heard on the insulators. Both corona and tracking were detected with ultrasound. The corona was corrected by cleaning both the insulator and the surrounding connections. To correct the tracking, the insulator had to be replaced due to cracking.

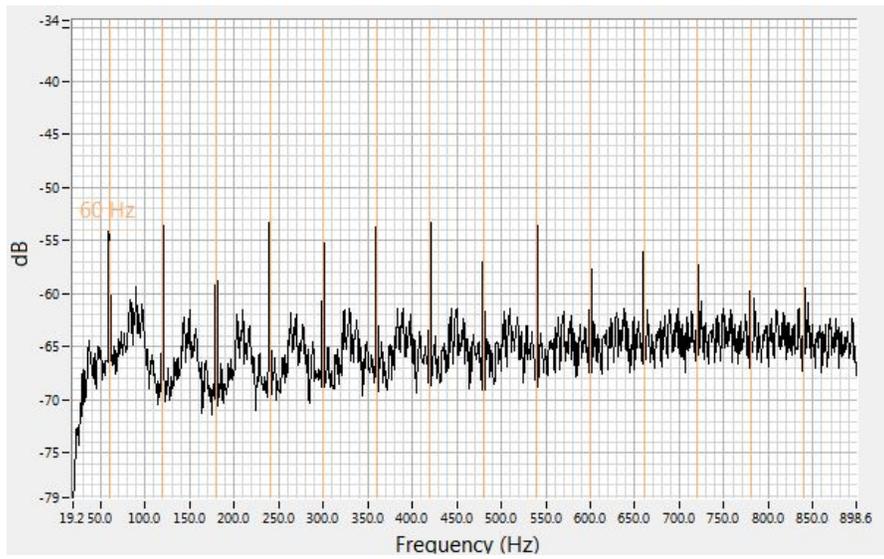
Corona

The images below are from the recorded ultrasounds from this transformer.
