Advanced Techniques in IR Thermography as a Tool for the Pest Management Professional

Jon L. Grossman
Hi-Tech Inspection Services, Inc.
7520 NW 54th Street
Miami, FL 33166
Ph: 305-639-1820
Fax: 305-639-1928
www.hi-techinspections.com

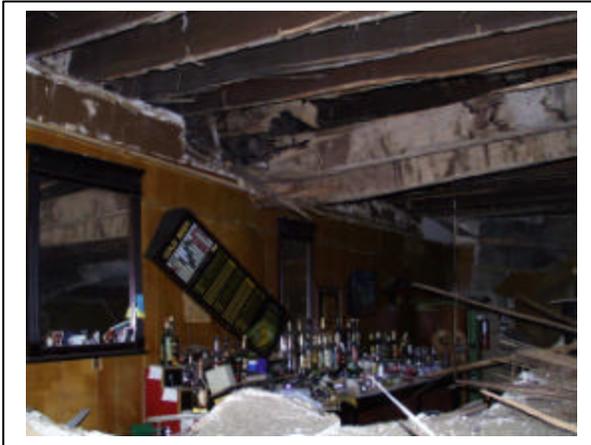
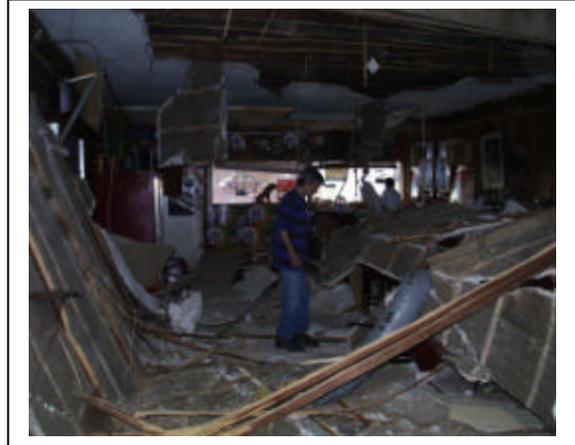
Above are two views of the Le Dale Hotel and Bar ceiling that collapsed from Formosan termite damage. Courtesy Jack Leonard – New Orleans

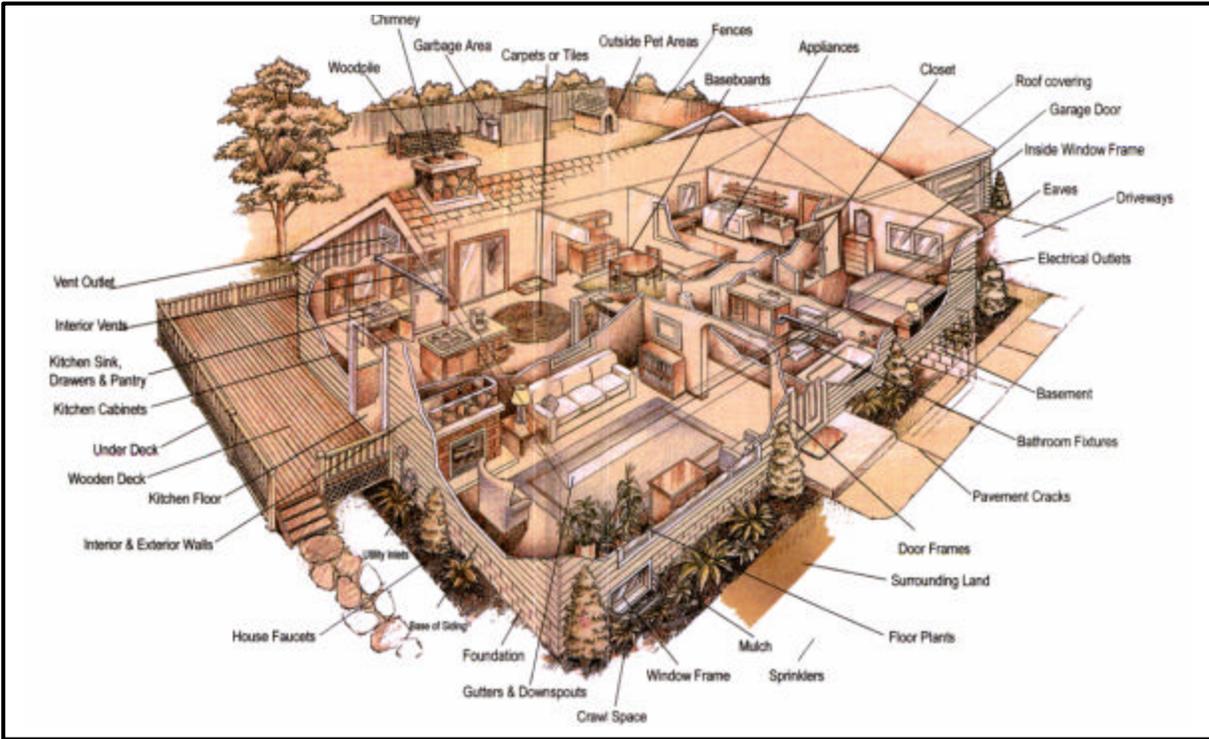
Pest control inspections can be a tedious process. If one thinks about the work that needs to be performed, time is money, and the longer an inspection takes, the higher the cost to the inspector. Ideally, any inspector would like to do a drive by inspection. You ask, what's a drive by inspection. It's when you leave the motor running and do a complete house inspection in 15 minutes and, of course, sign off on it. Very few people realize the extent of or the number of elements that are required in a complete pest inspection. Even fewer inspectors have priced their inspections at rates that permit them to make a living. The following image points out most, but not all, of the elements that must be taken into consideration in a pest inspection.

You will note that there are elements both inside and outside. One must be careful. A complete inspection will cover scanning almost every inch of the premises. With the increase in liability factors and the fact that we are becoming a more litigious society, many pest inspectors and even the public are beginning to realize that a more professional inspection needs to be performed and this cannot be done for free nor for an immodest sum of money. A thorough inspection, including validation, will take at least one to two hours for a small to medium sized house for an experienced inspector/thermographer.

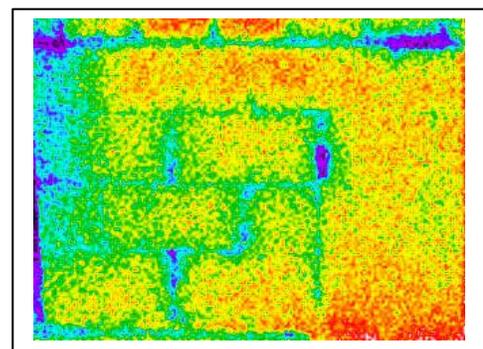
Cement block – Termites? Mold?

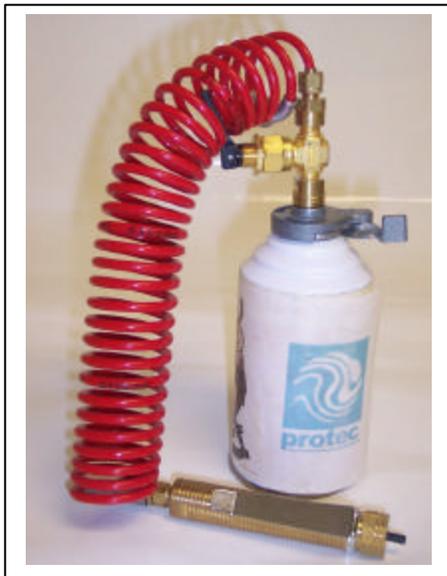
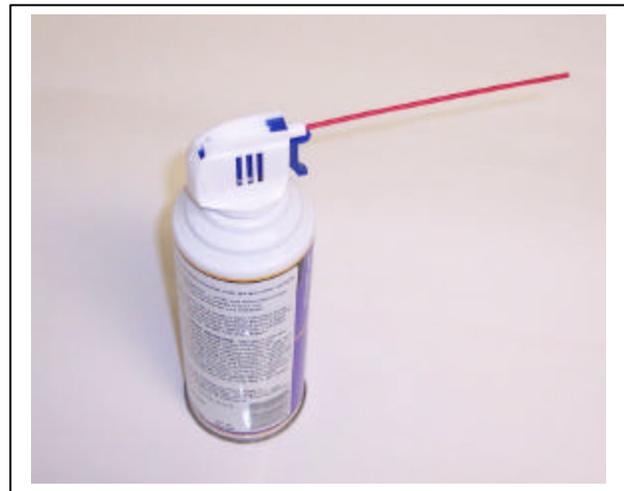
Compressed Air w/ a variety of hoses & applicator tips

Active cooling can be accomplished by injecting air or other gasses that have been compressed into holes or crevices. As the air is being injected, it will expand from its compressed state and will cause a cooling effect of the surrounding materials it contacts, thus creating anomalous cooling. The effects will be seen anywhere from milliseconds to a few seconds depending upon the depth and volume of the internal structure as well as the depth from the surface and the insulating abilities of the material. Metal, for instance, will react more quickly than wood.

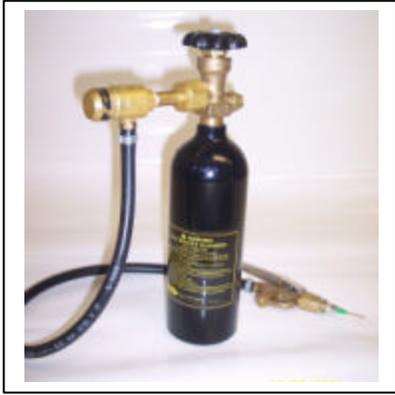
Compressed CO₂ with Air hose

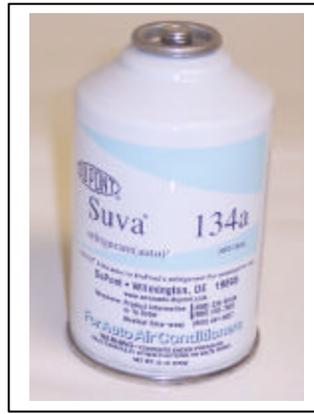
Refrigerant (above)

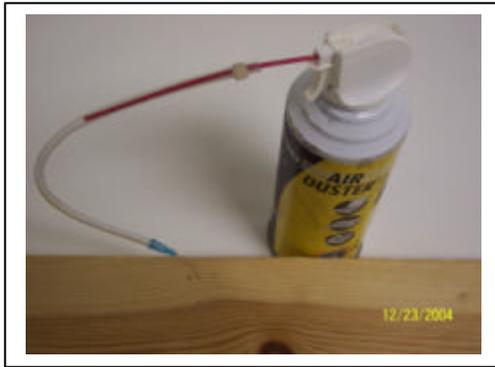
Compressed Air w/ Hose & Needle Insert (above)

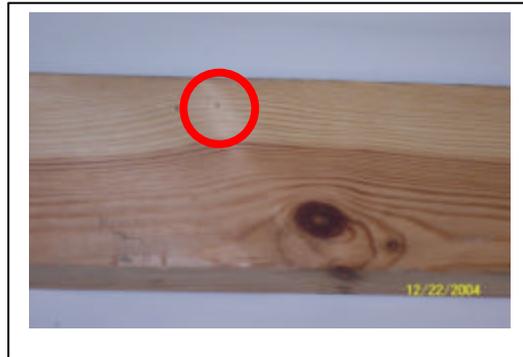
2 x 4 Exhibiting Spot - Possible Kick Hole

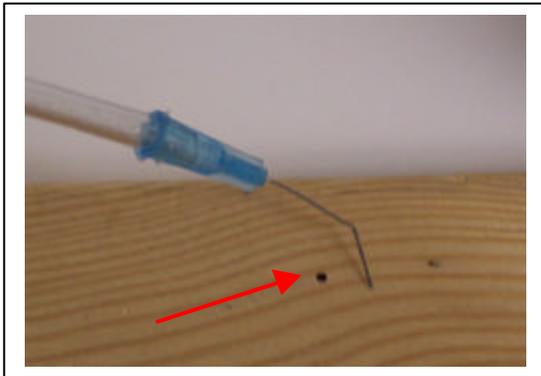
Air hose with Tip to Kick Hole

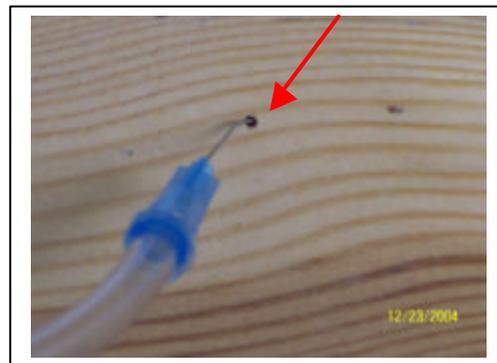
Tip in Kick Hole

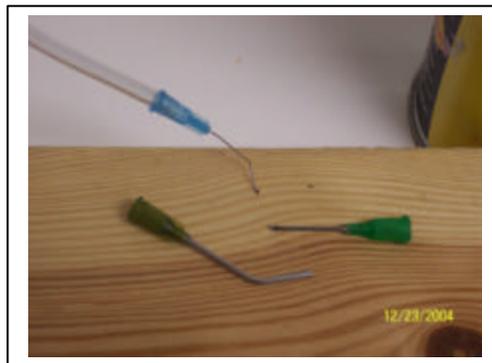
Different Tips

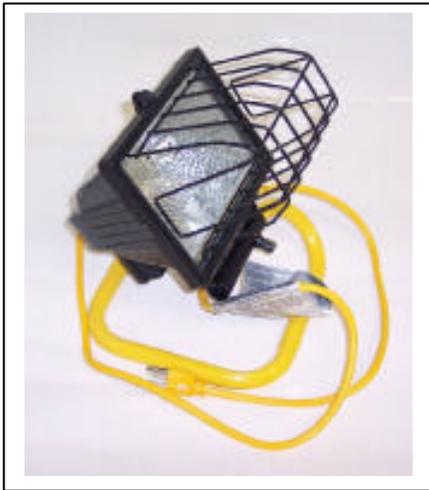
Halogen Lamp w/ Switch

Active heating can be used to identify areas with subsurface defects. This can be accomplished by actively heating the area you are examining with lamps or forced air. As the surface is cooling, the areas with anomalous cooling behavior will begin to show. The effects will be seen anywhere from a few milliseconds to a few seconds depending upon the depth and volume of the internal cavity structure as well as the depth from the surface and the insulating abilities of the material. Metal, for instance, will react more quickly than wood.

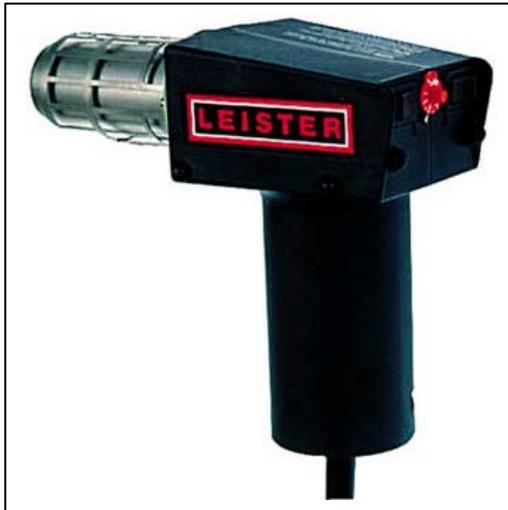
Hot Air Gun – Variable Temperature

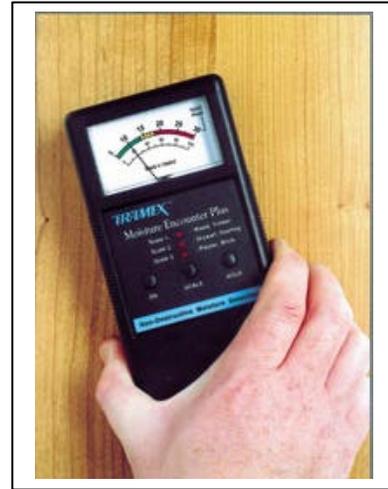
**Tramex
Moisture
Meter**

Locating the presence of latent moisture is not enough. A pest thermographer must then confirm the presence and level of moisture. Usually, a moisture meter will be employed.

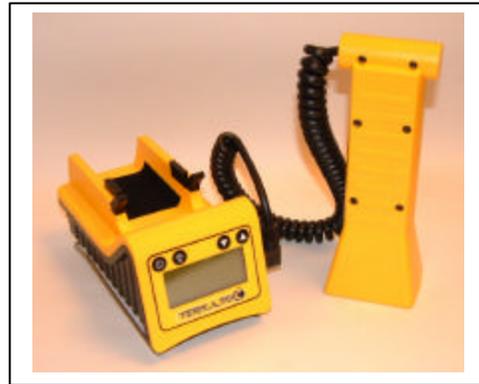
Termatrac[®] is a hand-held portable detection device using patented microwave technology. Termatrac[®] can detect insects and other pests in unseen areas such as wall voids, cracks, crevices, air pockets, construction flaws, beneath floors, and in ceilings, etc. Termatrac[®] will detect activity through a variety of materials such as brick, wood, stucco, concrete block, ceramic tile, marble, terracotta tile, mica, plastic veneers, vinyl and many other materials. Termatrac[®] is non-invasive and non-destructive, thereby avoiding damage to a client's property.

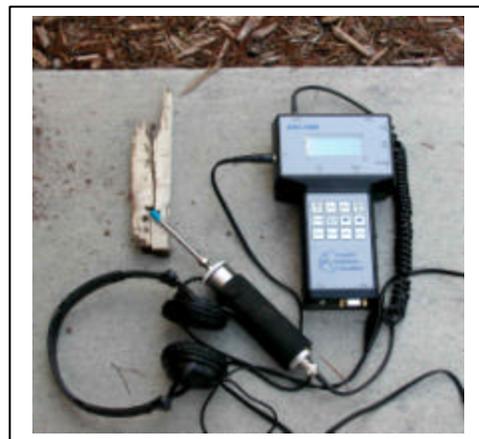
AED 2000L is a portable hand-held instrument that is the most advanced and sensitive acoustic detection system for locating termites and hidden insect pest infestations in wooden structures, trees, plants and soil. The AED, a product of several years collaboration with the USDA Agricultural Research Service, literally permits the user to listen to the insect pests eating their way through wood or even, in some cases, walking.

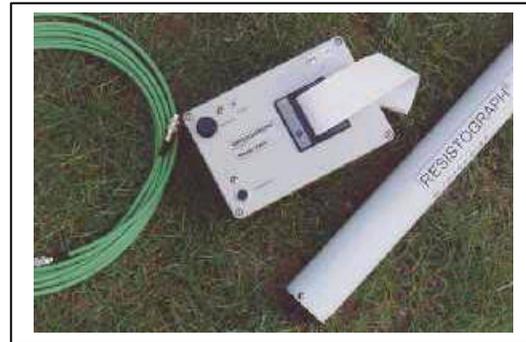
The Resistograph is an instrument that is utilized to measure the structural integrity of wood structures. Utilizing a very fine drill, the Resistograph, as the drill penetrates the wood structure at a predetermined rate and torque, measures the resistance and changes in torque to provide a printable data record of the probing actions. If there is an insect pest gallery present or if there is wood decay, the Resistograph will provide the data necessary to make a structural analysis of the situation.

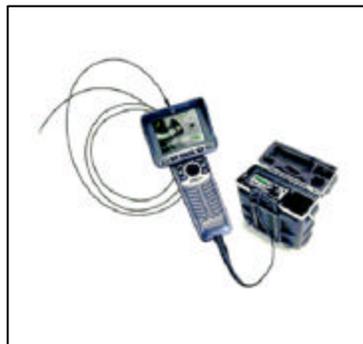
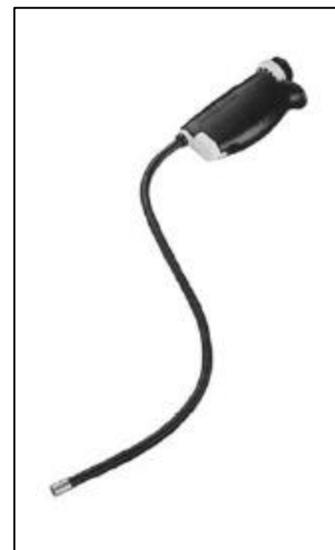
Borosopes, both manual and video imaging, can provide crucial confirmation of the presence of insect pest infestations. Inserted through a tiny hole, the boroscope probe can be manipulated to the suspected area of infestation where visual confirmation can be obtained. Either video or a digital imaging camera can be utilized to record the findings.

**Simple Articulating Boroscope (above)
Video Imaging Boroscope (left)**

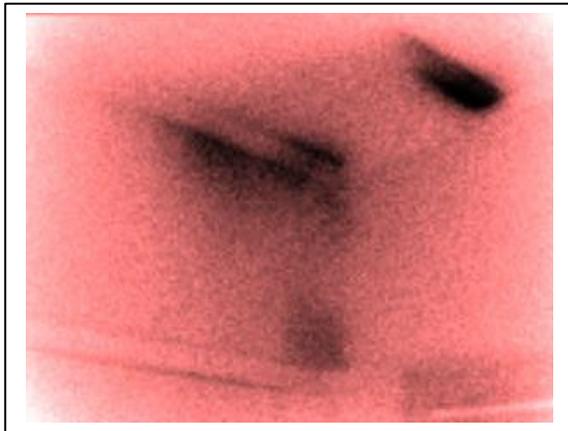
Example #1 – Anomalous cooling in ceiling and adjacent wall

Preliminary – moisture (source unknown)

Validation – use moisture meter

Confirmed – moisture – level in red zone

Suspicion – insect pests or mold

Validation – use Termatrac

Result – no activity

Validation – use boroscope

Result – Mold

Search for source of moisture

Diagnosis - Mold caused by roof leak

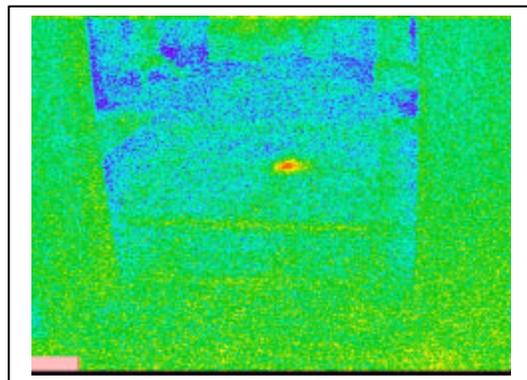
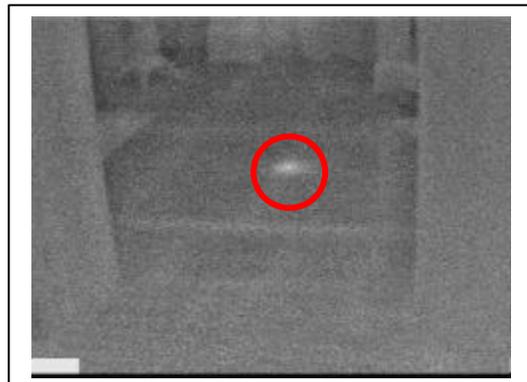
Example # 2 - Remember Page 6 , Question #1

Anomalous heating in floor area

Preliminary – wiring problem

Validation – no apparent electrical conduit or circuitry

Validation – use Termatrac

Result – meter indicated activity

Validation – use AED

Result – hear active termites

Diagnosis – Termites – above ground colony

Additional tools & activities – boroscope, search crawl space or basement, track back to entry point

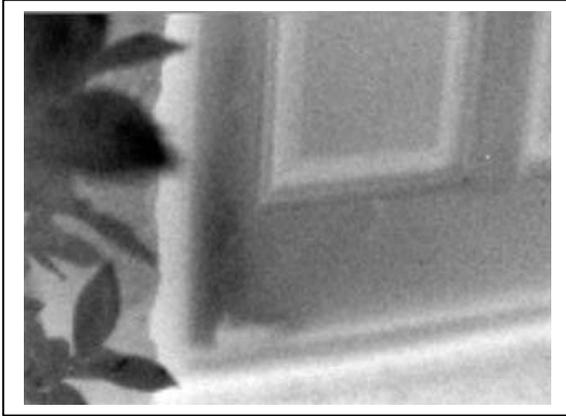
Example # 3 – Subsurface defect in side of door

Preliminary – moisture or subsurface defect

Validation – moisture meter

Results – slightly above ambient

Validation - Termatrac

Results – activity

Diagnosis – termites

Active steps – inject cool air

Diagnosis – Dry wood termites, gallery lit up

Additional tools & activities – use Resistograph

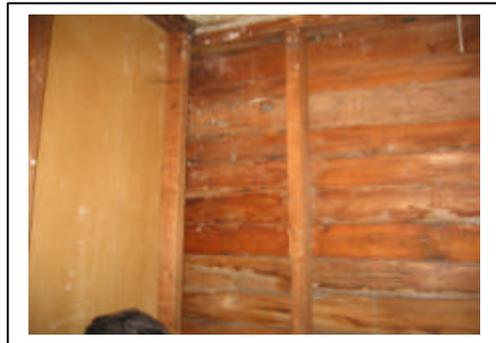
Situation: Subsurface defects seen

Other visual evidence of damage

No evidence of anomalous cooling

Frass evident

Tiny holes seen, possibly kick holes

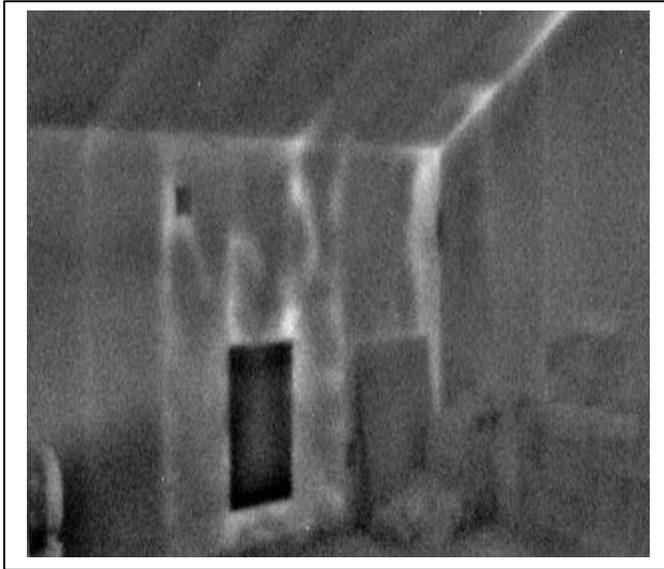
The presence of warmer appearing areas within wall structures may be somewhat confusing. The warmer areas in this image are due to displaced insulation. They are actually caused by mice tunneling within the walls, displacing the insulation in areas surrounding an air duct inside the walls of a child's playroom. These tracks would go undetected in an ordinary visual inspection.

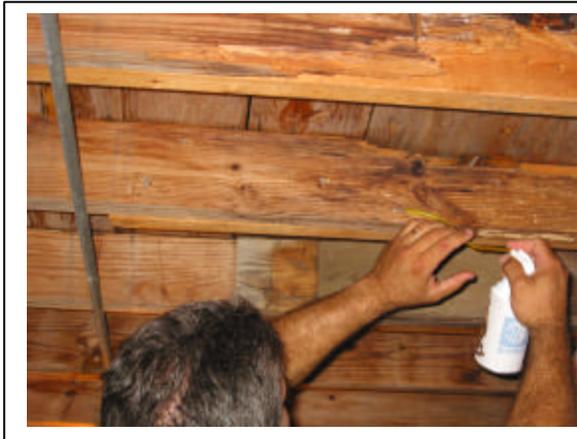
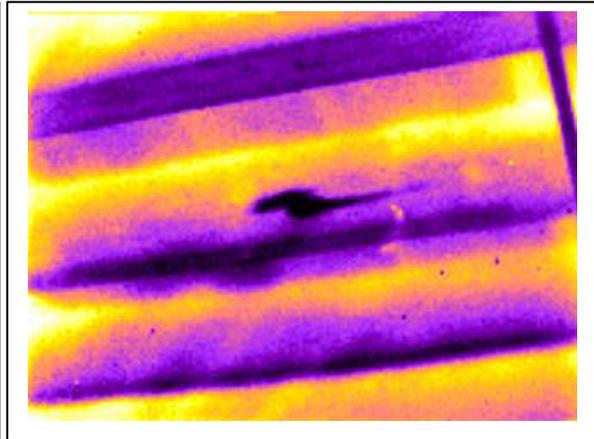
Initiating active cooling to enhance dry wood termite gallery

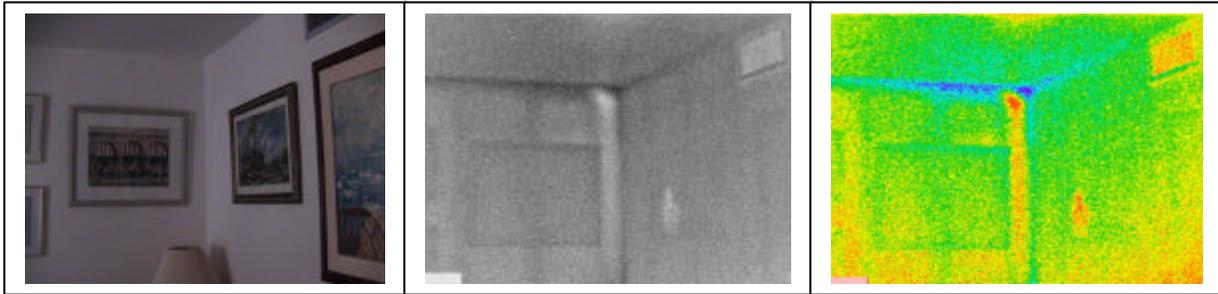
What is it? From page 6

Answer - Digital, grayscale and colorized image of wall area with active termite activity.
Courtesy - Michael Potter, PhD. Lex., KY.

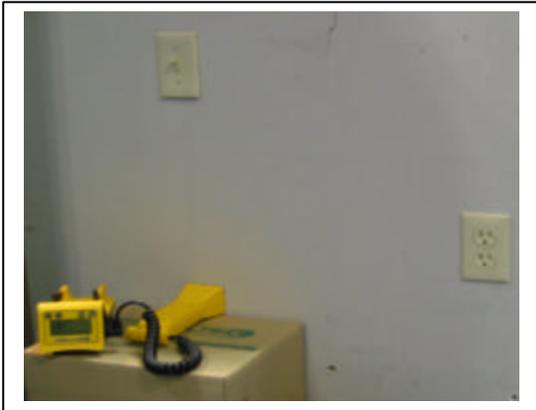
Wall face showing Termatrac in use

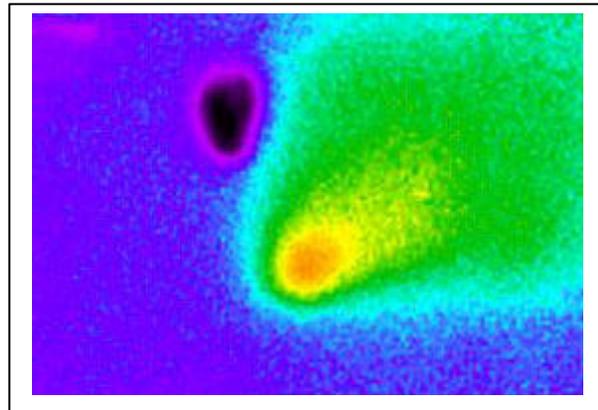
IR HC image of anomalous heating and cooling

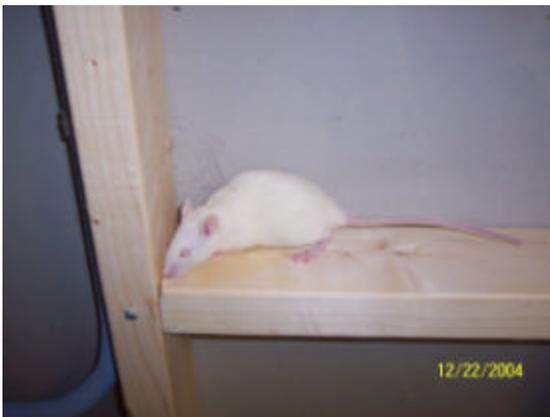
Trade show display

Heat – rat in wall display
Cooling – water placed on display to demonstrate moisture

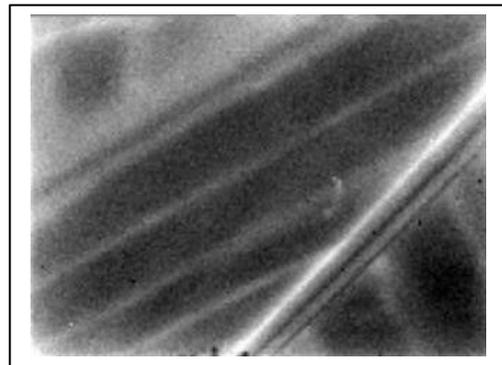
Beams seen in a cathedral ceiling

In addition, since the use of thermal imaging will permit the ability to see the thermal patterns caused by hidden wall structures, the use of the imager to locate appropriate locations for chemical treatments or for the remediation of a pest problem is an essential tool. As can be seen in the image at the right, assume that an infestation has been found in a cathedral ceiling, the uses of a

thermal imager will permit the placing of the required treatment chemicals in the required locations. If a section is missed, it may provide harborage for the insect pest to survive.
