Infrared Applications in Building Diagnostics

Ron Lucier, ITC Training Center
FLIR Systems, Inc.
16 Esquire Road
North Billerica, MA 01862
Ph: 978-901-8675
www.flirthermography.com

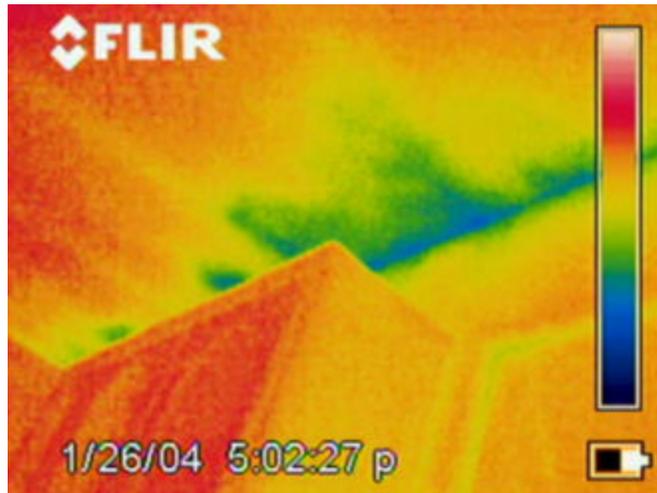
This infrared color thermal image shows a thermal pattern typical of moisture infiltration, a potential source of mold growth, in the corner of ceiling.

Infrared imaging can identify thermal patterns associated with latent moisture, and thus potential mold, in building materials by their difference in temperature from nearby dry areas. Typically, wet areas on interior building surfaces are cooler by several degrees Fahrenheit than materially similar, but dry areas. Thermal imaging minimizes the need to perform destructive testing, provides instant visual documentation of findings and provides evidentiary-quality, intuitively understandable data with a much higher degree of accuracy and reliability than moisture meters and other moisture detection technologies, allowing restoration and construction companies to complete their work much faster and less expensively than in the past.

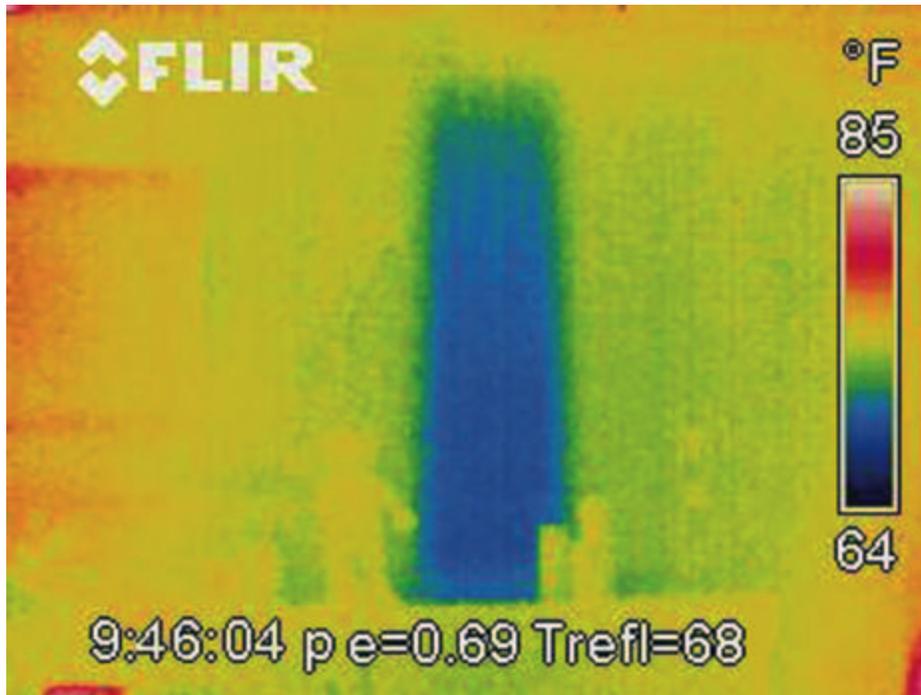
This IR thermogram clearly identifies the source of a cold spot in a residential living room: a stud bay missed during blow-in insulation process.

An IR camera can quickly and non-destructively detect areas of missing, moisture-laden or otherwise damaged insulation in walls, crawlspaces and attics or around doors, windows, electrical outlets and other access plates. All can increase a building's energy costs by allowing cold air to enter the building and heated air to escape in the winter, and the reverse in the warmer, summer months. IR can also identify poorly insulated or uninsulated pipes, another source of costly heat losses.

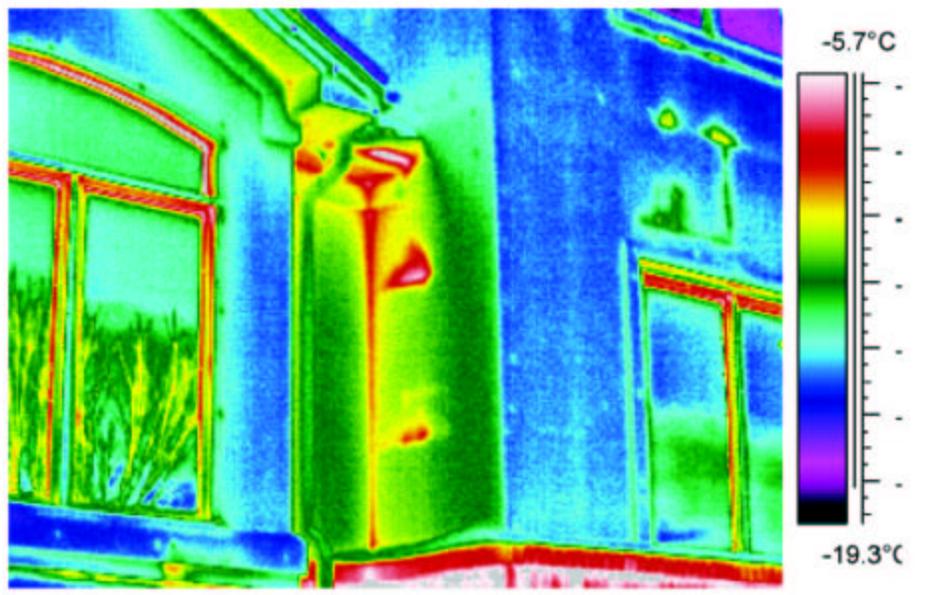
The red hot spot on this infrared thermogram was caused by latent moisture that entered due to a missing sheet metal 'kicker' flashing behind the EIFS facade of a single family home.

The increased use of EIFS (Exterior Insulation and Finish Systems), stone, stucco and brick veneers and siding as facades on residential as well as commercial buildings invites the possibility of water intrusion if they are not properly installed. IR can detect evidence of moisture infiltration in these weatherproofing 'barrier' systems, usually the result of insufficient detailing such as inadequate or improperly applied flashing or sealants. In addition, IR can monitor and track moisture migration paths within the wall cavity.

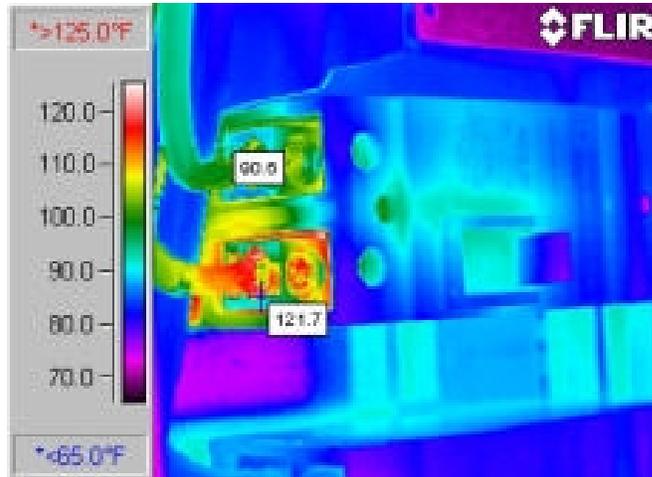
In this thermogram of a 240V 110A breaker, the load rating (95) of the B phase exceeds 80% ampacity and its temperature exceeds the breaker's rating.

Infrared cameras are very effective at detecting overloaded circuits, faulty wiring, and loose electrical connections. All generate heat and can pose serious fire hazards .

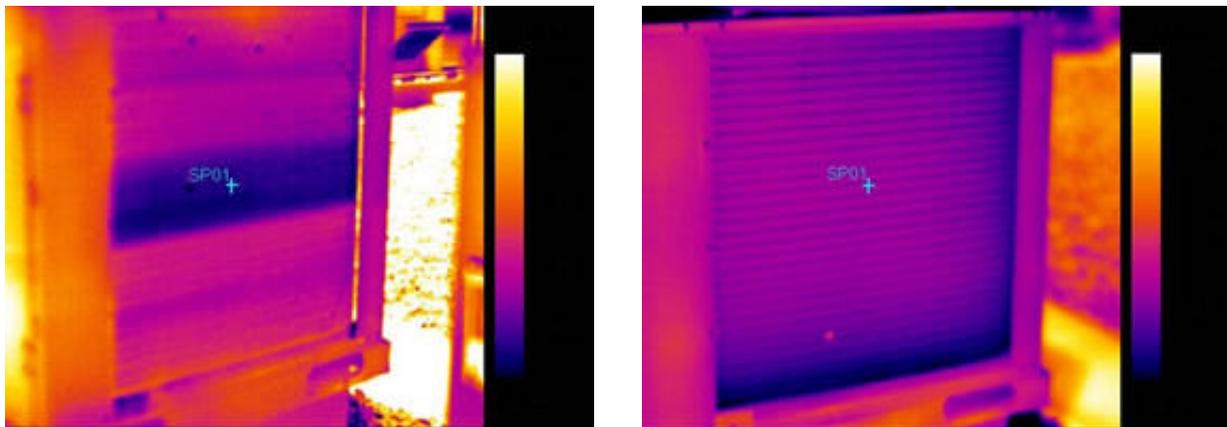
These IR images show rooftop HVAC units. The left image shows a dead evaporator coil bank. The right image shows proper operation.

IR can also detect thin spots in the linings of furnaces, heat exchangers and flues, mechanical problems such as worn, under-lubricated pumps and motors, bearings in fans and compressors and electrical faults, refrigerant leaks and blockages in HVAC components, another source of costly energy waste.

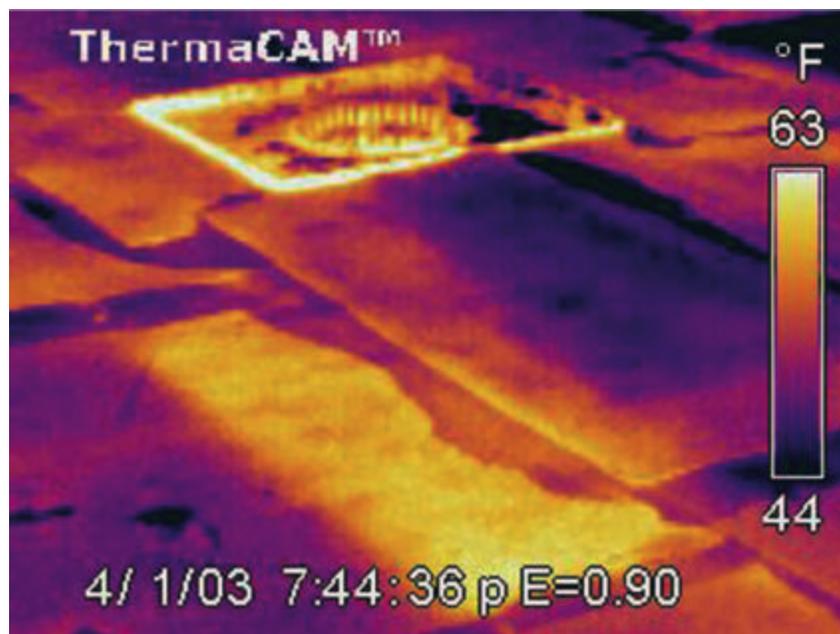
The warmer red, yellow and white areas of this IR thermogram of a roof taken after sunset indicate moisture-soaked insulation caused by leaks around the walkway and roof drain.

An IR roof inspection is best conducted after sunset, since the wet areas retain the heat absorbed during the day longer than the surrounding dry areas, causing a temperature difference that can be imaged, with the wet areas showing up as hot spots.

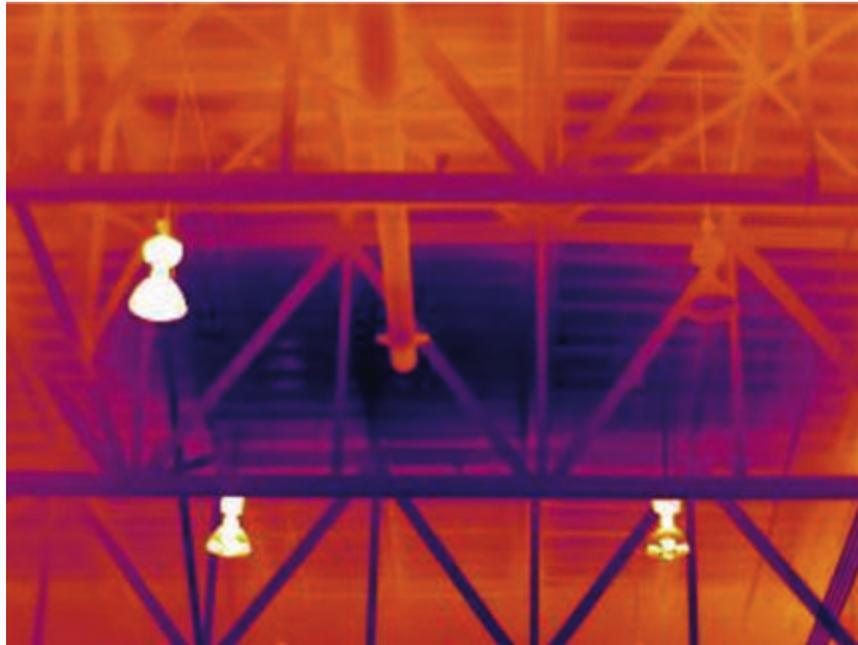
This IR thermogram of the underside of a standing-seam metal roof was taken in the morning. The purple area was later verified by invasive testing to be wet. The yellow and orange areas were dry.

IR can also be used to inspect roof decks from inside a building, a highly effective approach when working with metal and ballasted roofing systems, which are difficult or impossible to inspect from above. In this case, inspection is performed shortly after sunrise, when the wet areas of the underside of the roof warm up more slowly than dry areas and show up as cold spots. Such anomalies are easily imaged with currently available lightweight, handheld IR cameras, which can discern temperature differences down to 0.08 of a Fahrenheit degree.

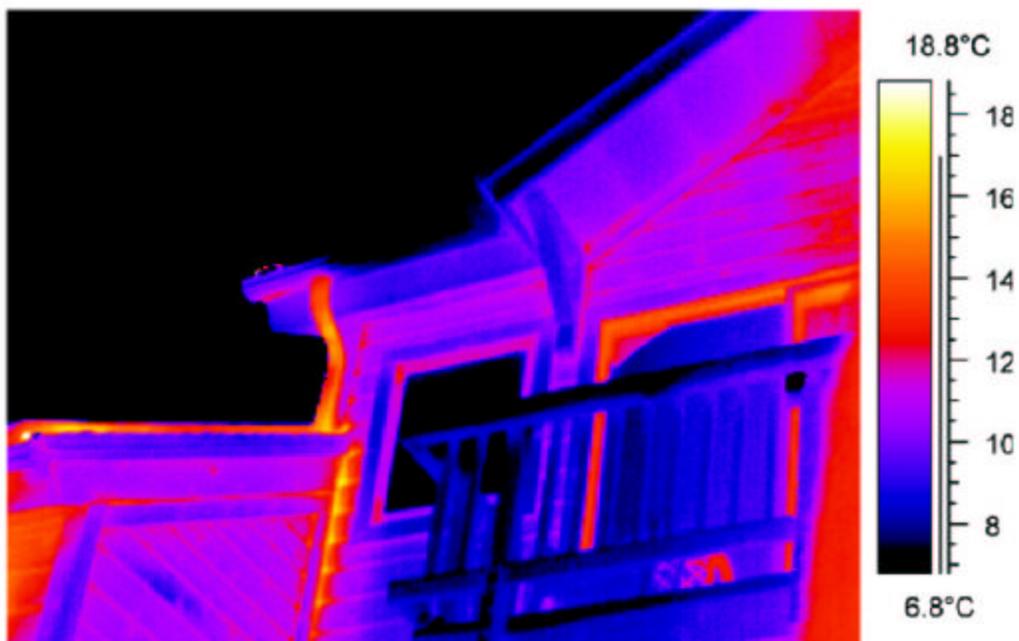
Here, IR identified a partially inoperative heat cable section in a gutter ice melt system, the result of a damaged cable and connection.

An IR camera can effectively evaluate deficient conditions in a cold roof system by measuring temperature differentials indicative of heat loss that can result in heated sheathing surfaces that allow snow melt and subsequent ice damming. IR can also be used to check for dead spots and insufficient coverage of ice melt systems used to prevent the freezing of gutters and downspouts.

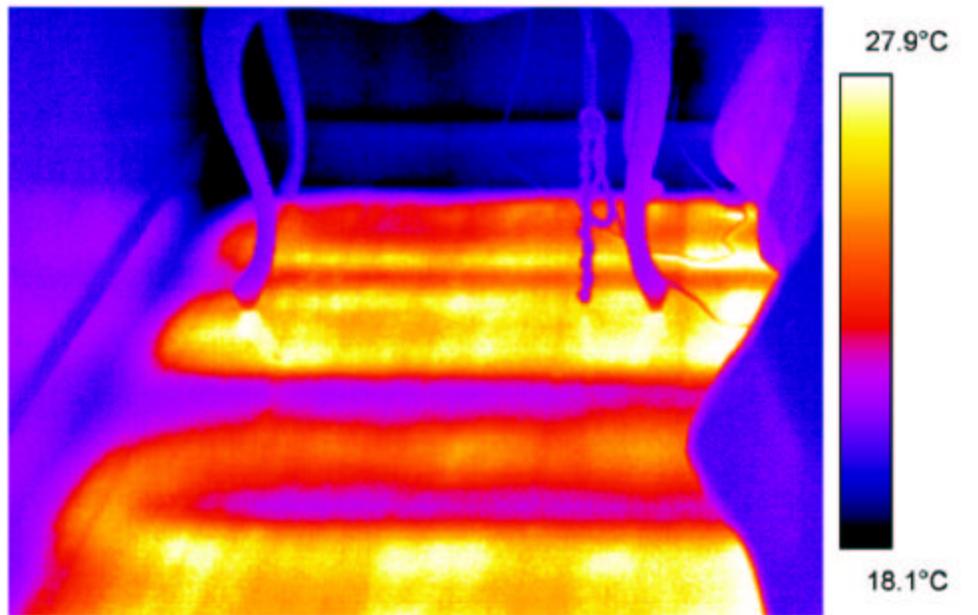
This infrared image shows the normal operation of an in-floor radiant heating system.

Infrared can be used to investigate interior and exterior in-floor radiant heat systems used for heating inside and for eliminating the need for shoveling to reduce the risk of slips and falls outside.

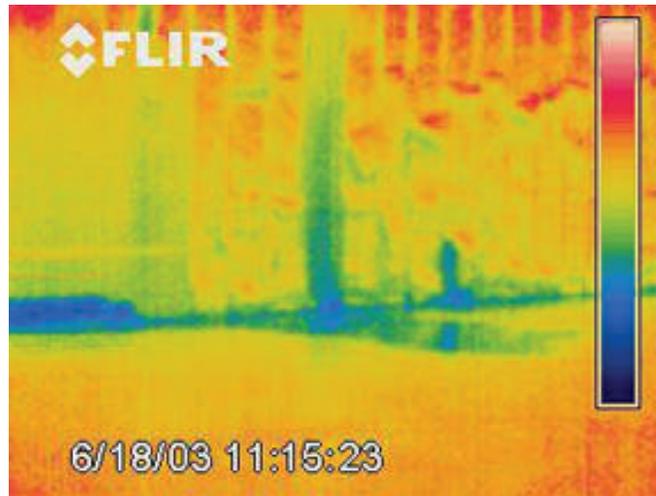
This thermogram shows water and moisture remaining from sprinklers that were activated during a fire that was knocked down about 11 hours earlier. Note how the IR image clearly identifies the wet areas in the insulation and building structure and on the floor by their relatively cooler temperatures.

After fires, for example, IR can quickly locate remnant hot spots or assure the fire is completely extinguished and provide invaluable data for insurance companies' Cause and Origin investigations. The clear IR images of diagnostic evidence normally invisible to the naked eye can assist in the planning and execution of the restoration effort and in the settlement process.

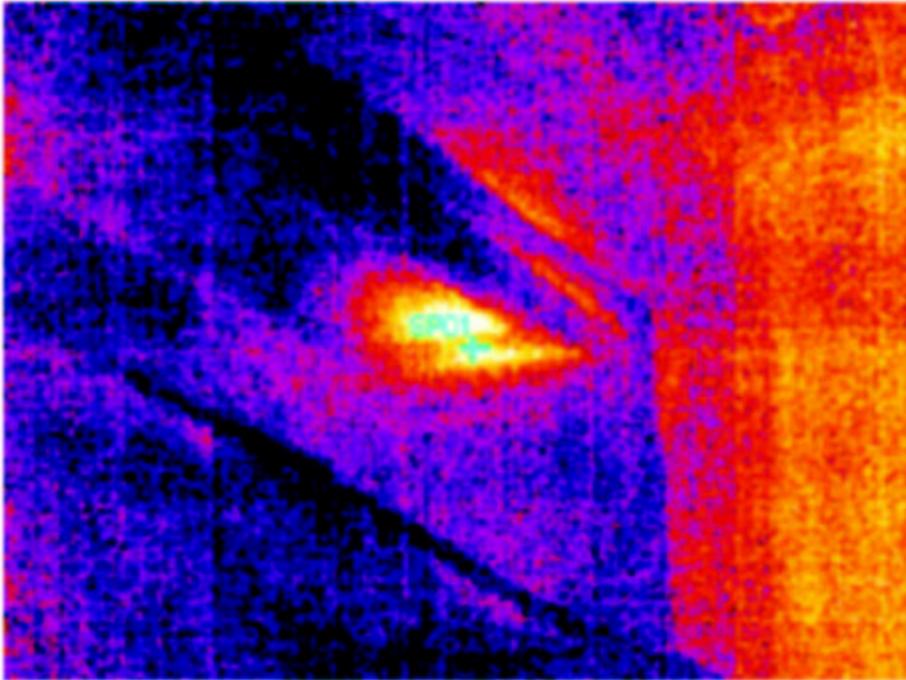
The yellow hot spot on this infrared thermal image of a door jamb indicates termite activity.

Although considered cold-blooded creatures, termites are hosts to bacteria, which help break down and digest cellulose, the main ingredient of the wood they digest. The digestion process generates heat, and when large numbers of termites in nests congregate, a substantial amount of heat is concentrated in one area. As this heat moves through the walls or floor of a building, an IR camera can detect it on the surface and help to facilitate corrective action.

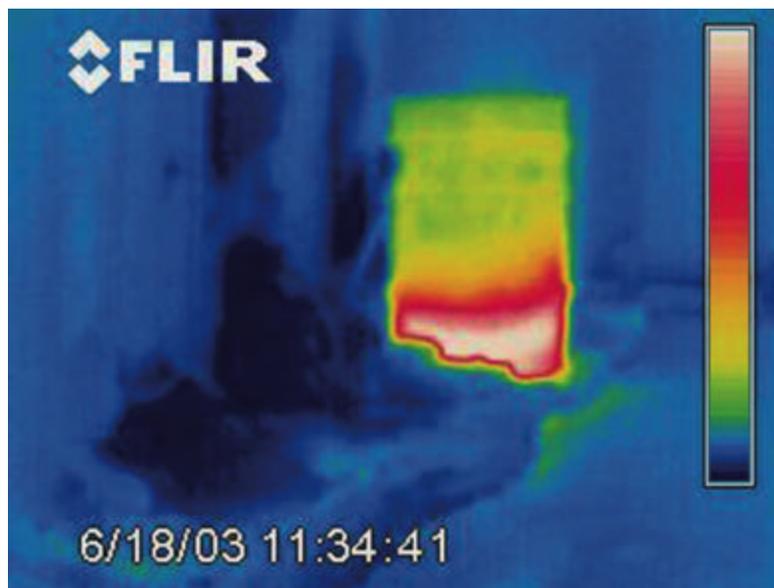
Here we see the IR thermogram that spotted a potentially catastrophic level of heat being generated by an exothermic reaction of sodium hydrosulfite and water in 32-gallon drum.

One such find occurred when Four Star Cleaning & Restoration of Fremont, CA was called in to document the water damage for insurance purposes at the site of a serious electrical fire at a garment dying facility. In addition to the wet walls, which had been soaked by the sprinkler system and fire department hoses, Four Star's IR camera found an unexpected thermal anomaly - an excessive heat source within a closed 32-gallon drum containing sodium hydrosulfite used in the dying process. Some water had apparently penetrated the drum to produce poisonous hydrogen sulfide gas and enough heat to potentially cause an explosive condition from spontaneous combustion. A hazardous waste hauler was called in, and under the supervision of HAZMAT and local County Health Services, the drum was disposed of.
