## **Using Infrared Thermography to Aid in Indoor Air Quality Inspection & Mold Remediation**

Lance Eisen, National Director Warranty &  
Monitoring Training Programs  
NORMI, Inc.  
22174 Prats Road  
Abita Springs, LA 70420  
Ph: 877-251-2296  
Fax: 866-211-4324

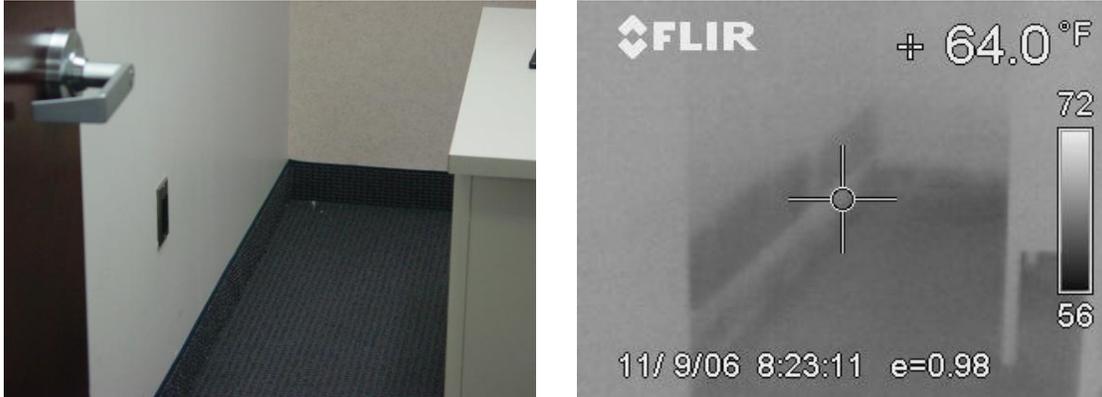
## Example 1

The image on the left is of an office in a 20,000 square foot building that had a large sewage leak within the previous 24 hours. Maintenance crews responded, cleaned surfaces, and extracted the water from the carpet. Fans were then used to dry exposed surfaces. A visual inspection of the room didn't identify a potential for contamination and growth.

The infrared image on the right indicates a thermal exception that appears to extend upward from the floor. A non-invasive moisture meter was used to confirm the presence of moisture in the wallboard. The readings of moisture saturation matched the exceptions visible in the image on the right.

In this example, the infrared camera was used as an investigative and predictive tool. The trained IAQ specialist can use this type of information to develop sanitization and remediation protocols.

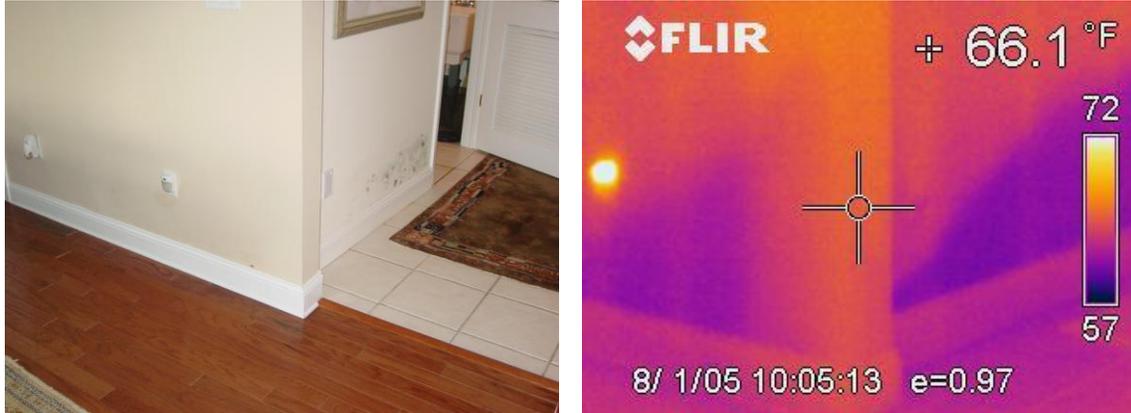
## Example 2

The image on the left shows visible microbial growth on the surface of the wallboard in a home. The growth was cultured and identified at a laboratory. The homeowner's insurance company authorized remediation of the growth only on the surface of the wall.

The image on the right was taken during a secondary inspection using infrared thermography. The second report indicated thermal changes in the wallboard consistent with moisture intrusion. In short, when presented with the second report, the insurance company approved and paid for the proper required remediation.
